HURRICANE IDA REPAIRS TO EXTERIOR OF THE  
BUILDING, INCLUDING RECONSTRUCTION OF  
SLATE ROOF, MASONRY STABILIZATION, AND  
WINDOW/SHUTTER REPAIRS

## 923 DECATUR STREET EXTERIOR REPAIRS

923 DECATUR ST  
NEW ORLEANS, LA 70116  
VIEUX CARRE COMMISSION SUBMISSION

DATE: 01.25.22  
PROJECT NO.: 01-21-1026-02

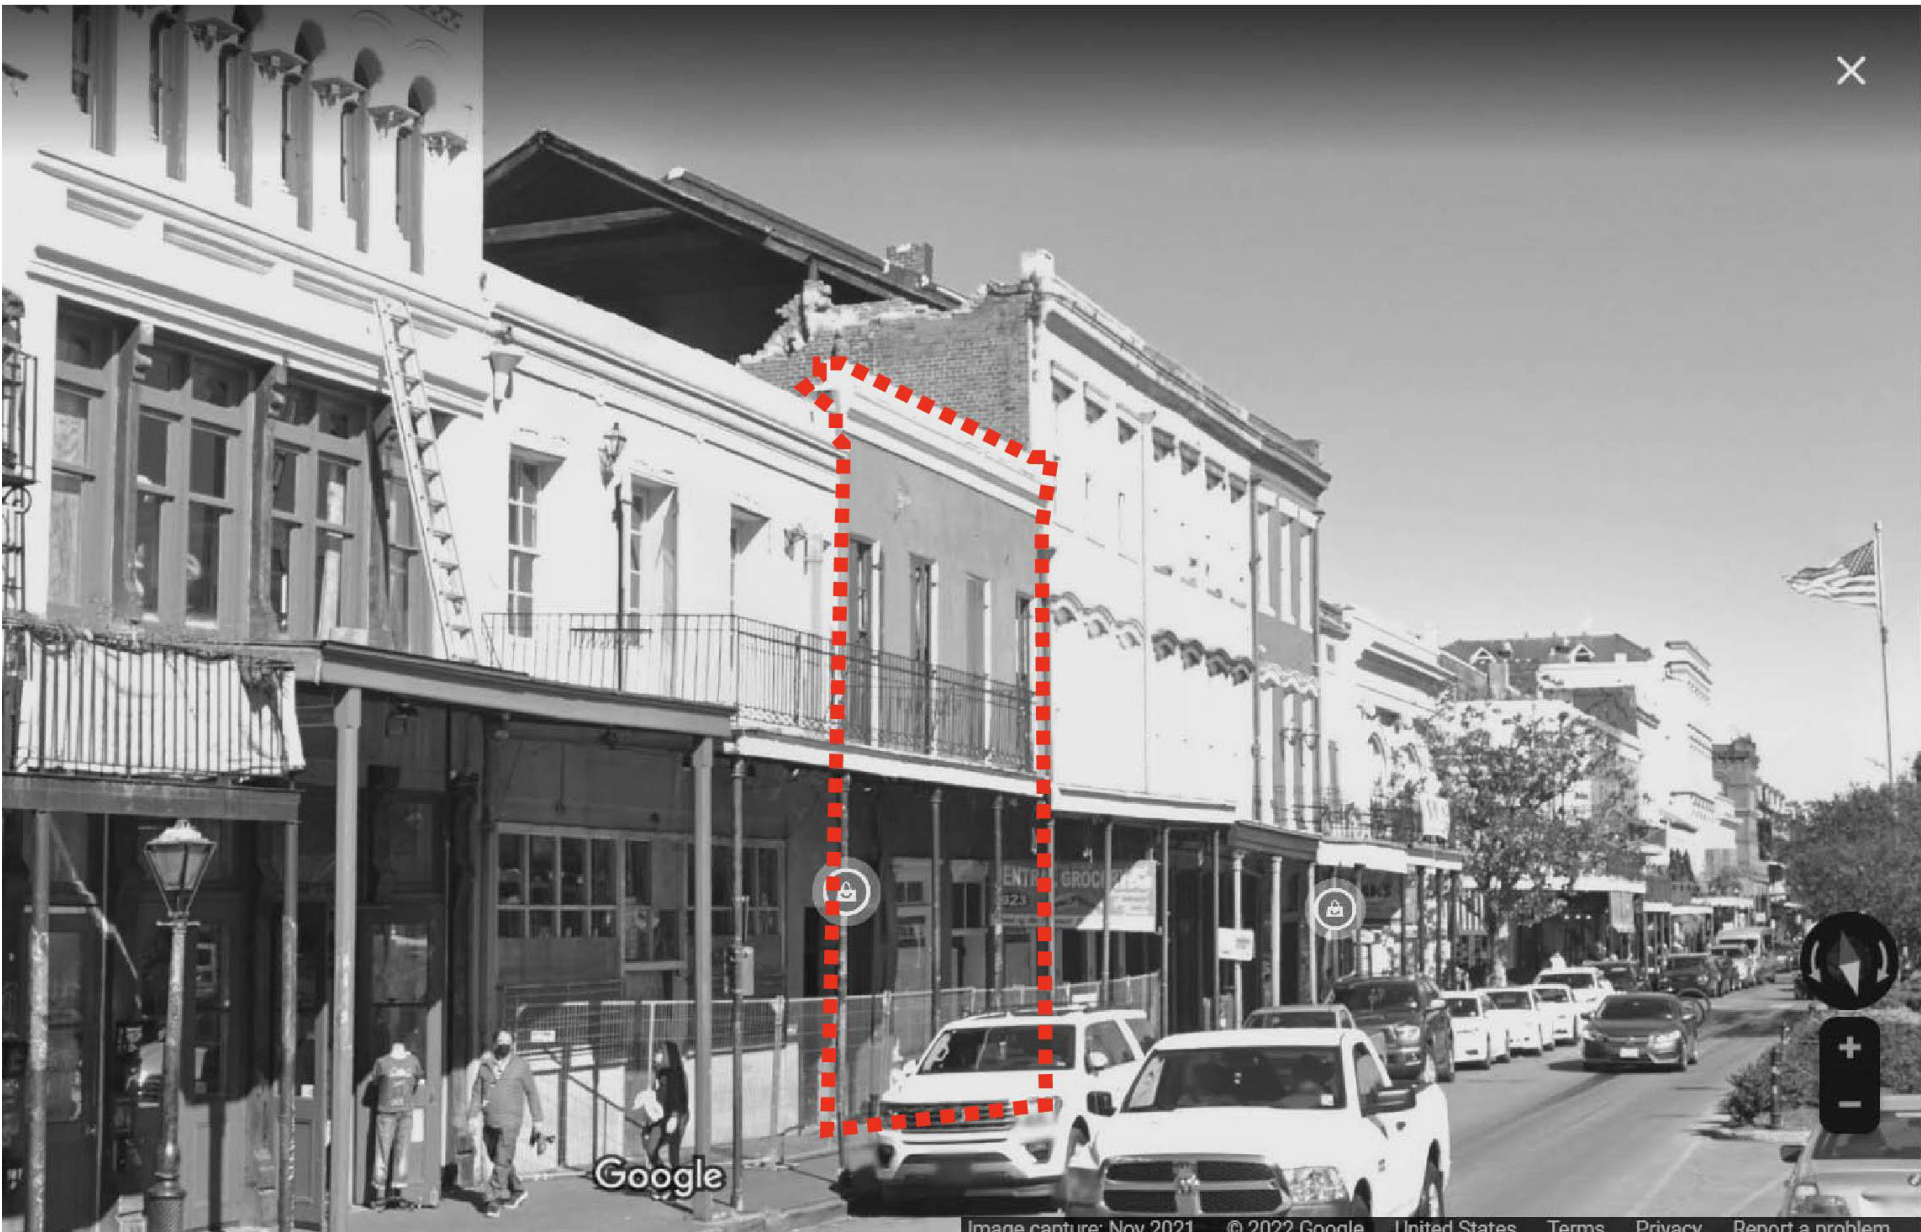
GOOGLE STREET VIEW IMAGE OF STREET FRONT AND DAMAGED PARTY WALL.

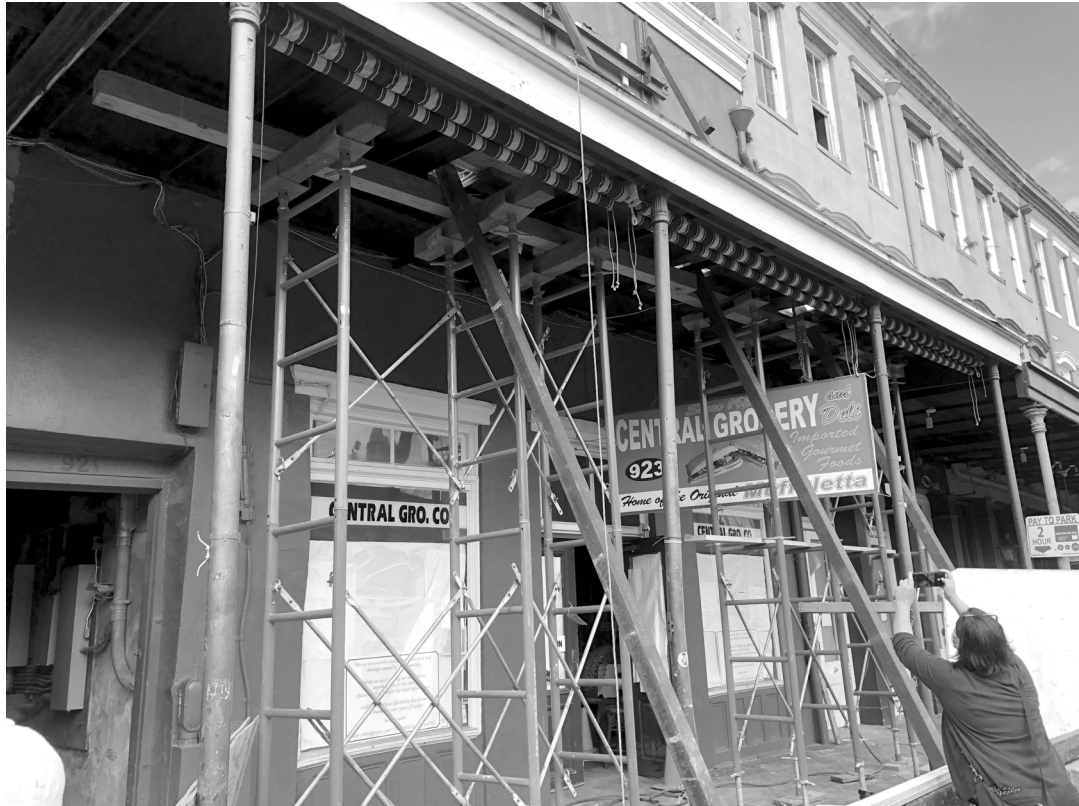
STREET FRONT FACADE WITH TEMPORARY SHORING IN PLACE.

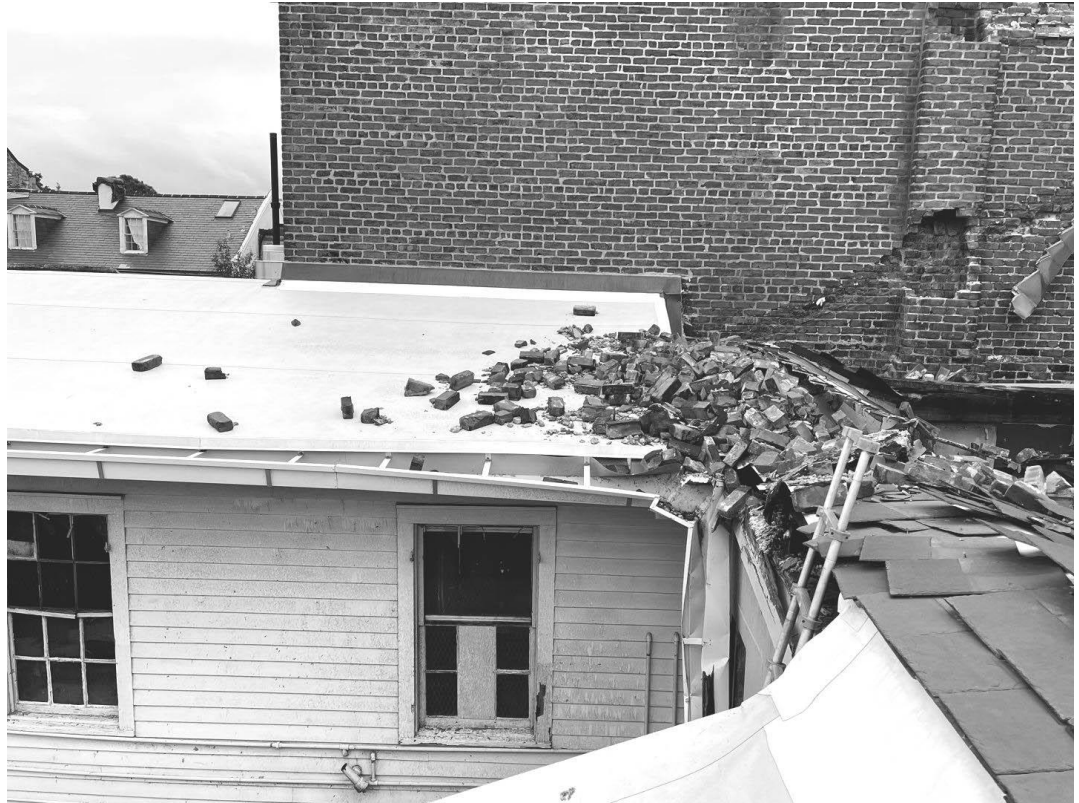
DRONE IMAGE OF BRICKS ON EXISTING ROOF STRUCTURES.

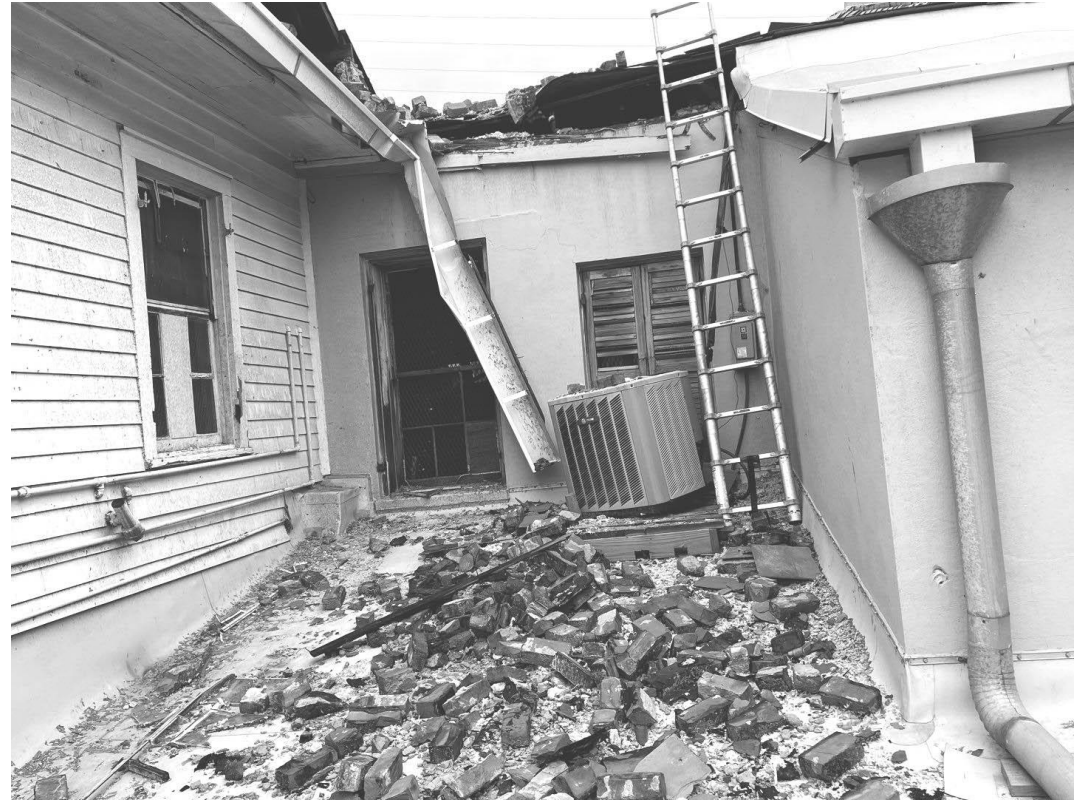
DRONE IMAGE OF BRICKS ON EXISTING ROOF STRUCTURES AND DAMAGED GUTTER.

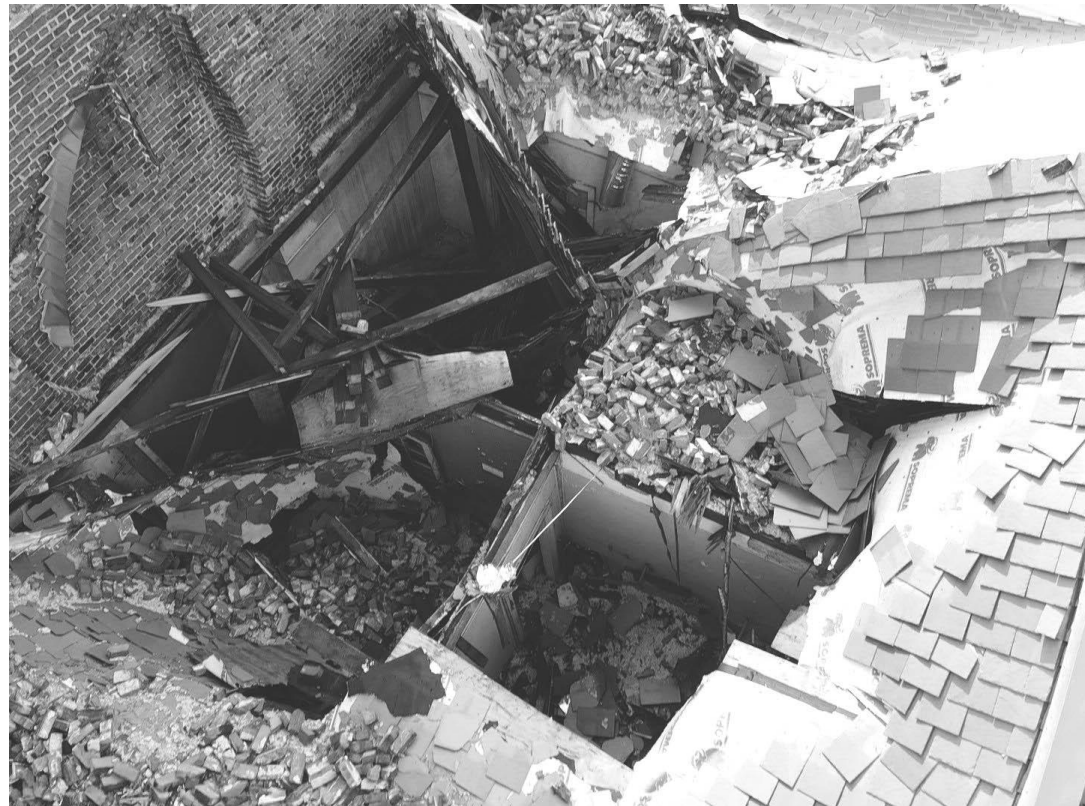
DRONE IMAGE OF COLLAPSED SLATE ROOF.

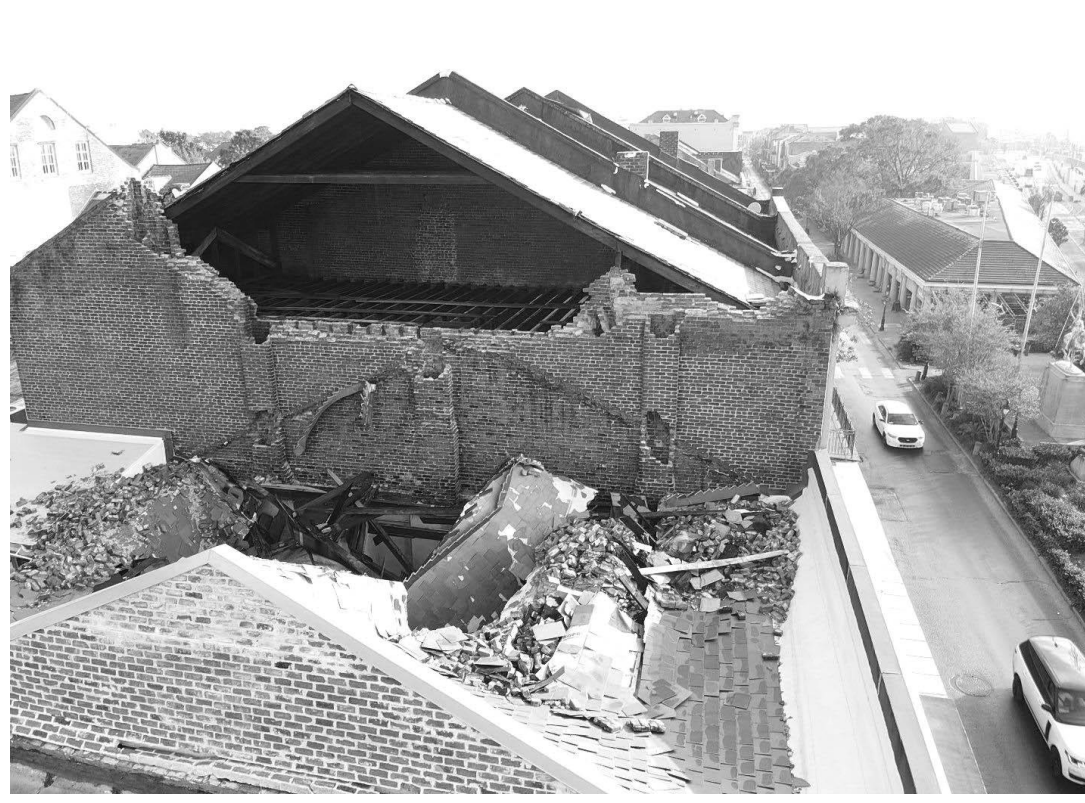
DRONE IMAGE OF COLLAPSED BRICK PARTY WALL.
