BUILDING ROOF-MANSARD AREA SHINGLE OVERLAY

Thursday, June 16, 2022

16 Issues Identified

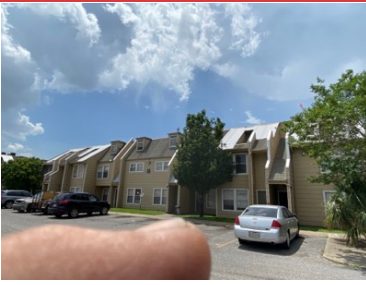
BUILD 8: shingle overlay left and right end of building penetrated with cap nails and synthetic. approx 50% of mansard roof area at front

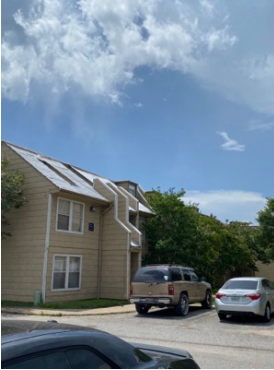
BUILD 7: shingle overlay left end of building penetrated with cap nails and synthetic. approx 20% of mansard roof area at front

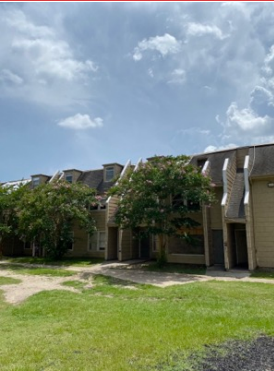
BUILD 7: right end no work req.

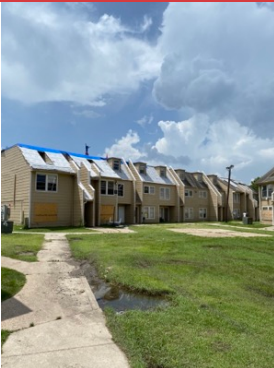
BUILD 18: shingle overlay left and right end of building penetrated with cap nails and synthetic. approx 40-45% of mansard roof area at front

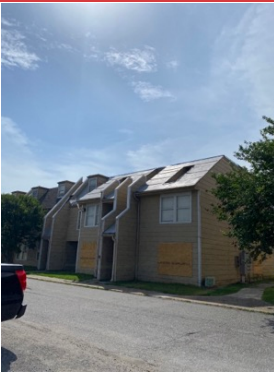
BUILDING 9: shingle overlay left and right end of building penetrated with cap nails and synthetic. approx 60-65% of mansard roof area at front

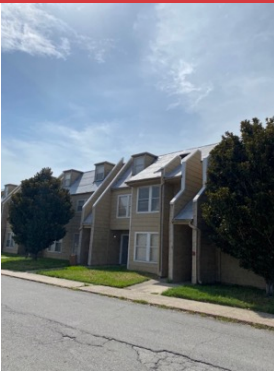
BUILDING 13: shingle overlay end of building penetrated with cap nails and synthetic. 100% of mansard roof area at front

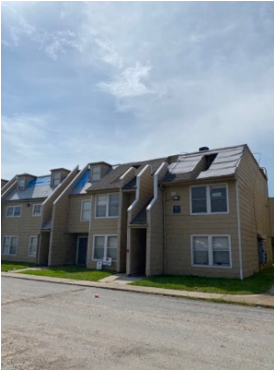
BUILDING 10 1ST: shingle overlay left and right end of building penetrated with cap nails and synthetic. approx 80-85% of mansard roof area at front

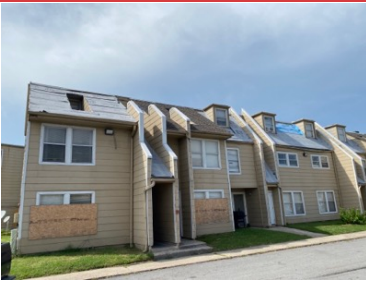
**BUILDING 10
2ND AREA ROOFED**

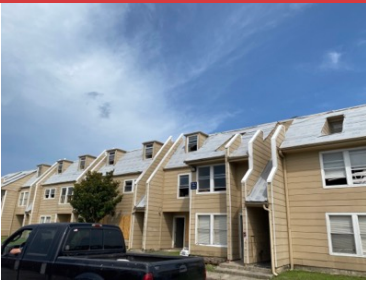
BUILDING 11: shingle overlay of building penetrated with cap nails and synthetic. approx 100% of mansard roof area at front

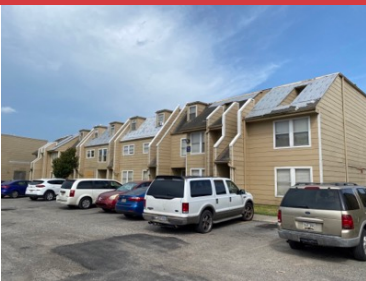
BUILDING 14: shingle overlay left and right end of building penetrated with cap nails and synthetic. approx 80-85% of mansard roof area at front

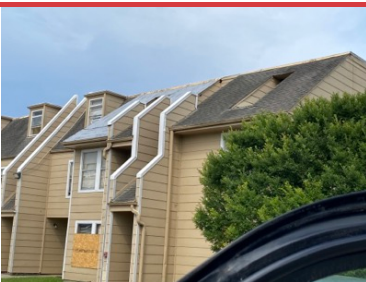
BUILDING 15: shingle overlay left and right end of building penetrated with cap nails and synthetic. approx 30-35% of mansard roof area at front

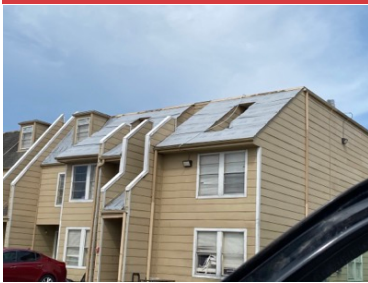
BUILDING 17: shingle overlay left and right end of building
penetrated with cap nails and synthetic. approx 50% of mansard
roof area at front

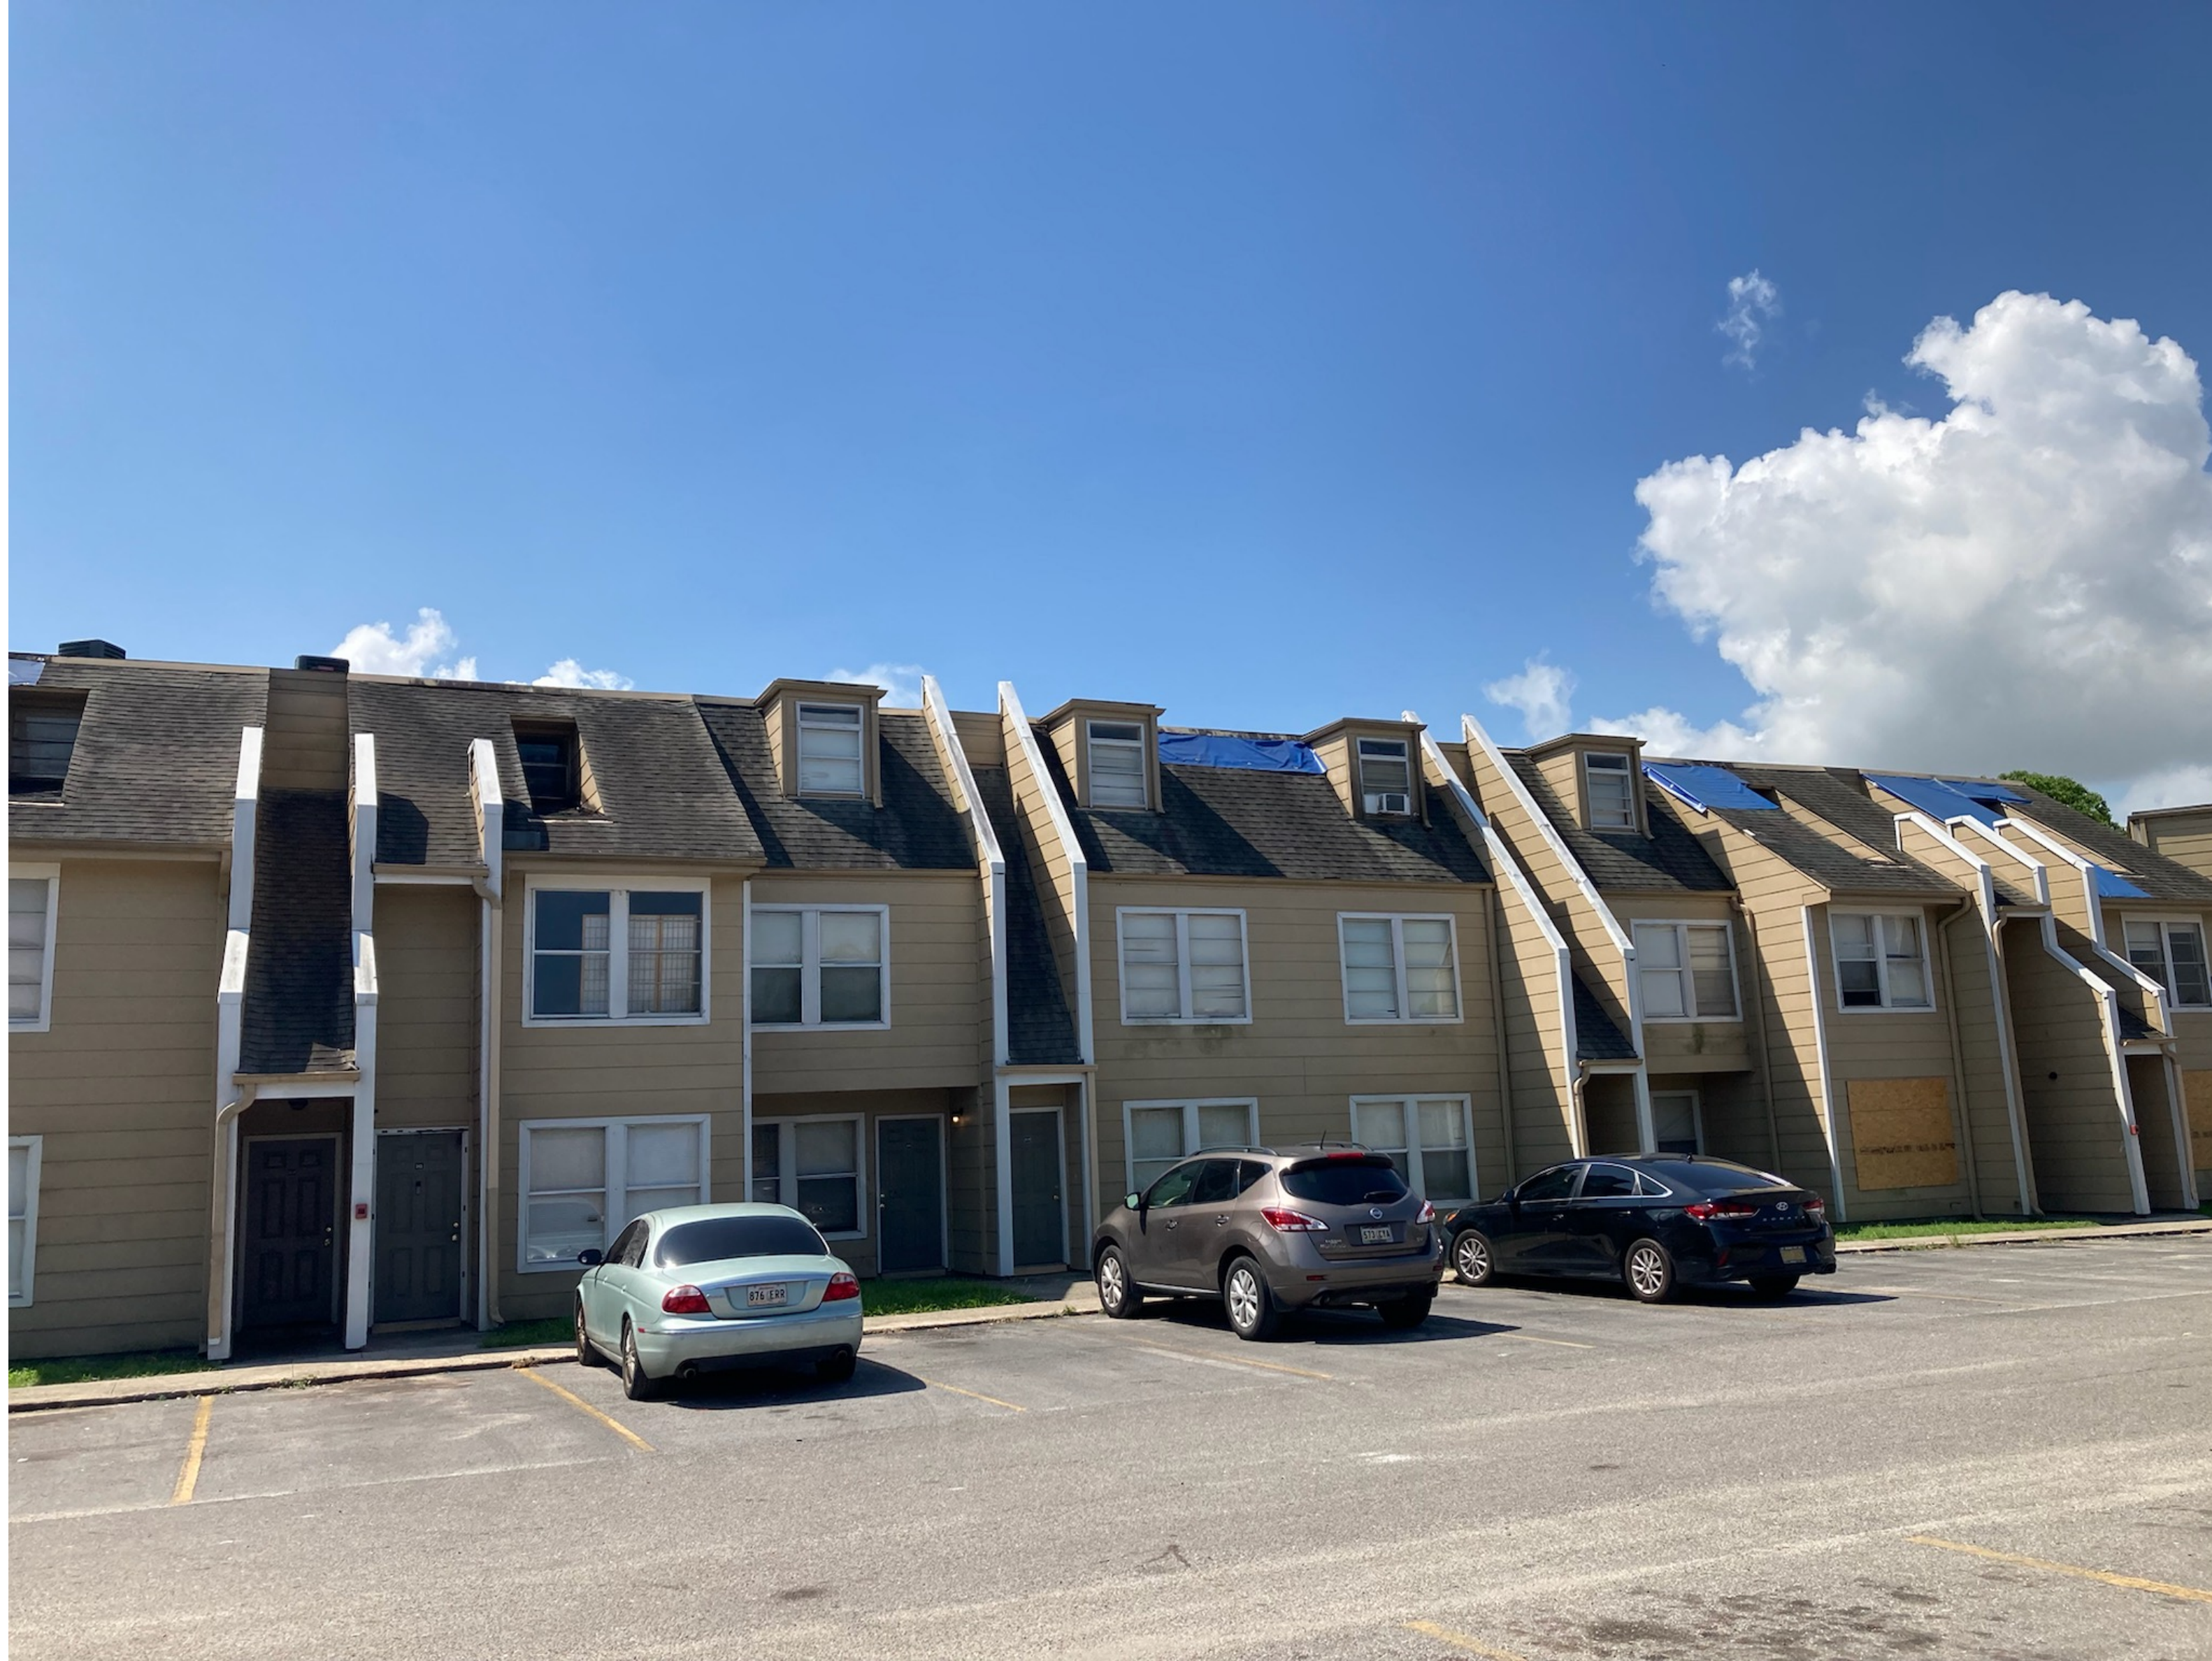
BUILDING 5: shingle overlay CENTER AND RIGHT of building penetrated with cap nails and synthetic. approx 40% of mansard roof area at front

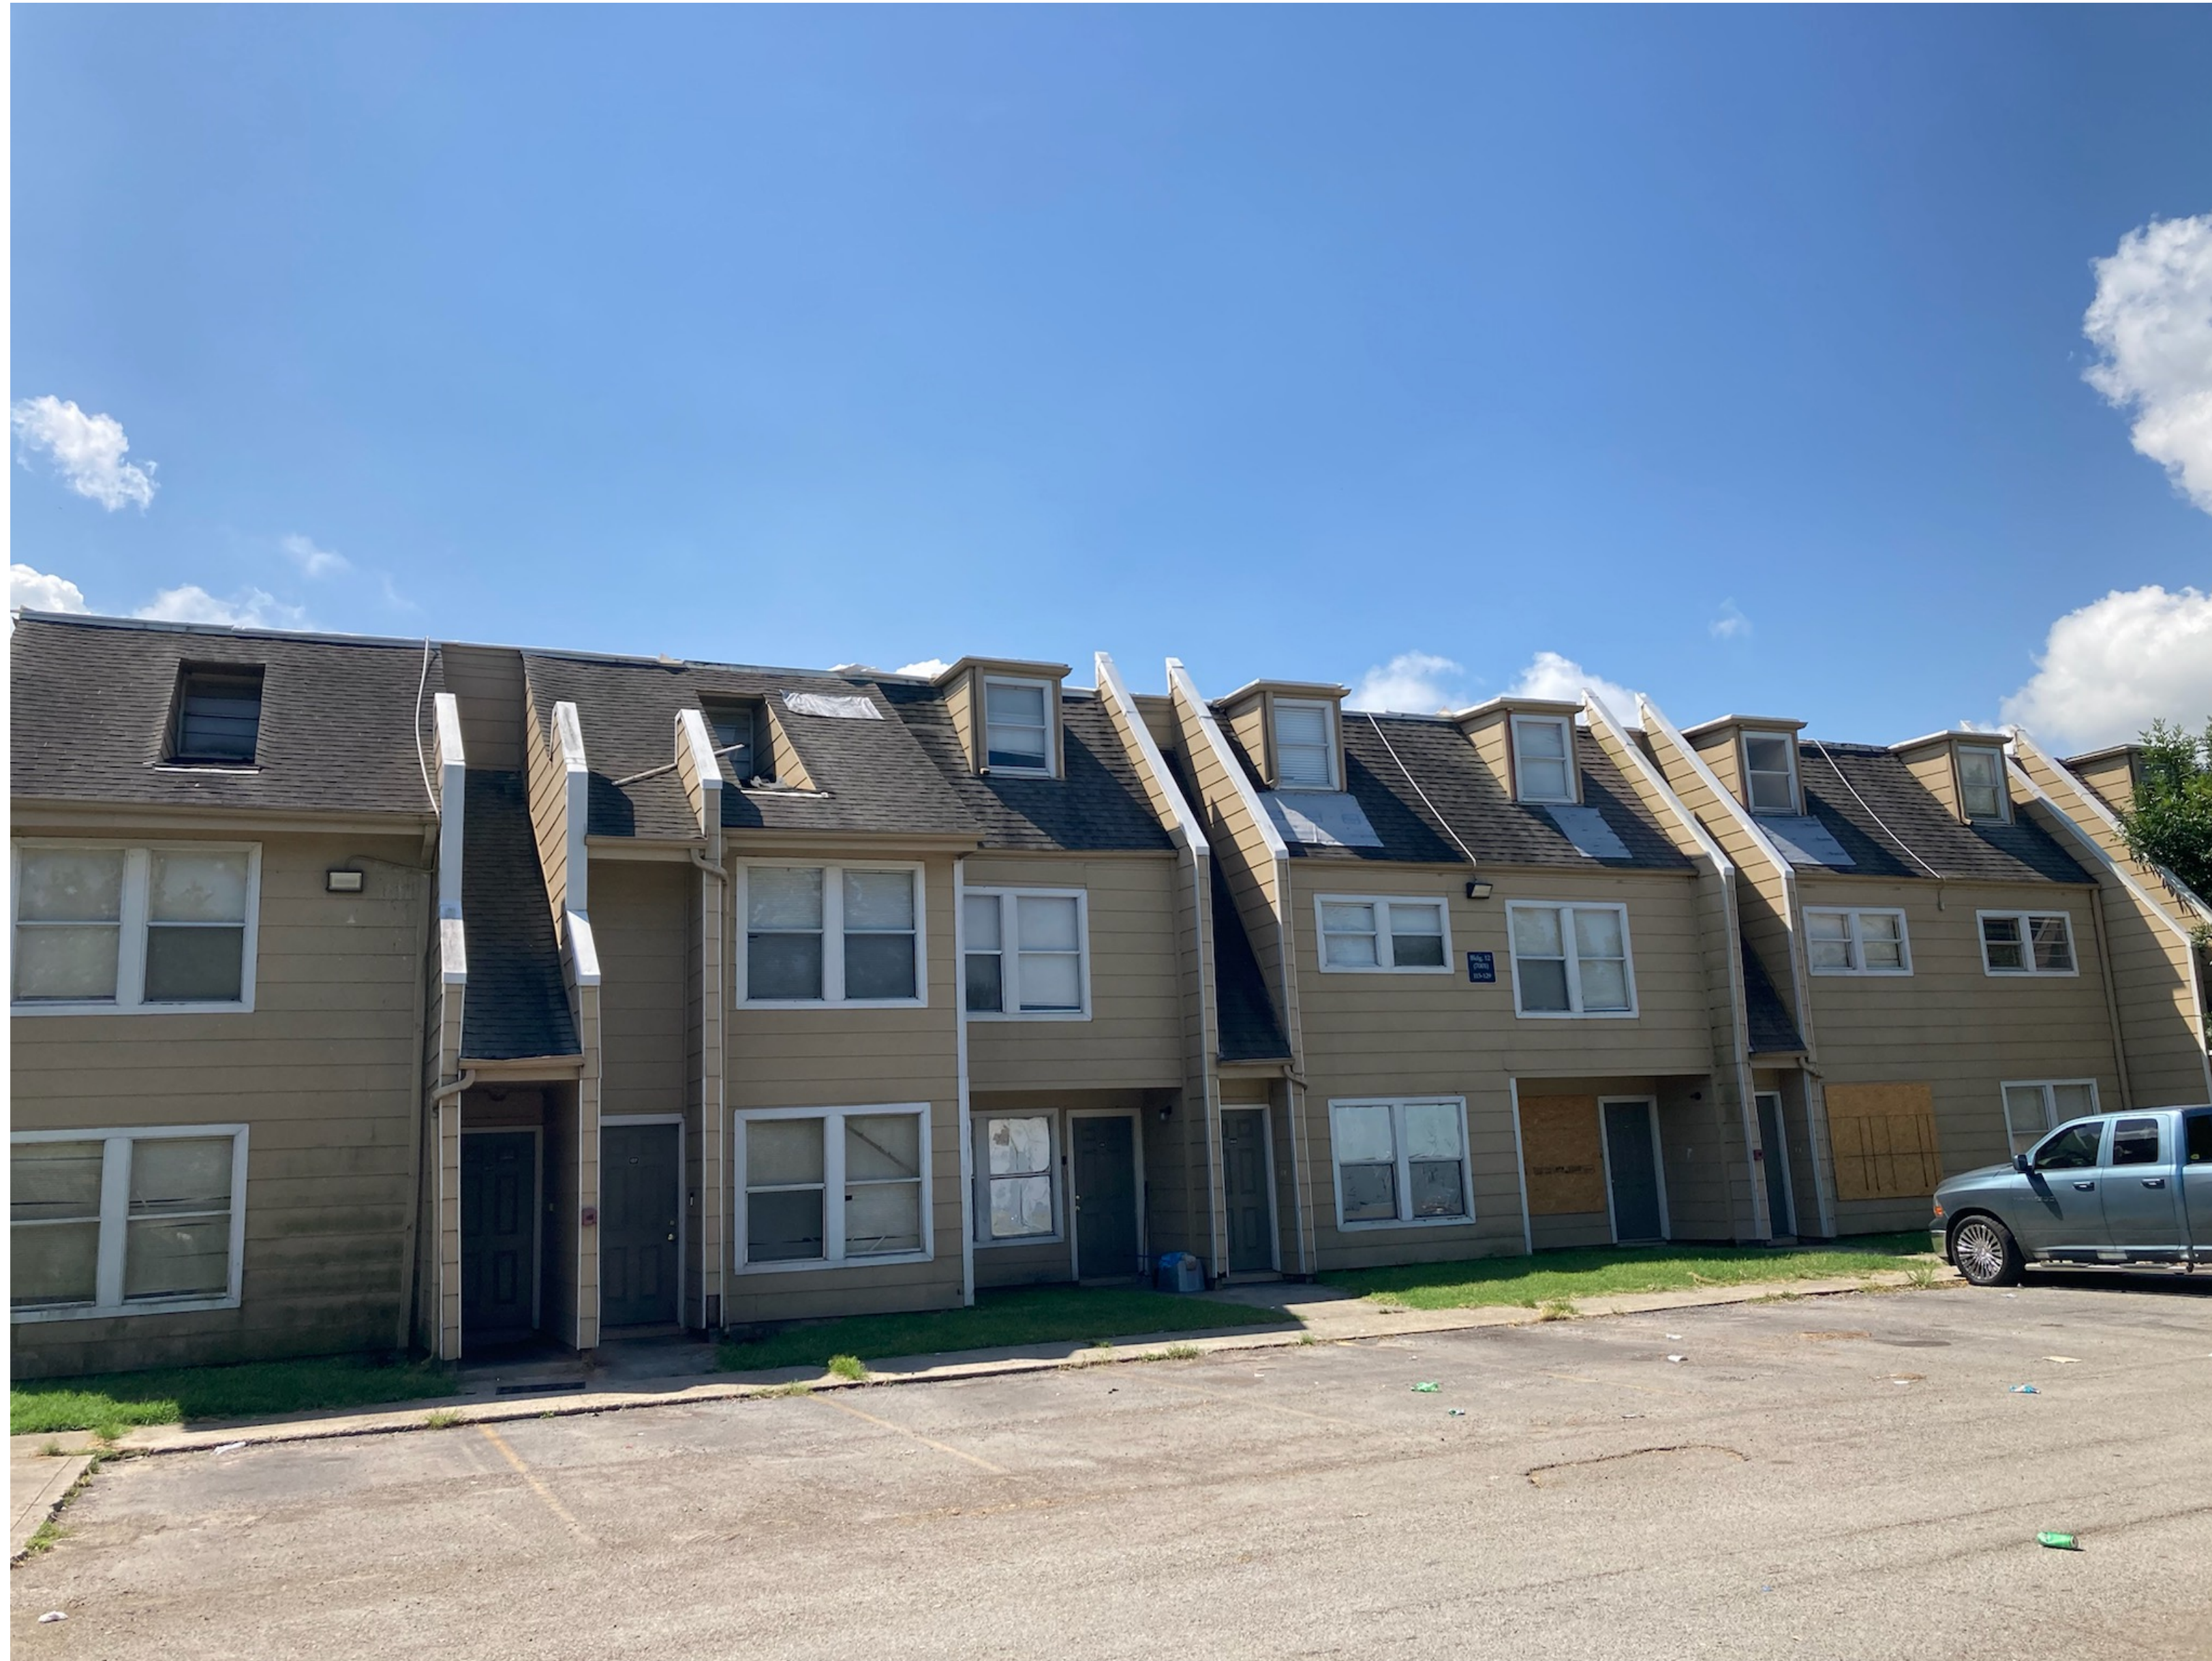
BUILDING 12: shingle overlay CENTER of building penetrated with cap nails and synthetic. approx 30% of mansard roof area at front
