Ref: 2815 Frenchmen LLC
2815 Frenchmen St.
New Orleans, LA
Claim # MU00179
VECO# 221235

Complying with your assignment we performed an inspection at the above referenced location on August 4, 2021. The purpose of our inspection was to determine the extent of structural damage in this building from a recent fire.

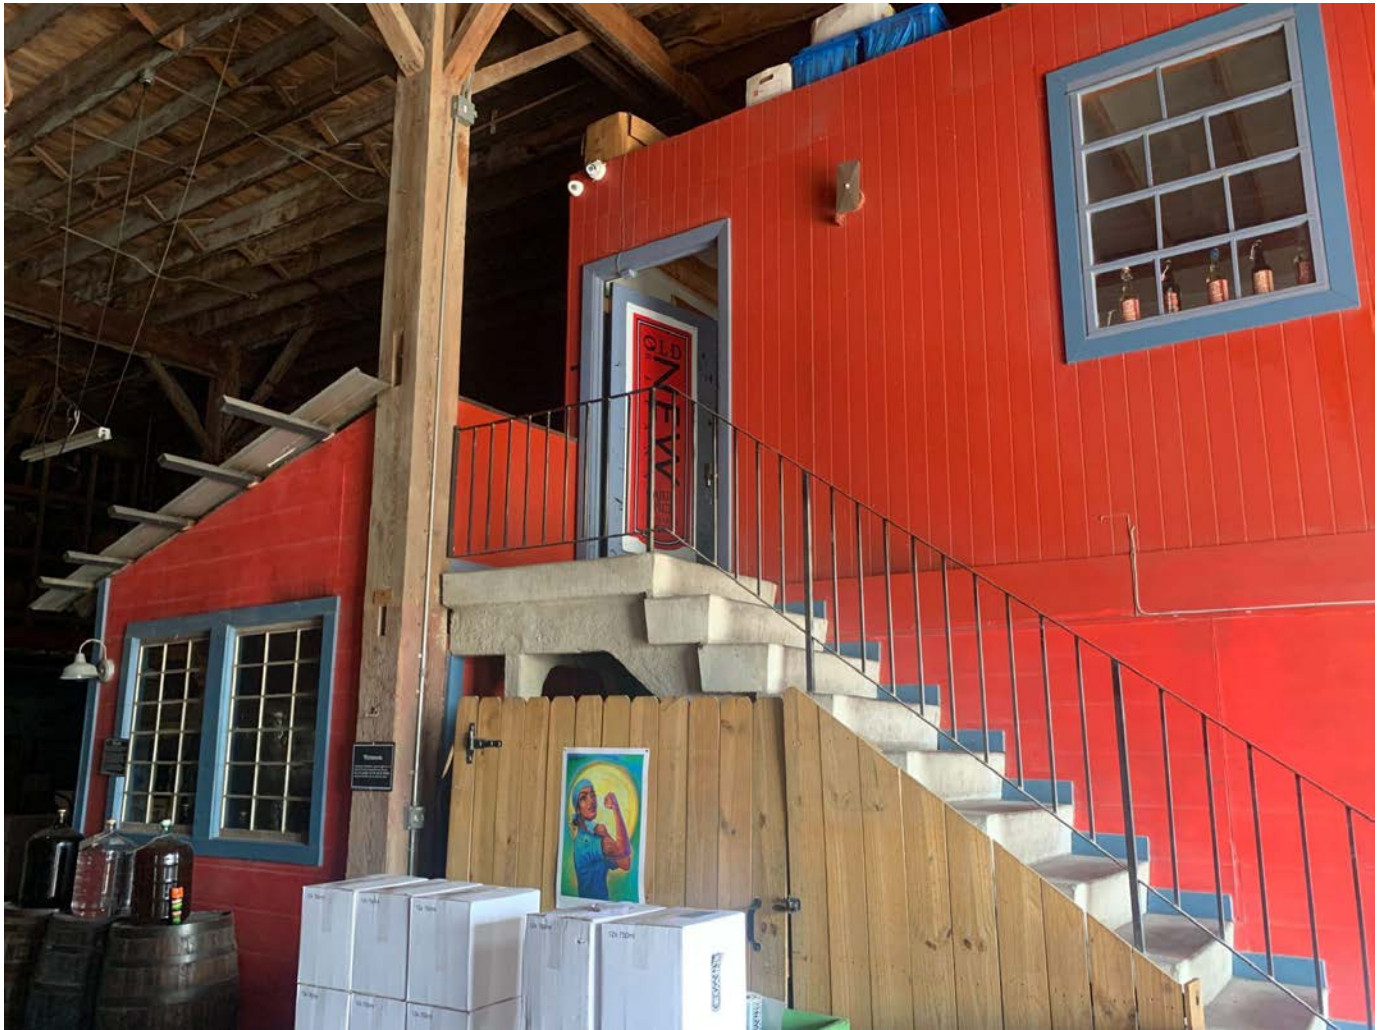
View of interior shell structure containing office and tasting room

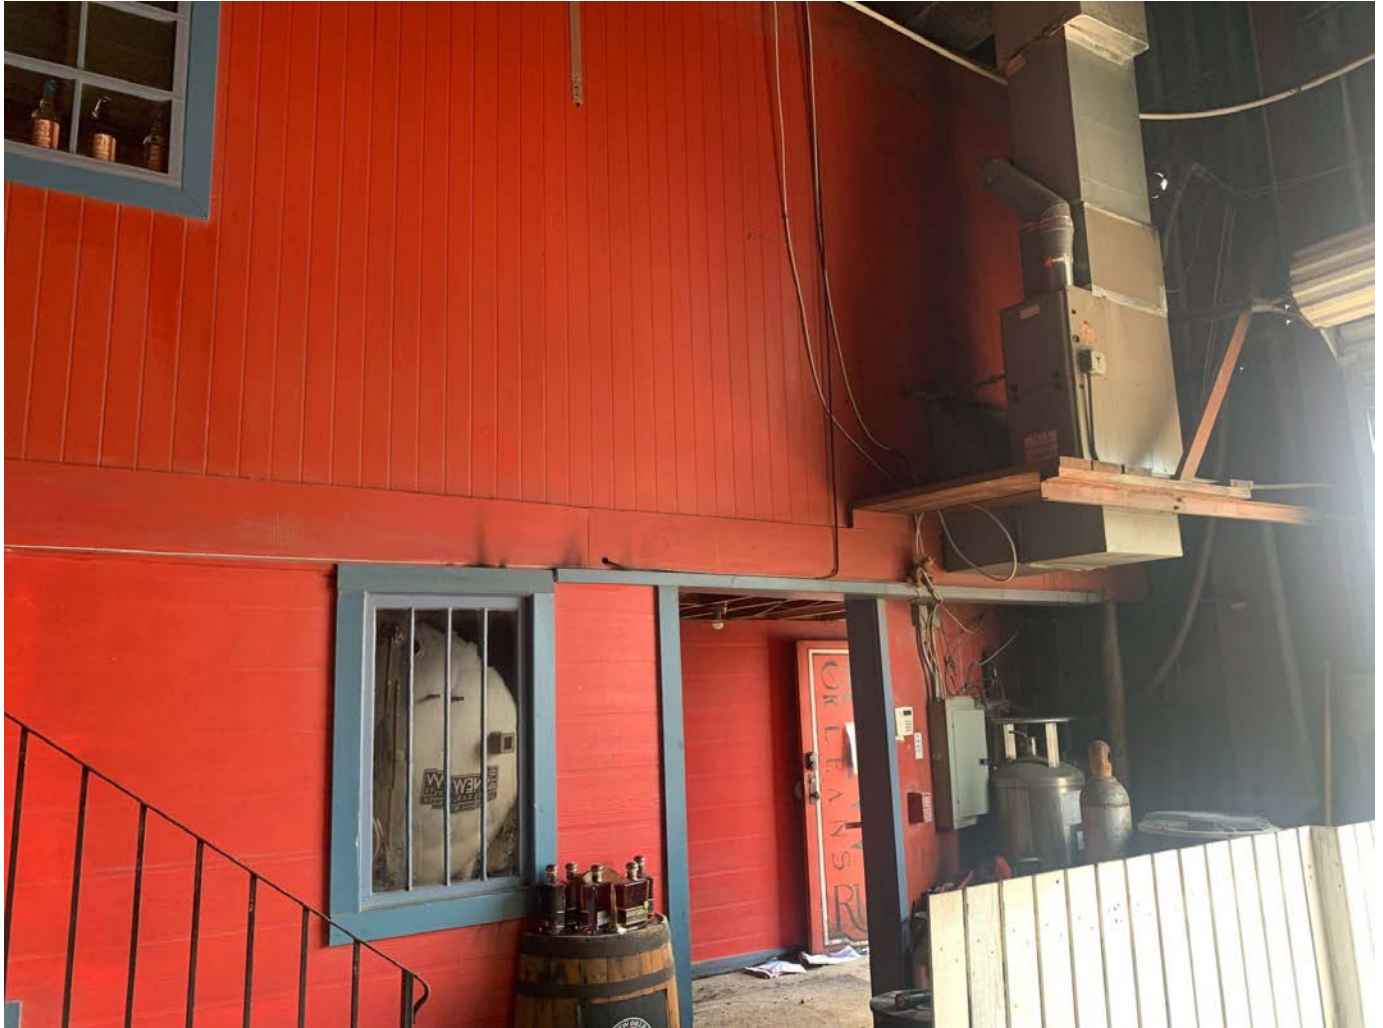
View of interior shell structure containing office and tasting room

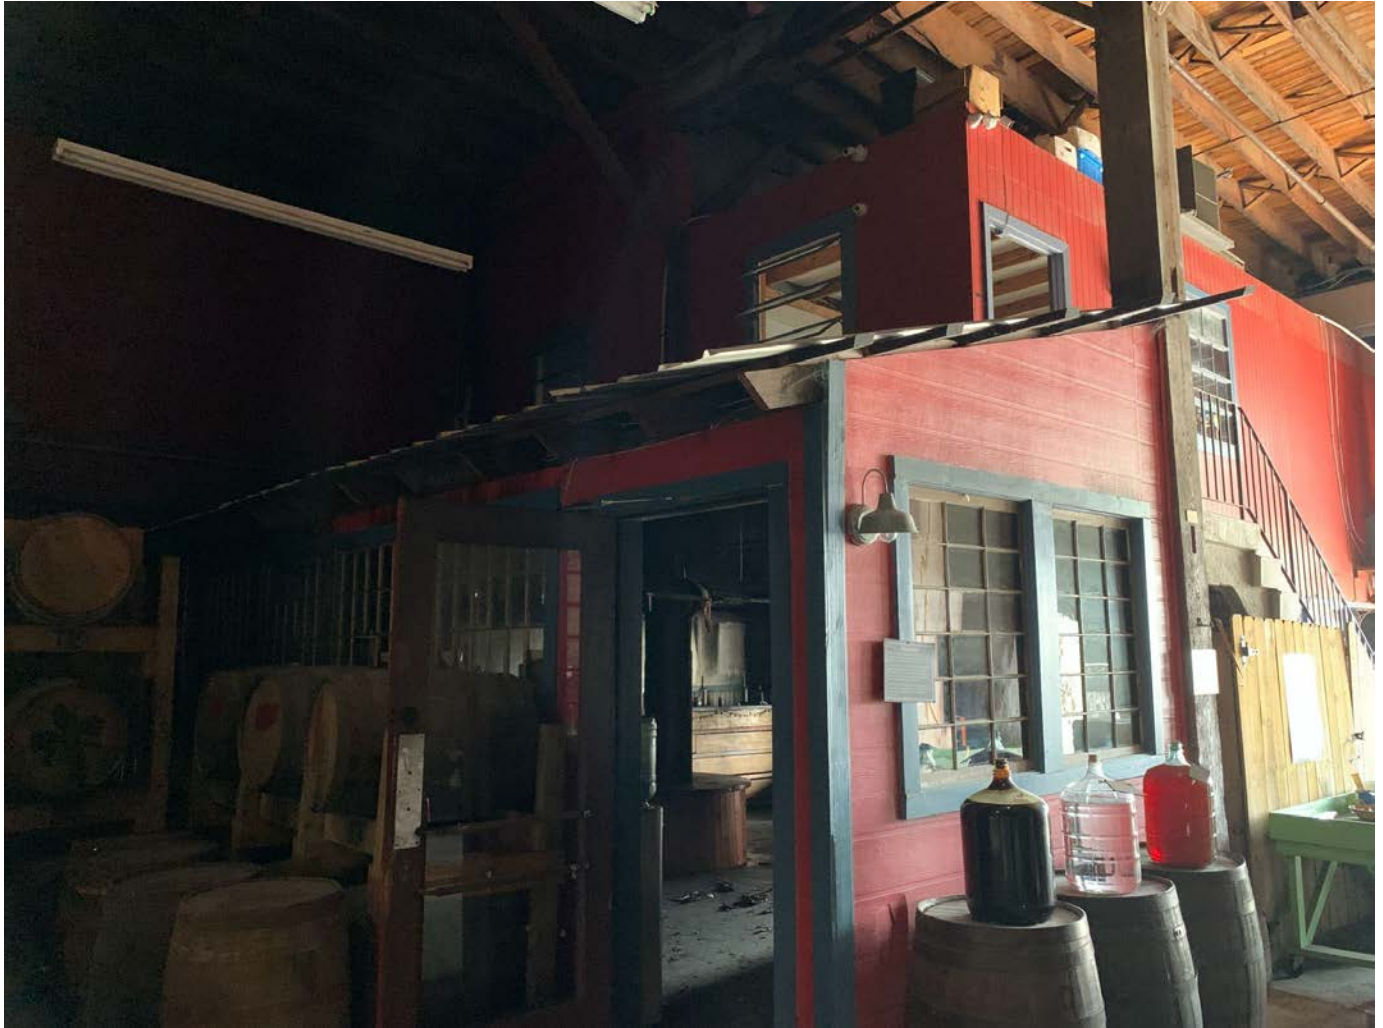
Left rear corner of shell building

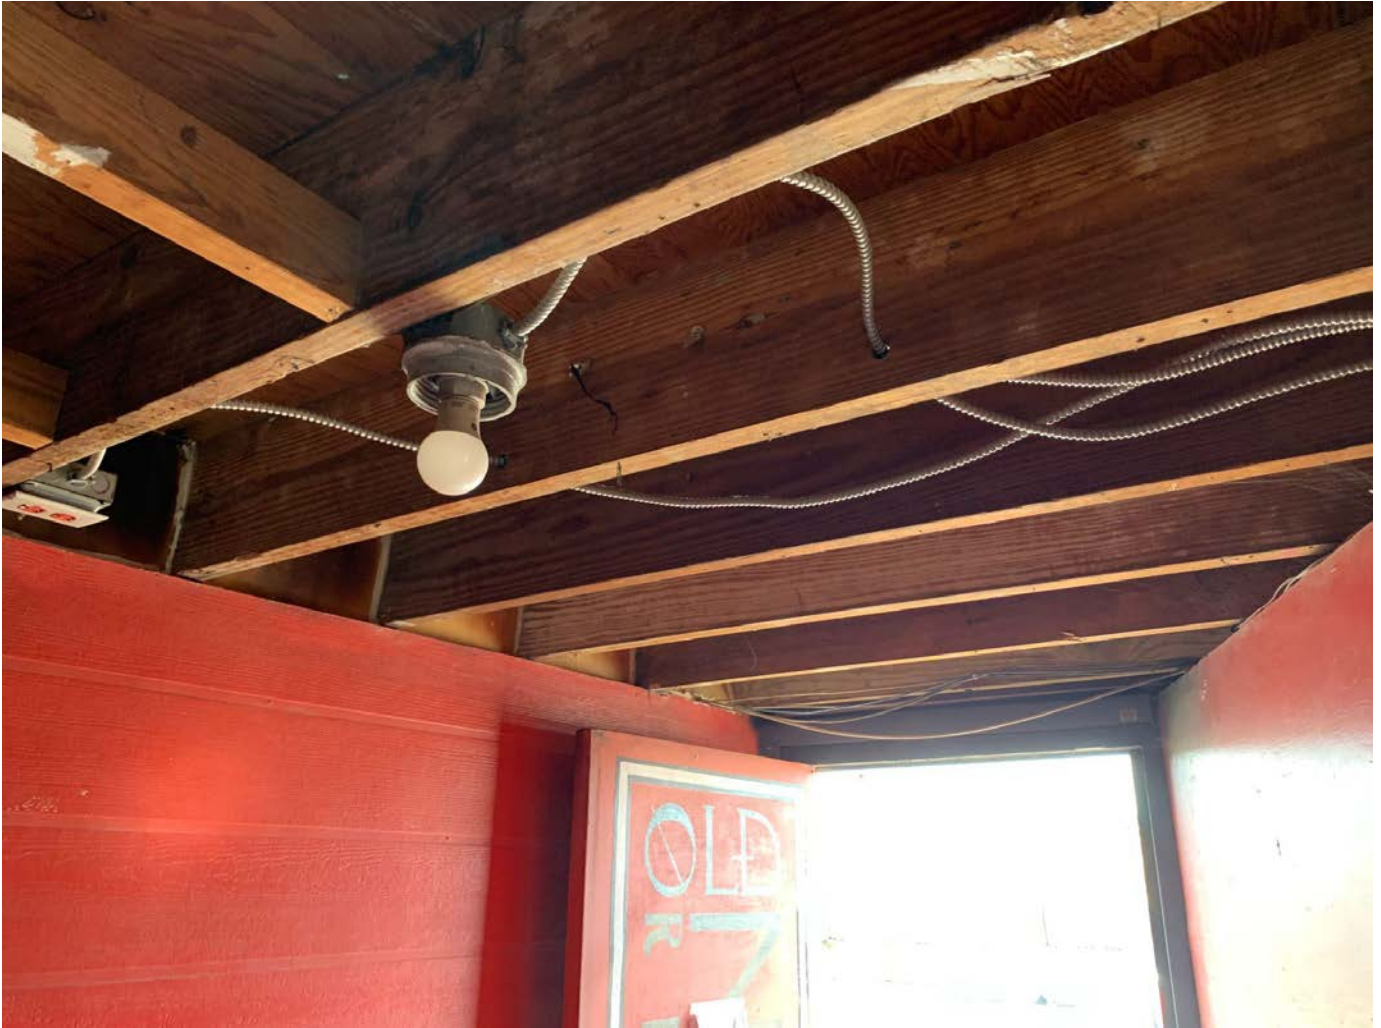
View of joists over front entry area which extend into tasting room ceiling

2. In addition to the joists mentioned above, joists which run parallel to the front wall from the front door to a distance of approximately 8 feet back from the entry to the tasting room will also require replacement due to charring and fire damage.

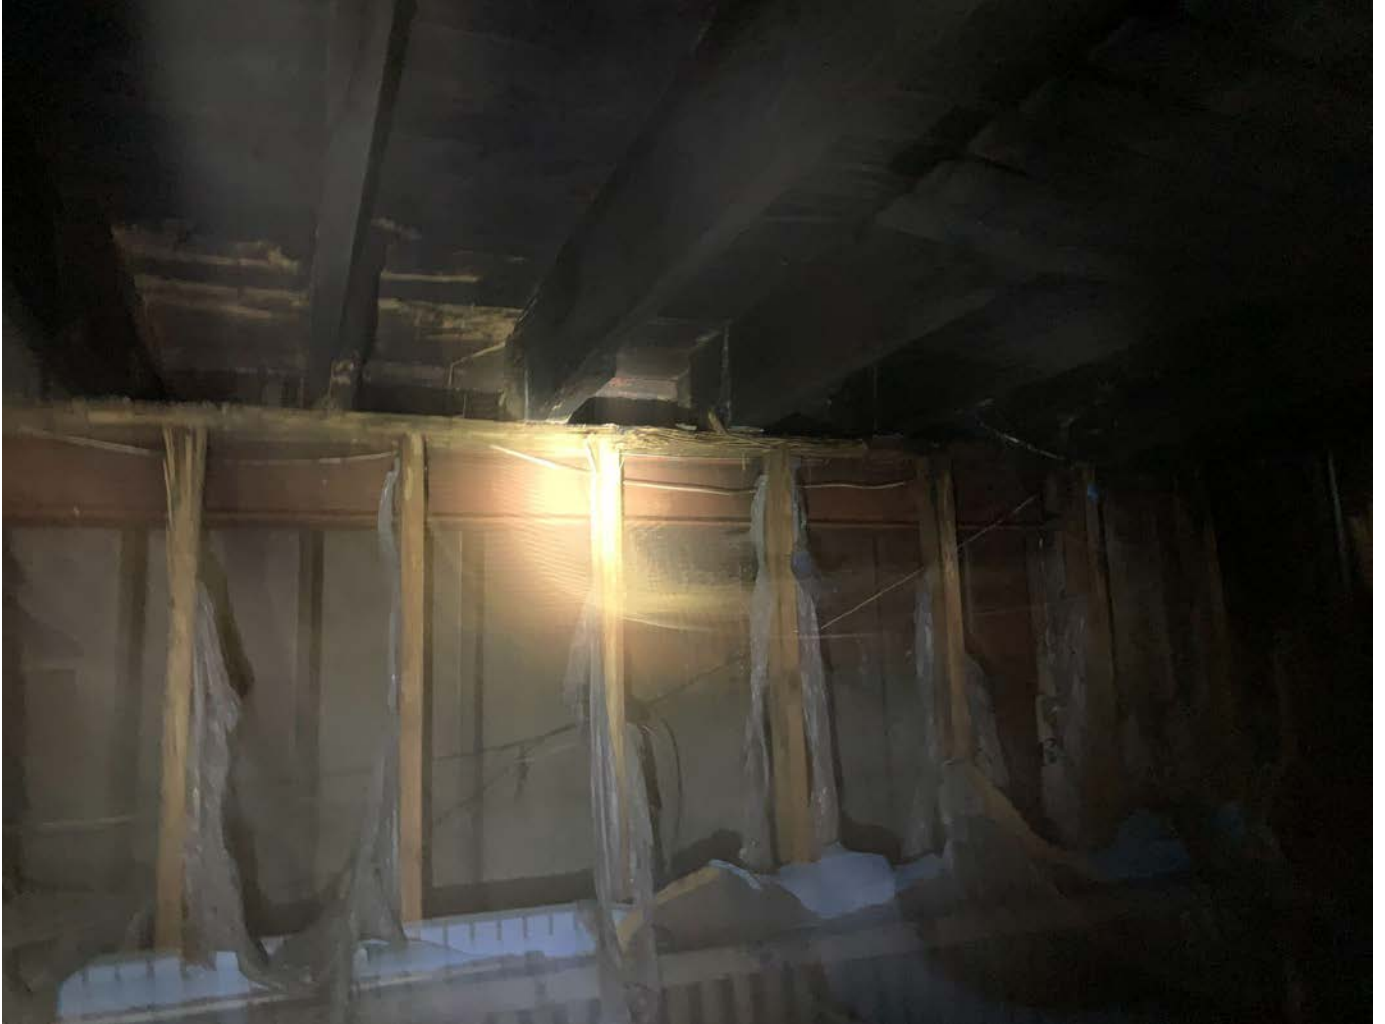
View of charred ceiling joists in tasting room

1. Structural damage from the fire was limited primarily to the ceiling joists in a limited area of the tasting room and the subflooring on top of the joists. We recommended removal of the ceiling joists which run perpendicular to the front wall from the front wall to the bathroom support beam.

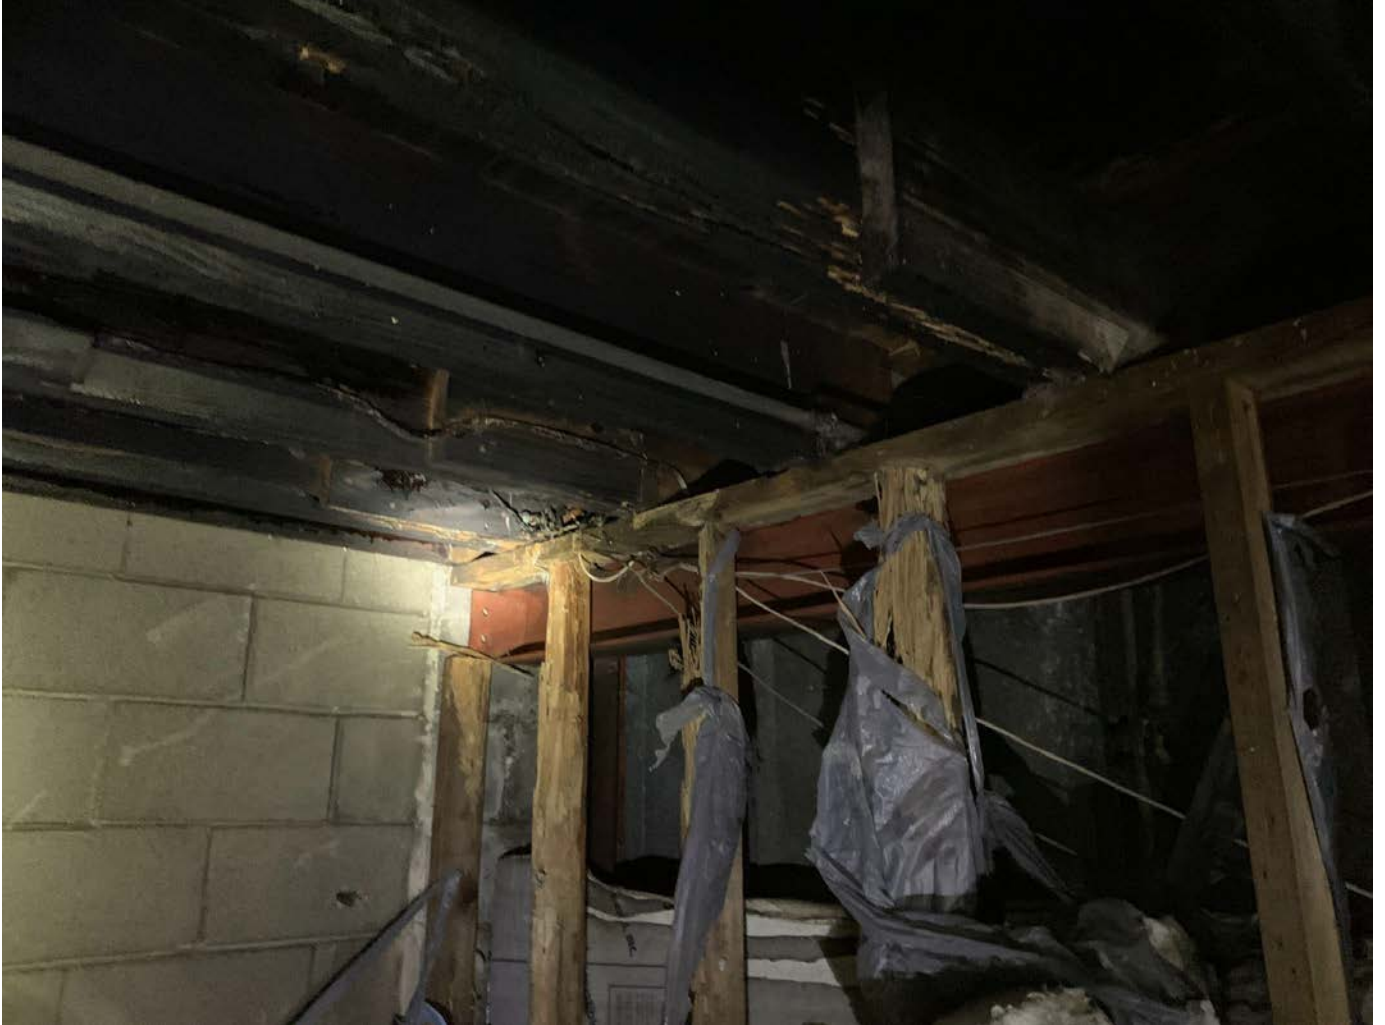
View of charred joist at front

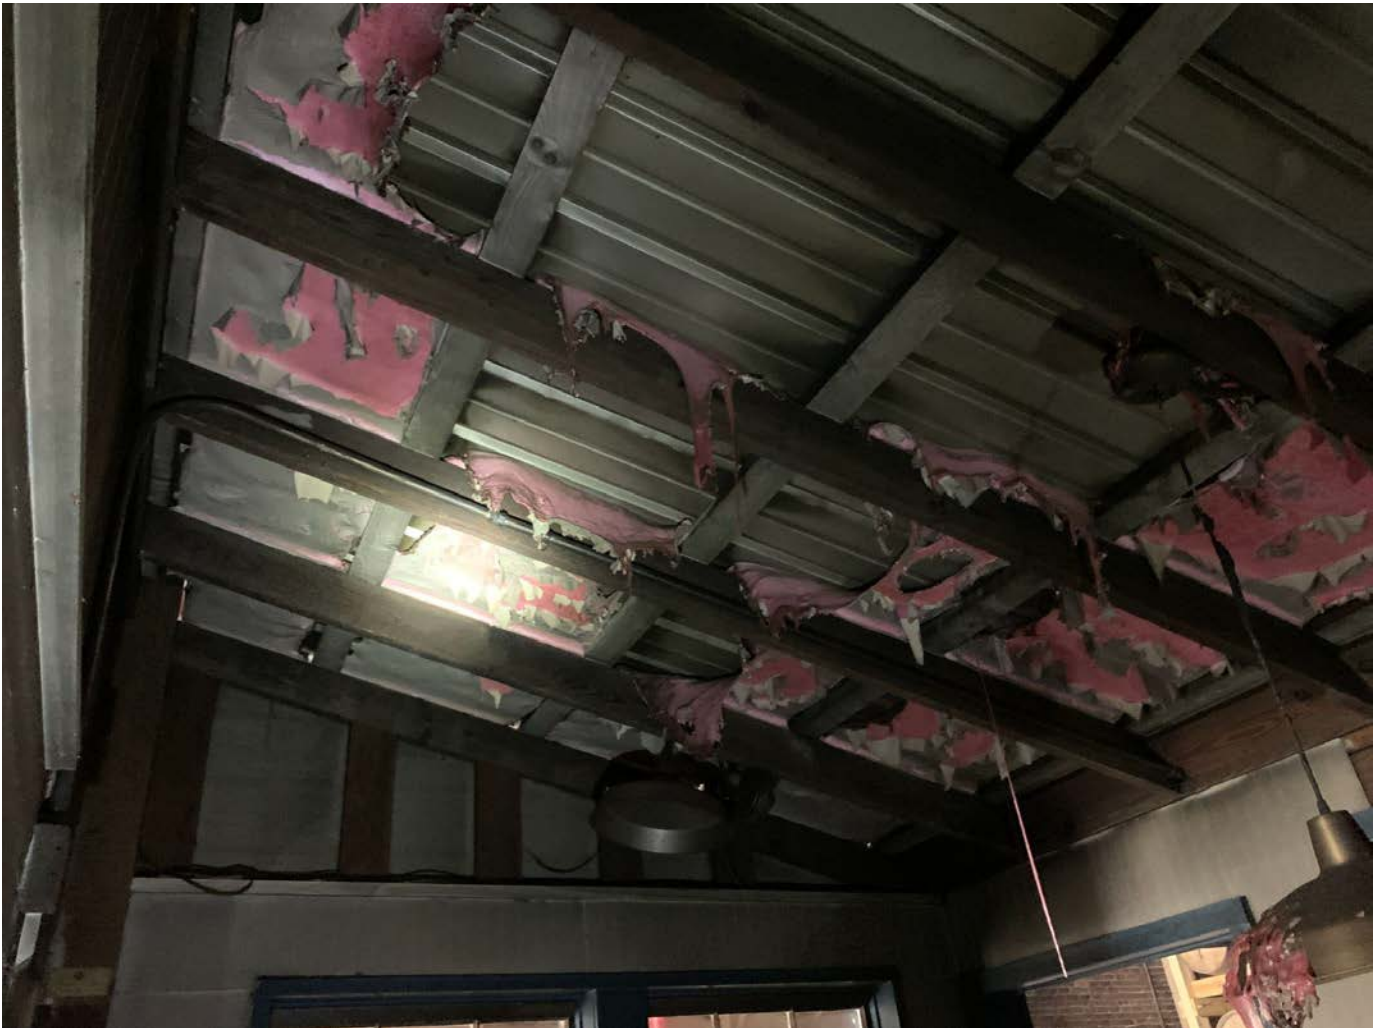
Smoke staining to rafters at rear of tasting room which were undamaged

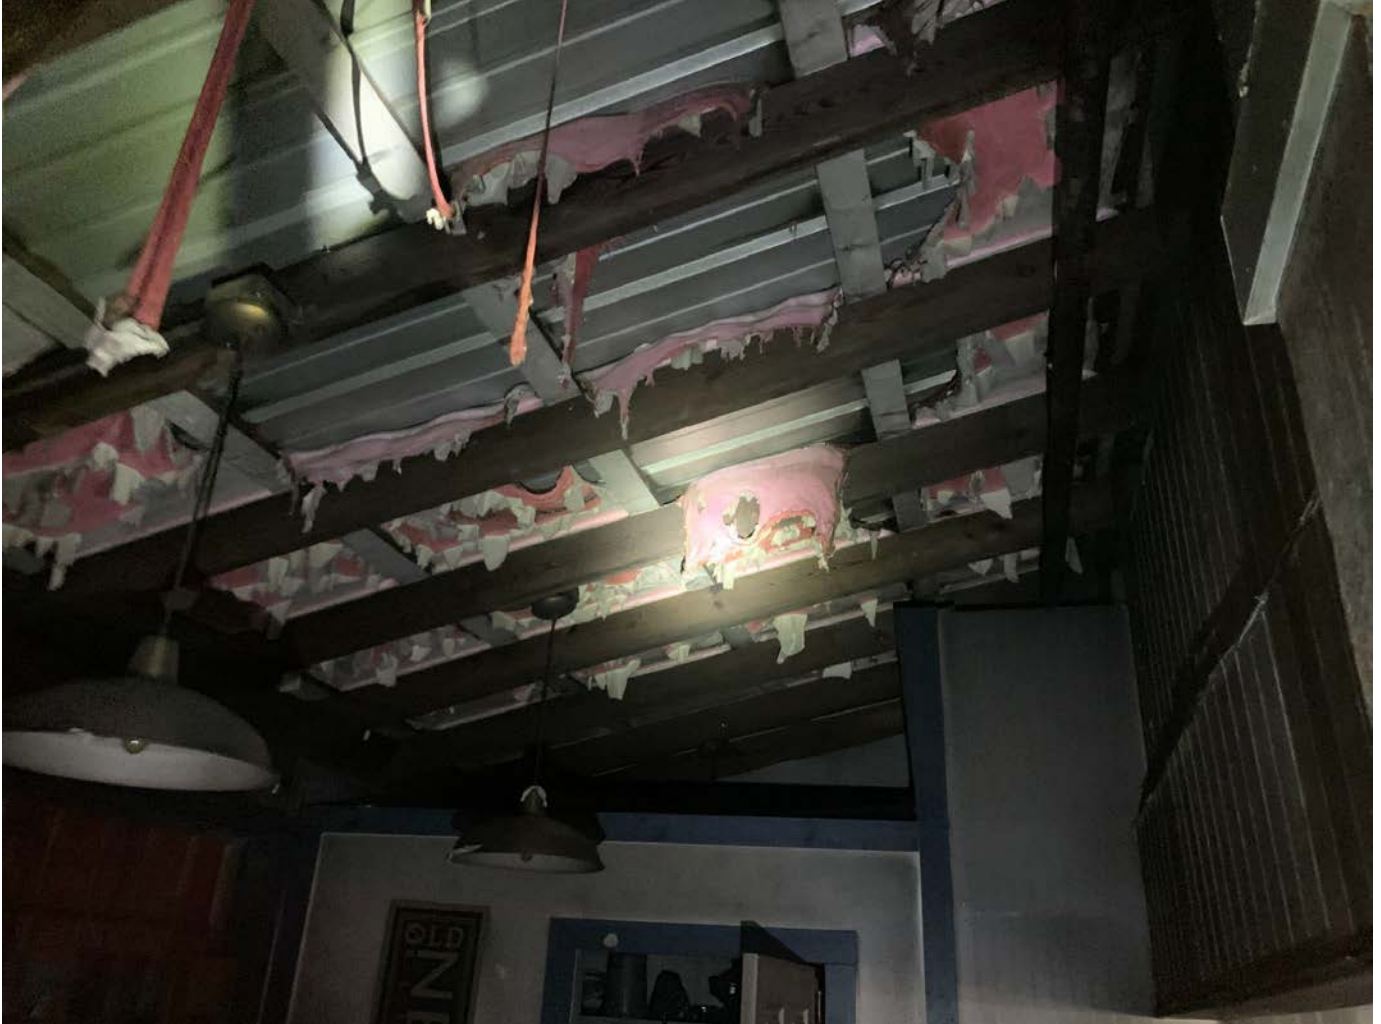
Smoke staining to rafters at rear of tasting room which were undamaged

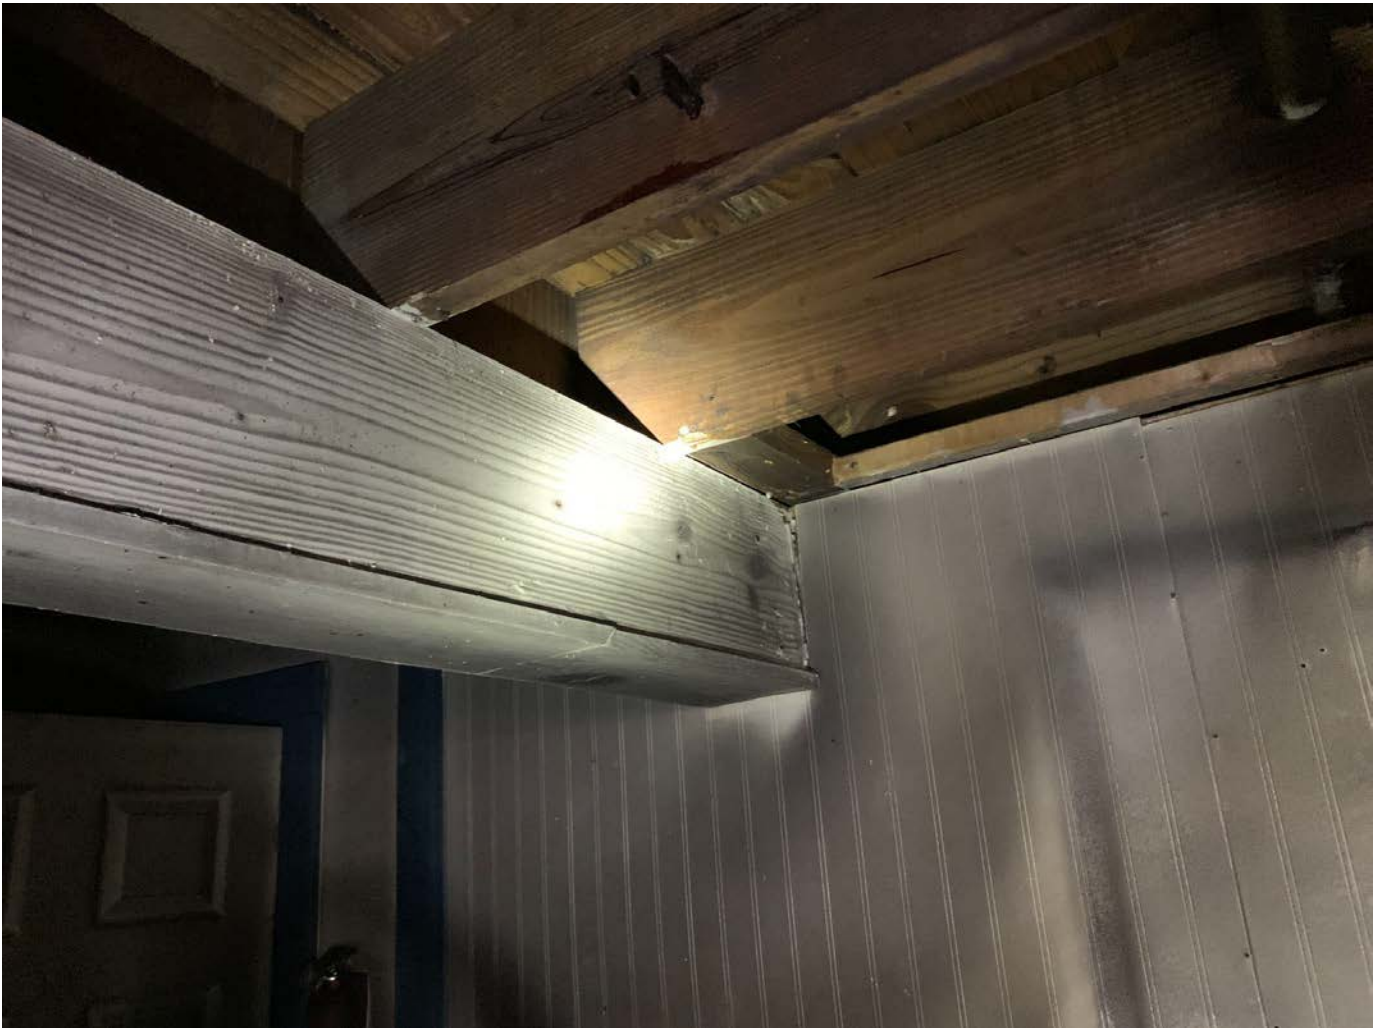
Beam supporting joists in rear of tasting room was undamaged

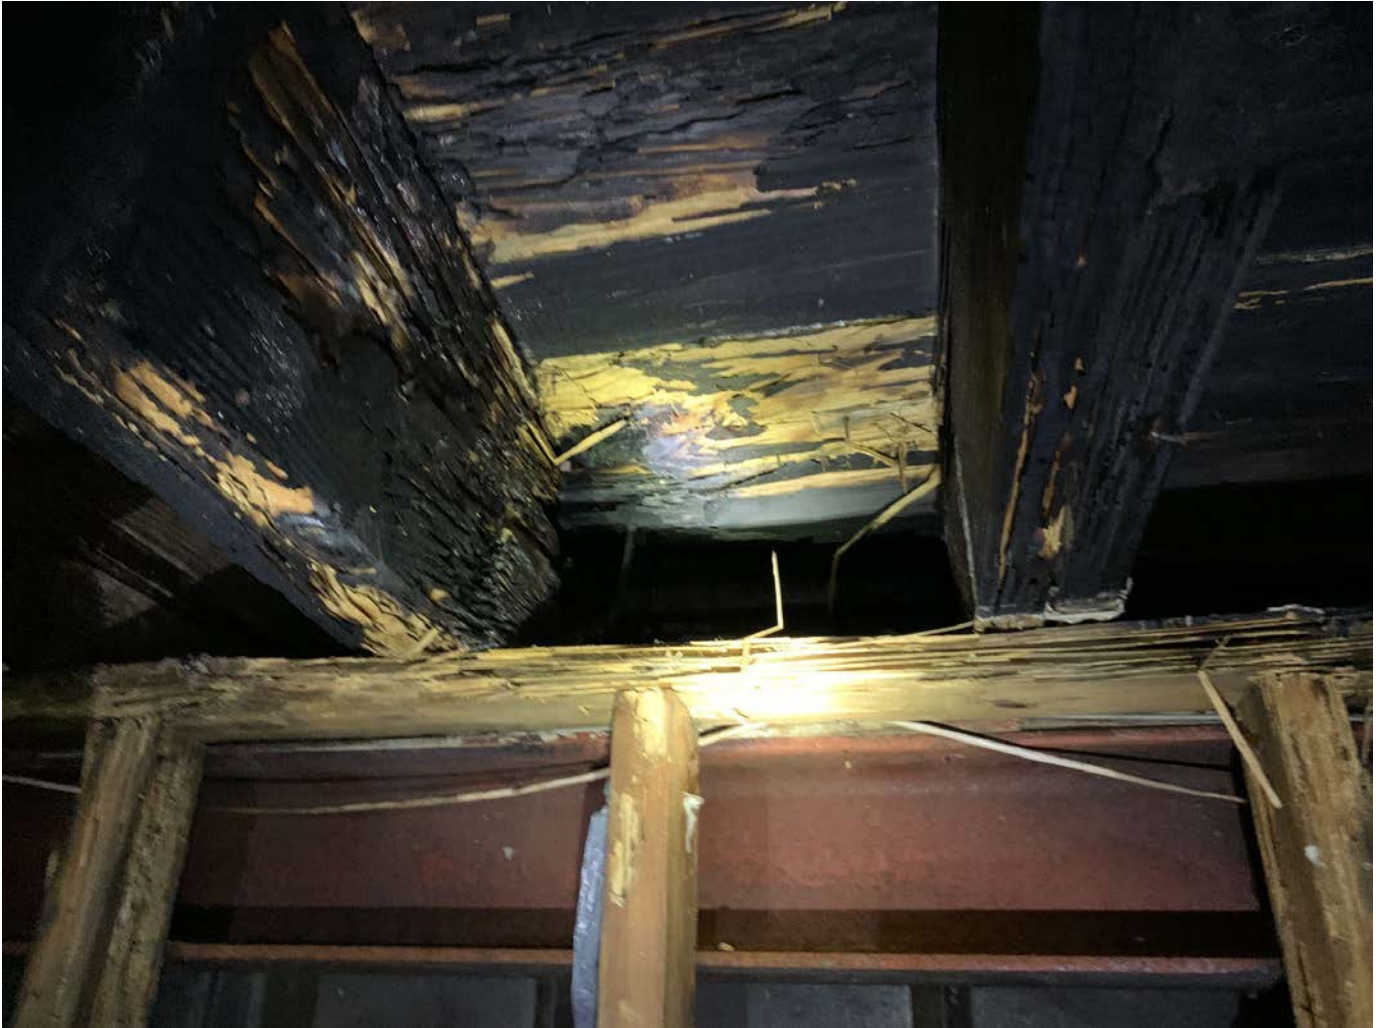
Charred ceiling joist with old termite damage

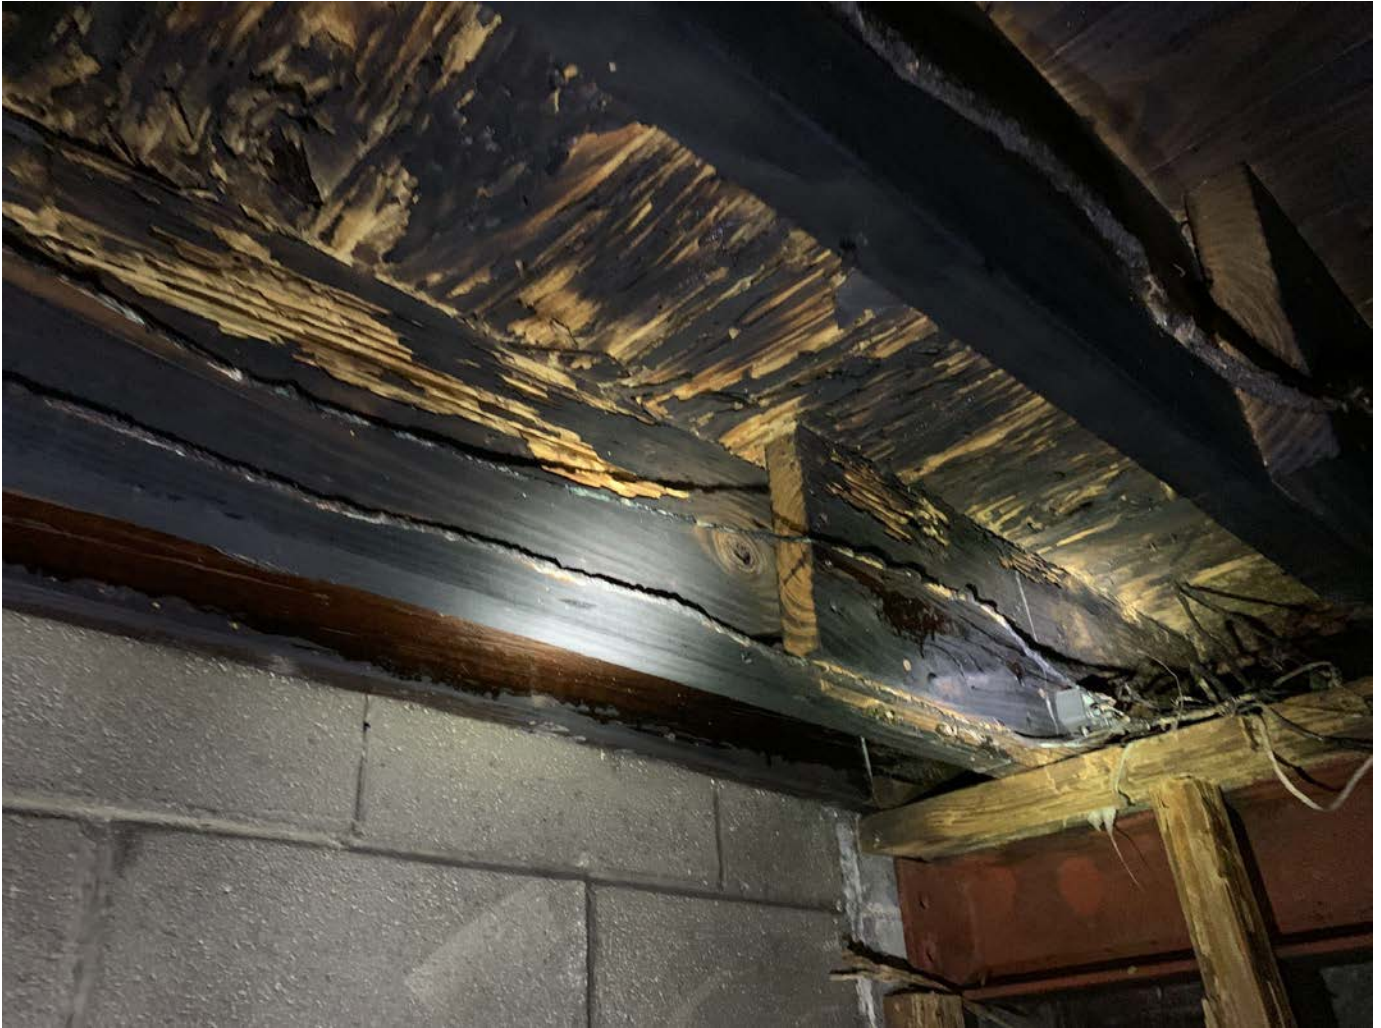
Charred subflooring, joists and termite damage

4. The subflooring and flooring in the upstairs office and a portion of the sitting room will require replacement due to fire damage. These areas were outlined and delineated during our onsite inspection with both the owner and adjusters.

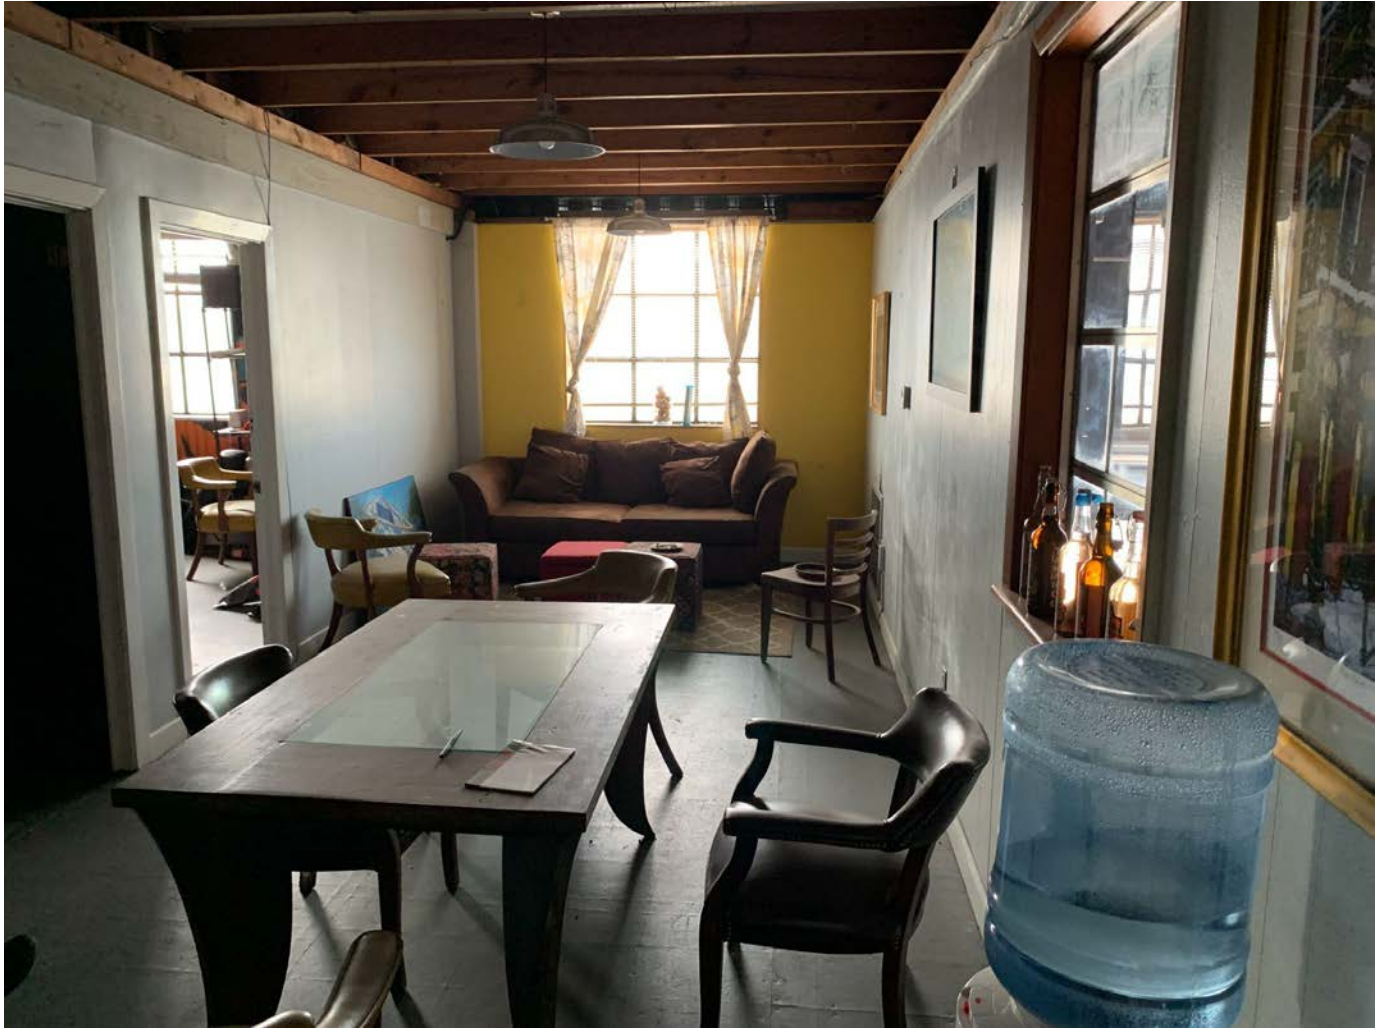
View of sitting room on second floor

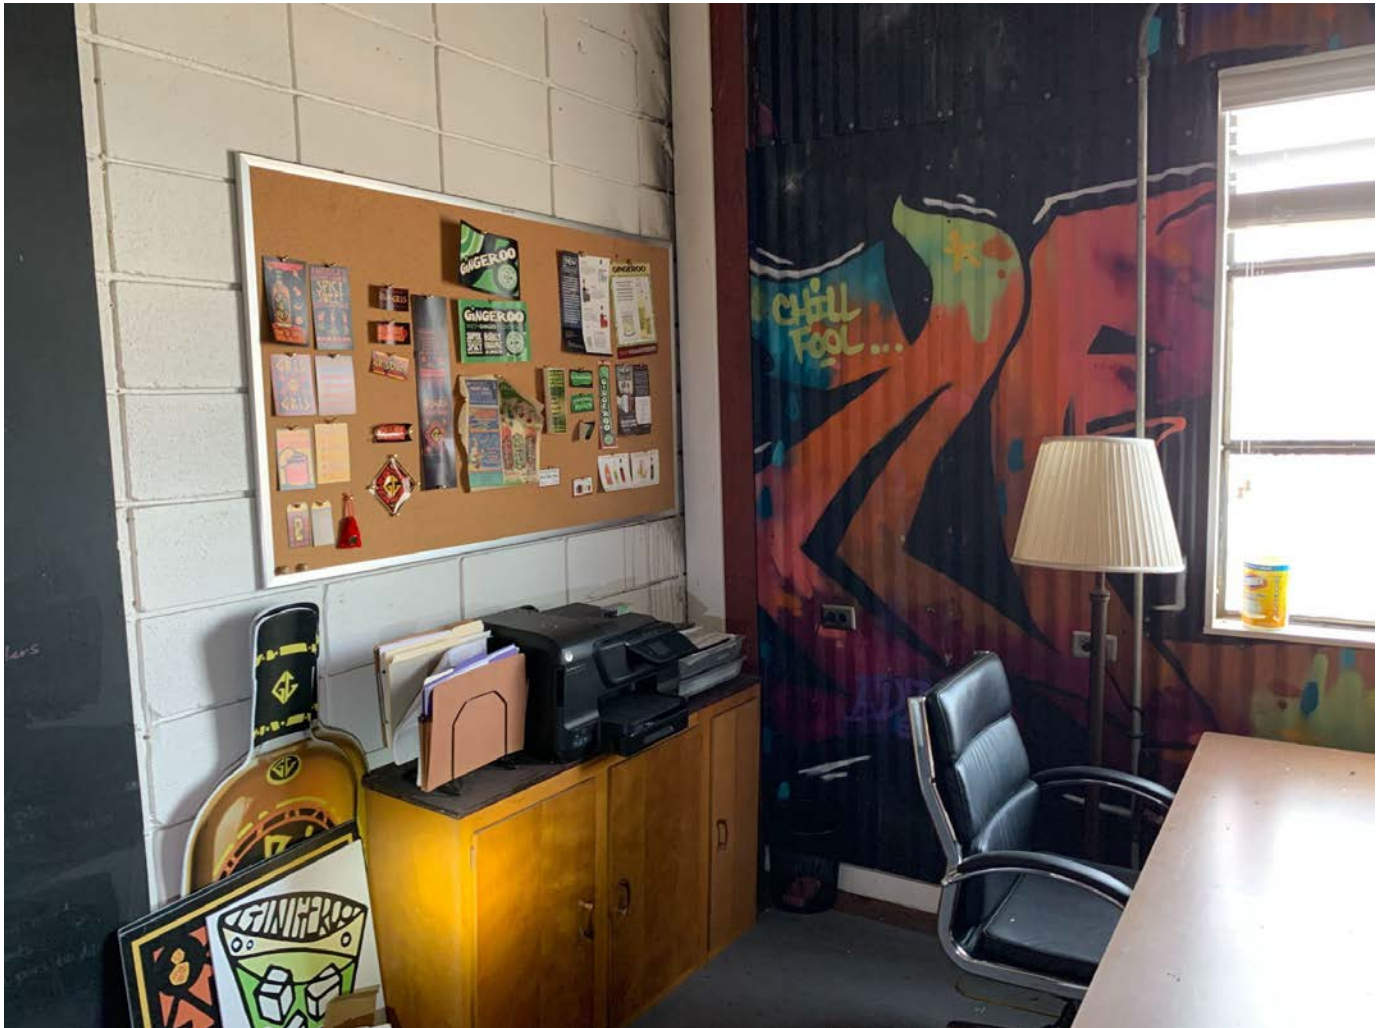
Overall view of office area

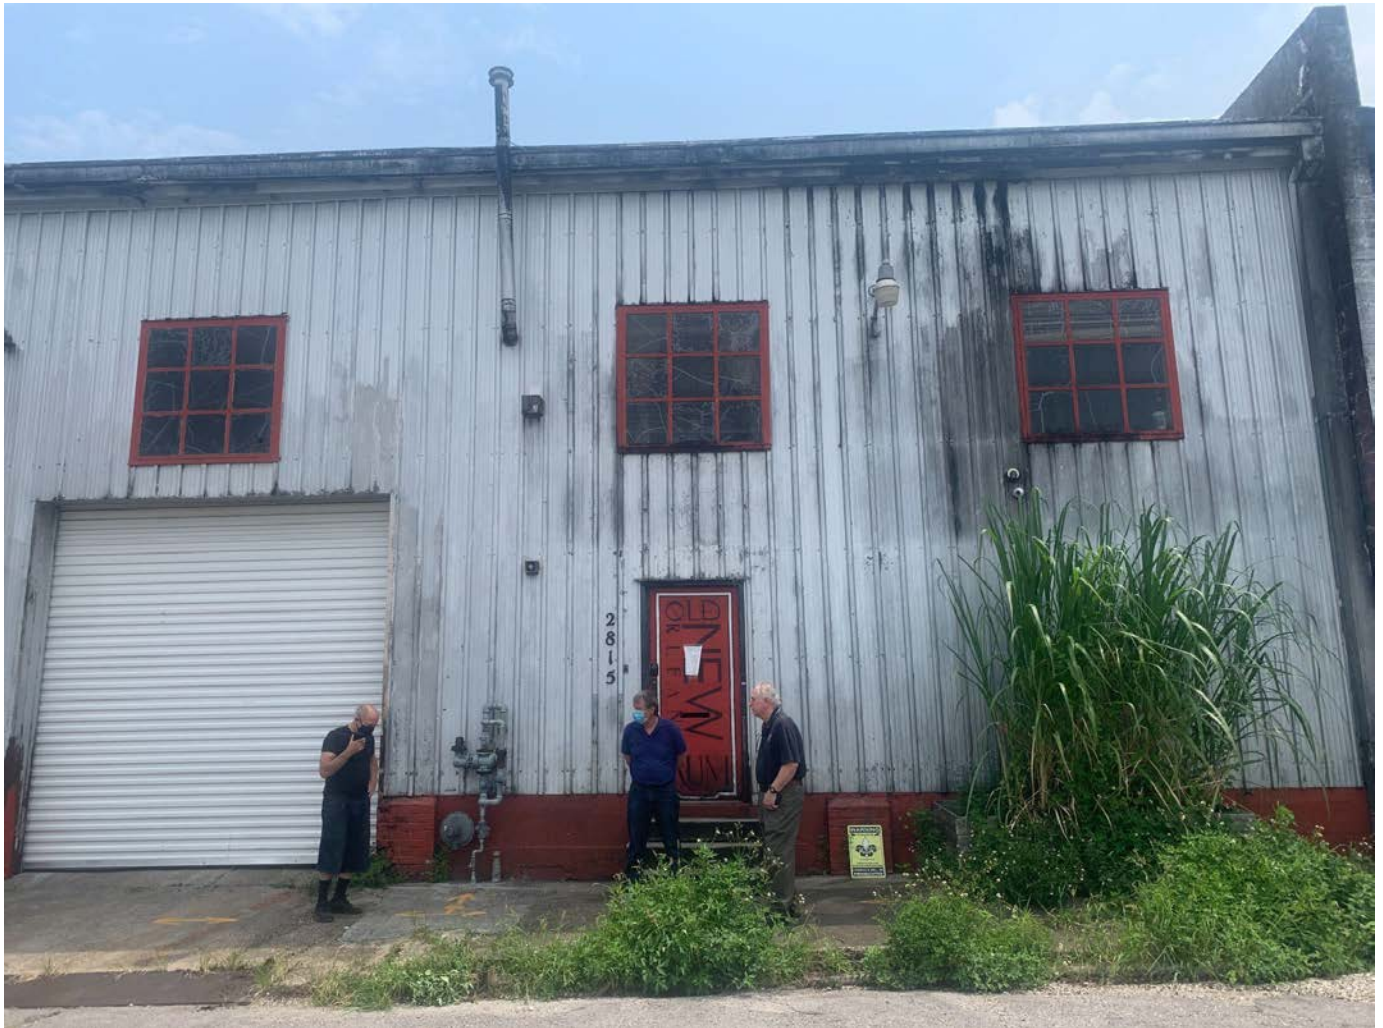
Front view of building

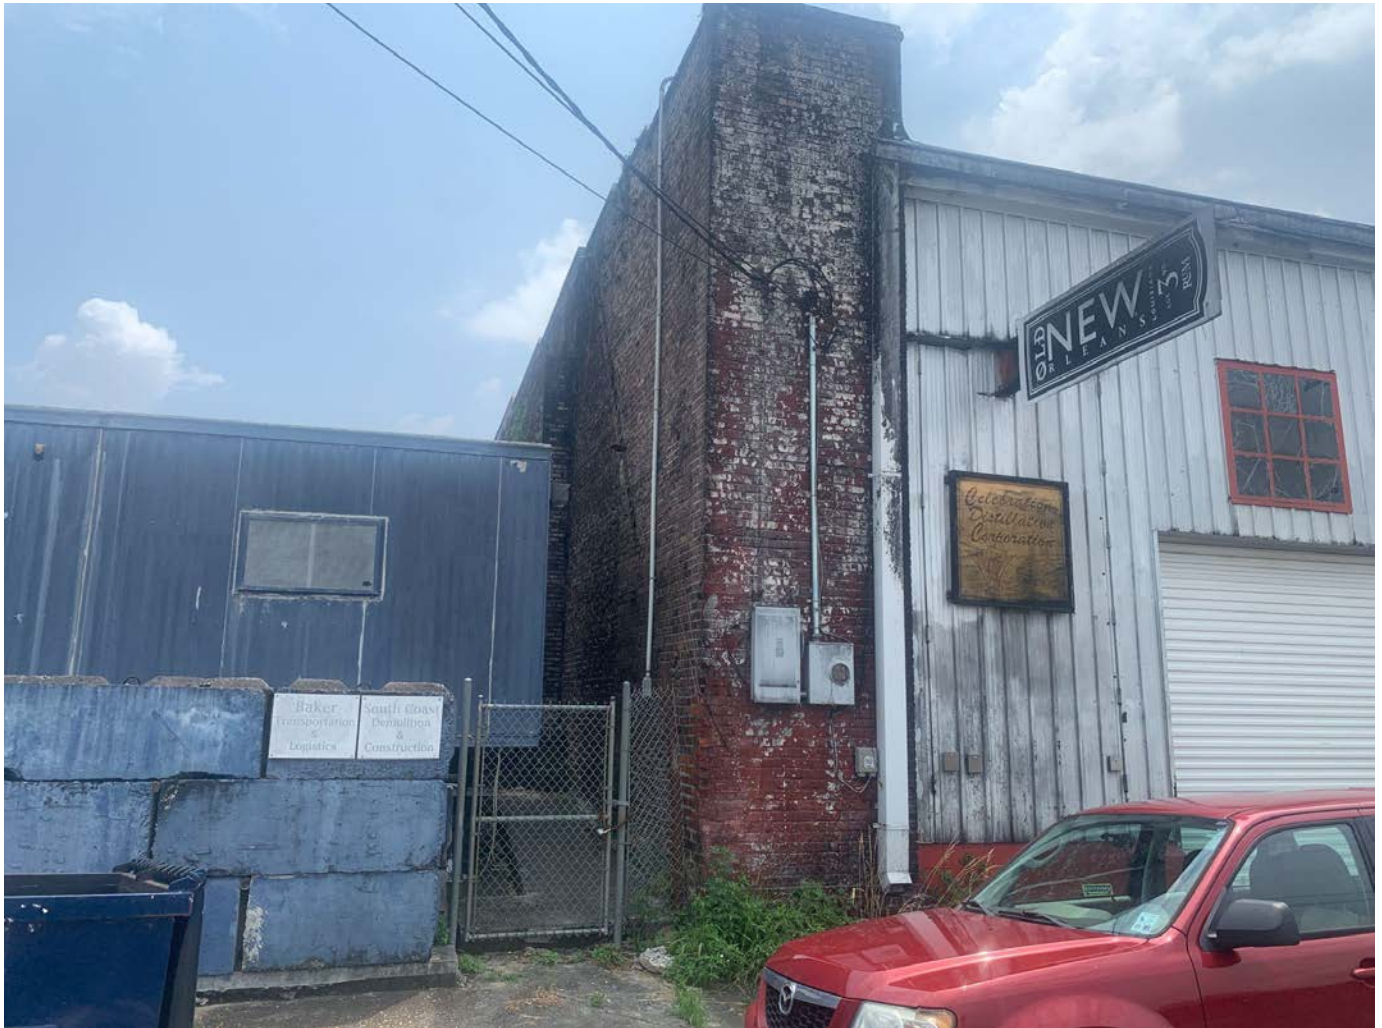
Left front corner of warehouse building
