HURRICANE IDA STORM DAMAGE ASSESSMENT

Upperline Condominiums

1114 Lyons Street
New Orleans, LA 70115

May 26, 2022

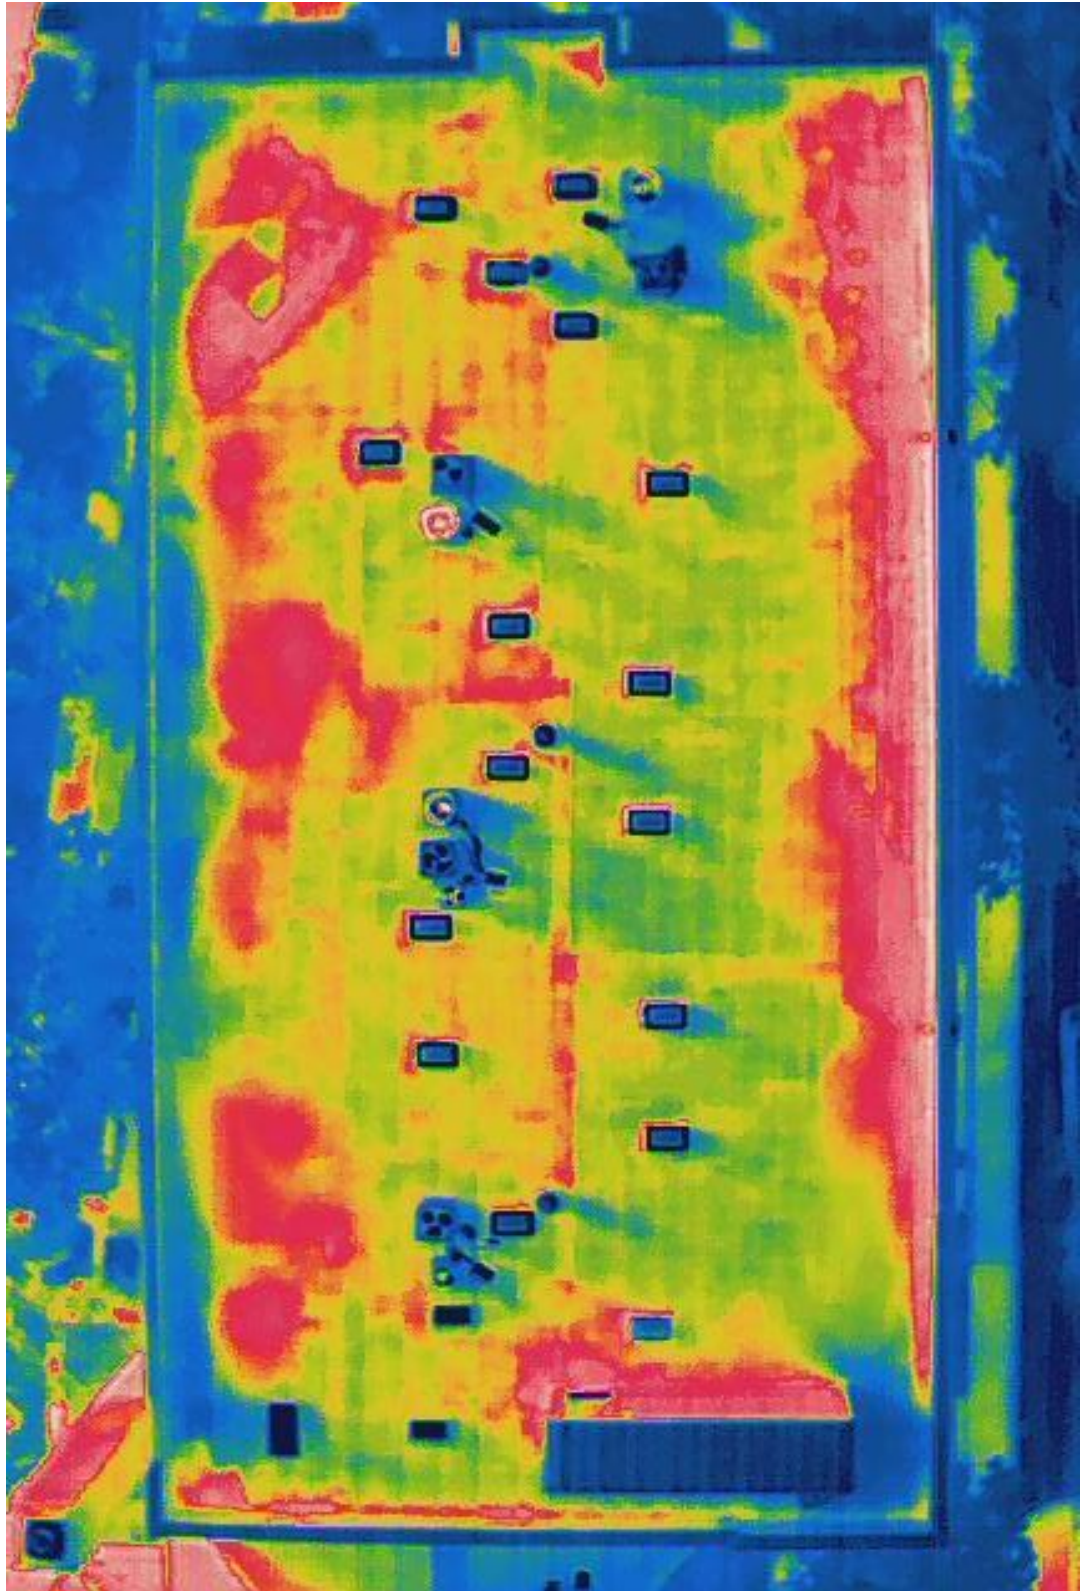
Reference 3:

Imagery from
CES drone IR
scan of the low
slope roof.

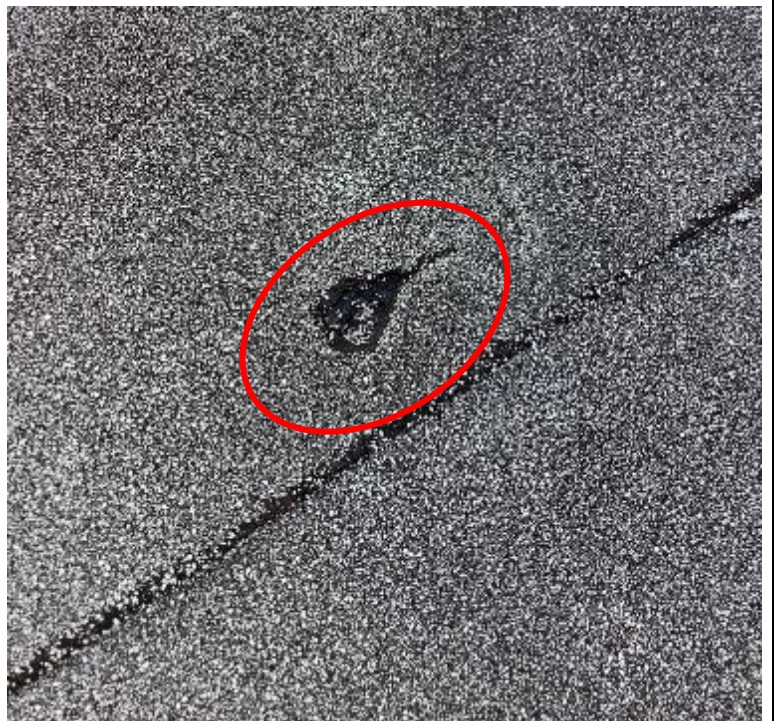
Photo 1:

An example of windborne debris impact damage as observed at the low slope roof MB membrane (*red ellipse*).

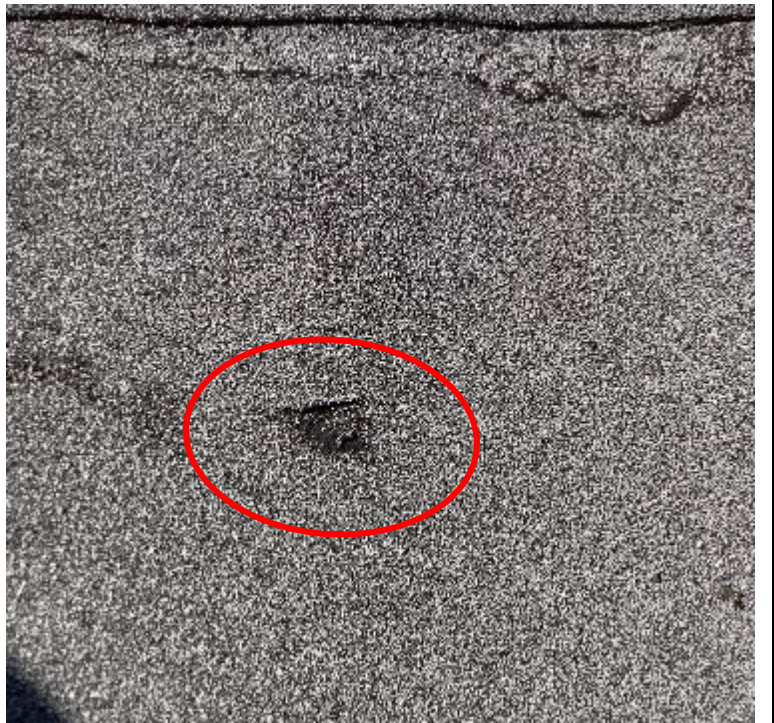
Photo 2:

An example of windborne debris impact damage as observed at the low slope roof MB membrane (*red ellipse*).

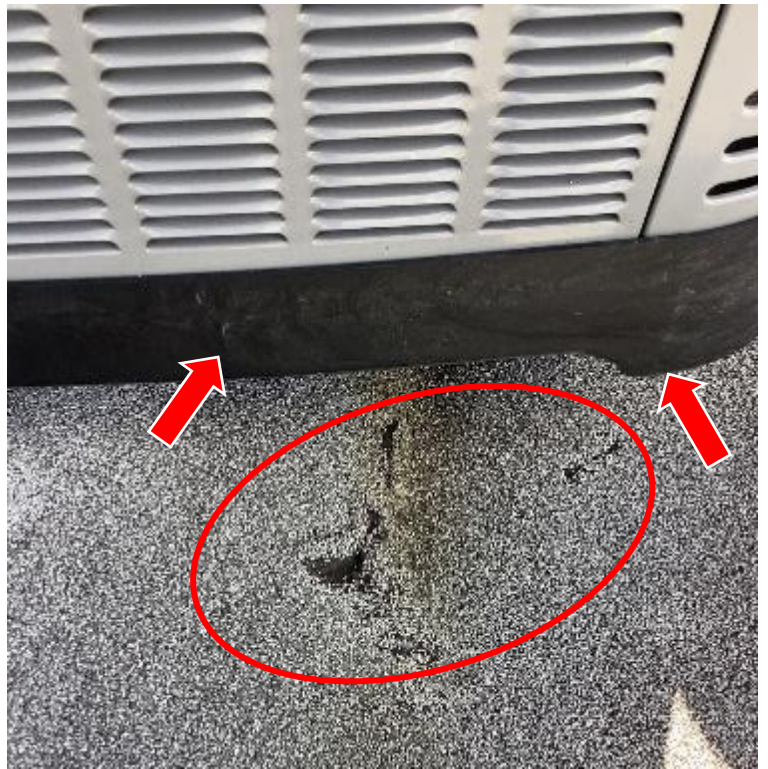
Photo 3:

An example of windborne debris impact damage as observed at the low slope roof MB membrane (*red ellipse*). Note the proximity to an A/C unit and the resemblance of some of the damage and the foot of the A/C unit (*red arrows*) suggesting this damage was resultant of the A/C unit displacement.

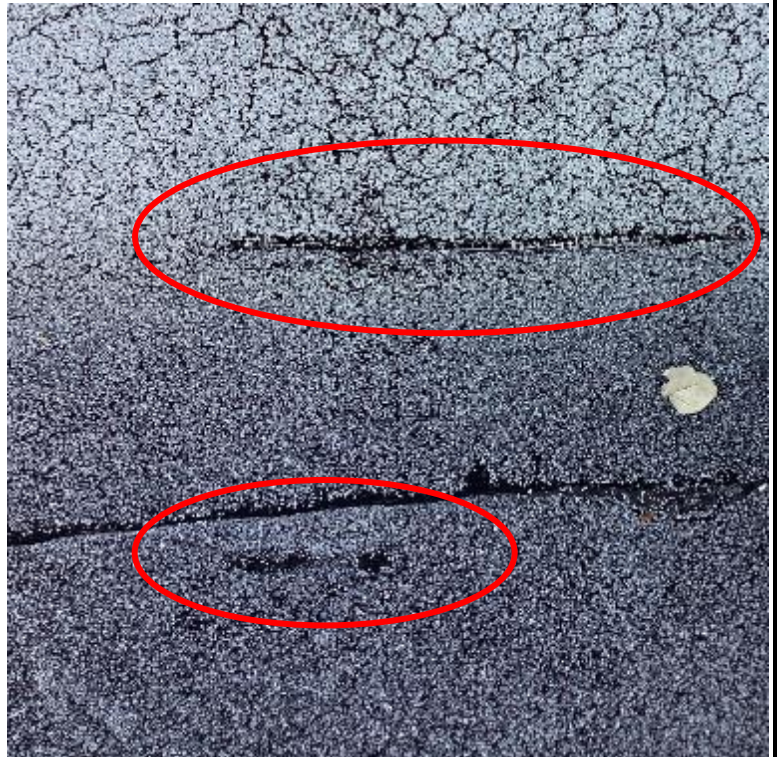
Photo 4:

An example of windborne debris impact damage as observed at the low slope roof parapet MB membrane (*red ellipses*).

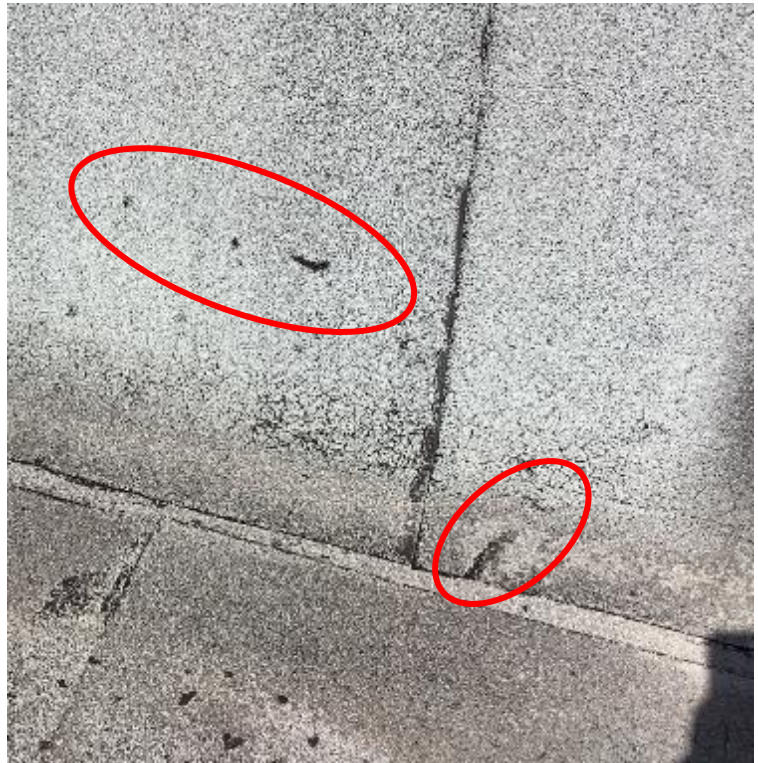
Photo 5:

An example of windborne debris impact damage as observed at the low slope roof parapet MB membrane (*red ellipses*).

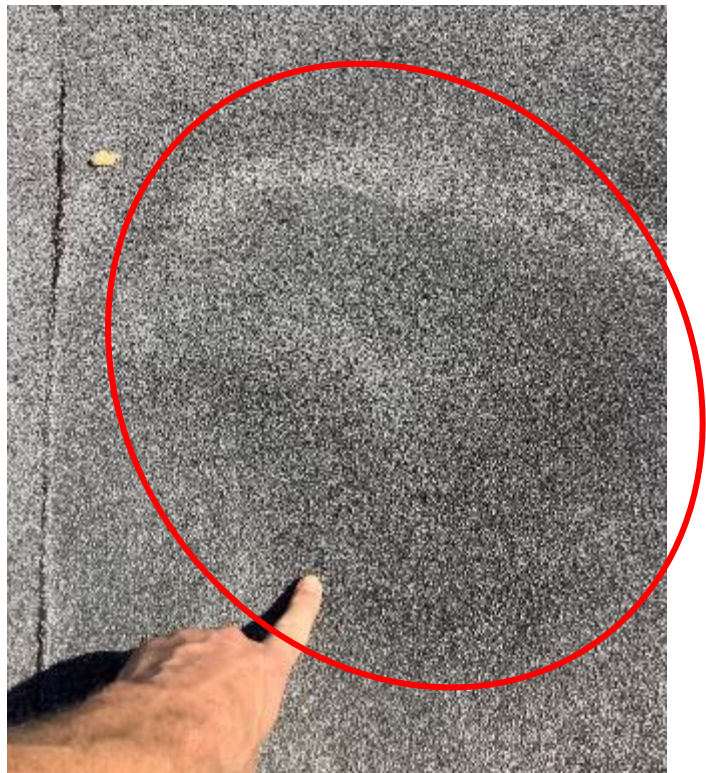
Photo 6:

An example of the blisters observed at the low slope roof MB membrane (*red ellipse*).

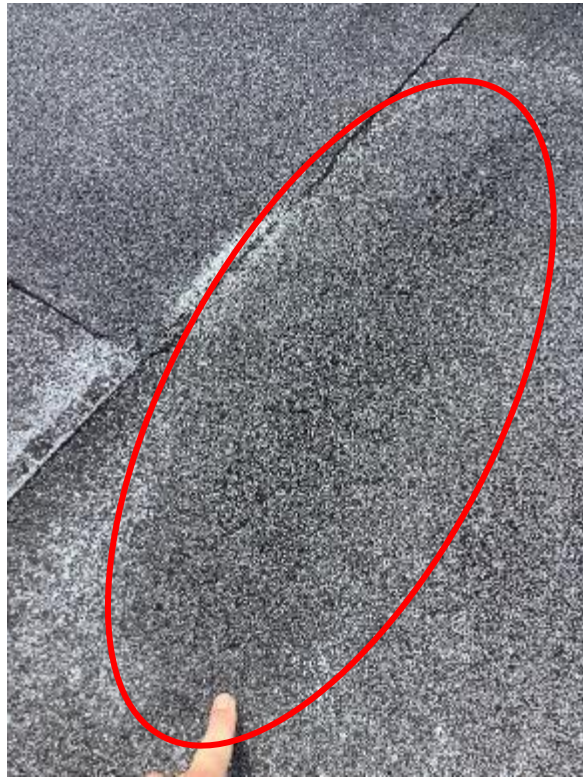
Photo 7:

An example of the blisters observed at the low slope roof MB membrane (*red ellipse*).

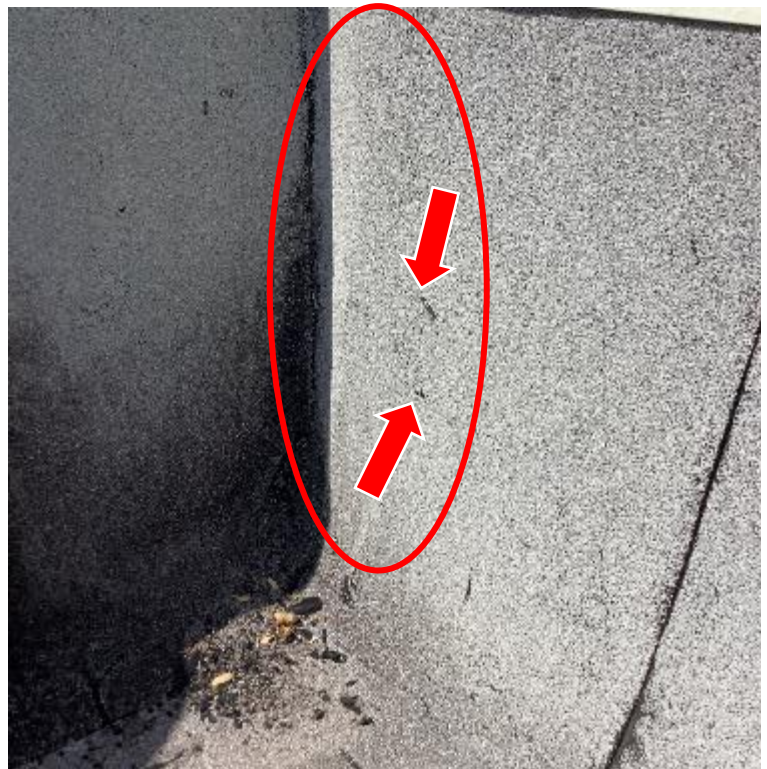
Photo 8:

An example of the blisters observed at the low slope roof parapet MB membrane (*red ellipse*). Note windborne debris impact marks at the blister (*red arrows*).

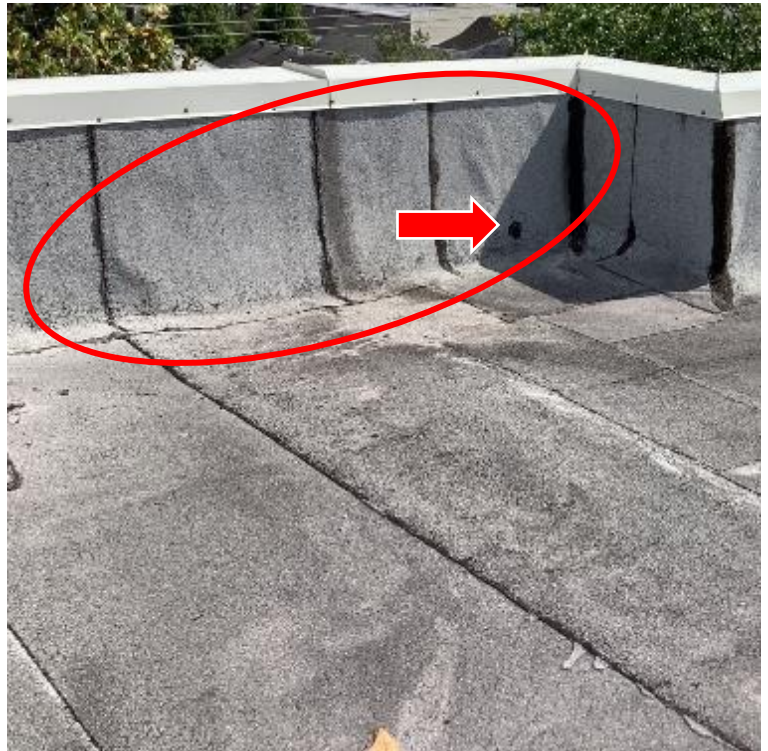
Photo 9:

An example of the blisters observed at the low slope roof parapet MB membrane (*red ellipse*). Note windborne debris impact mark near the blistering (*red arrow*).

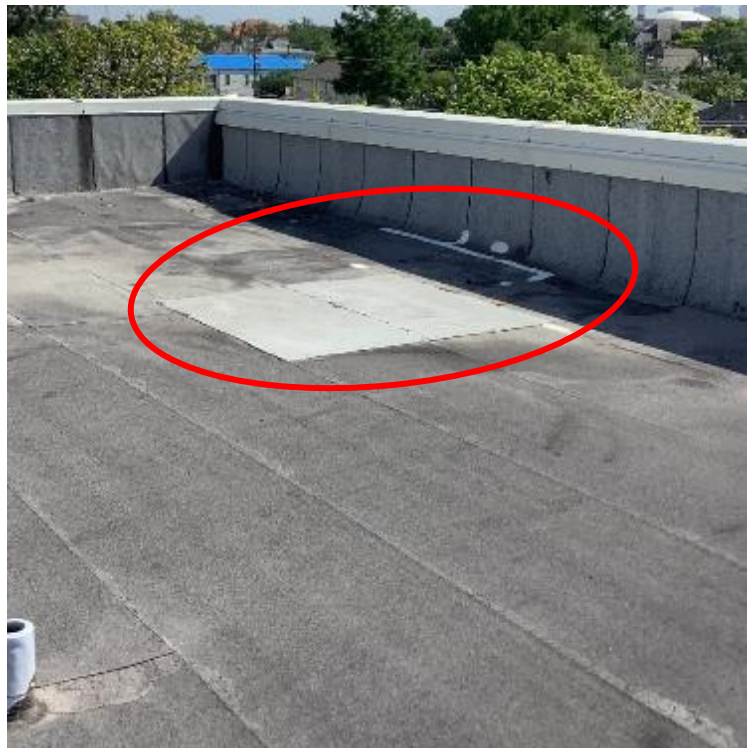
Photo 10:

An example of prior repairs observed at the low slope roof system (*red ellipse*).

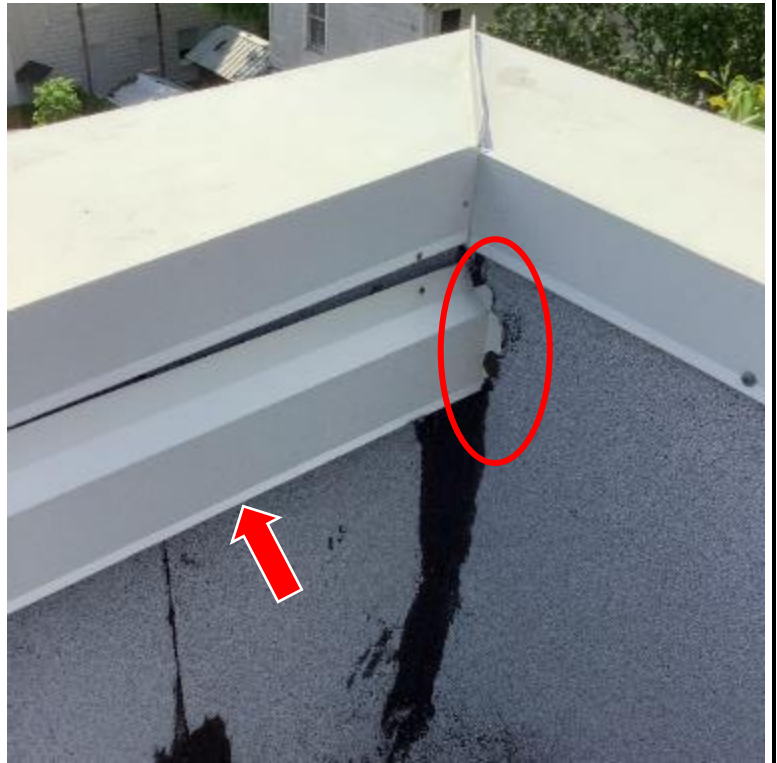
Photo 13:

A view of the displaced section of parapet counterflashing (*red arrow*). Note the displacement of the counterflashing has damaged the parapet MB membrane (*red ellipse*).

The disengaged fasteners at the stairwell penthouse siding should be replaced and the fastener holes abandoned, installing the new fastener in a new location bearing in mind fastener and material edge distance spacing. All fasteners and abandoned fastener holes should be sealed. The winds of Hurricane Ida are capable of buffeting the siding leading to fastener disengagement. Water damaged siding and failed sealants should be removed and replaced. The damaged parapet coping counterflashing should also be removed and replaced.

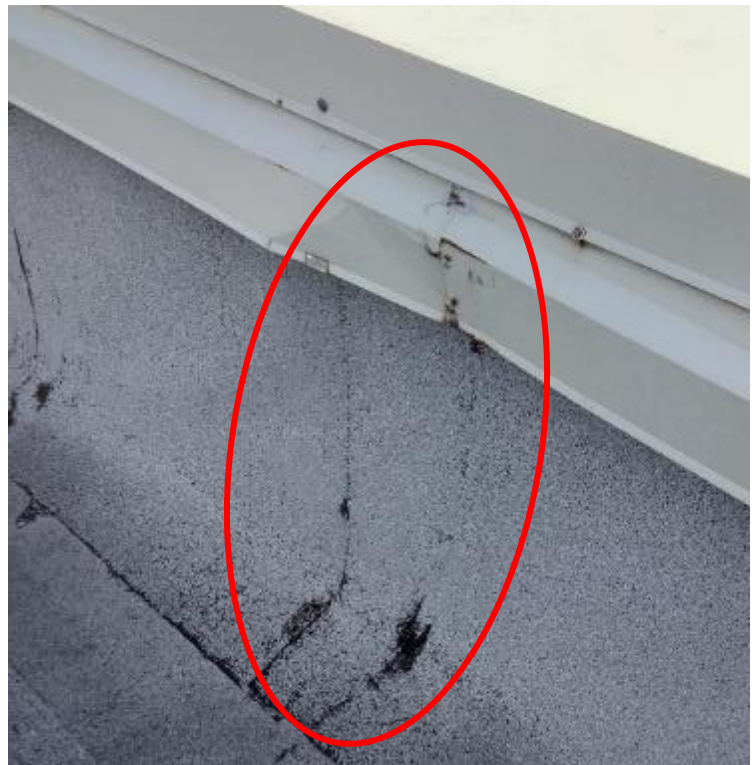
Photo 14:

A view of the impact damage observed within a few feet of the displaced counterflashing (*red ellipse*).

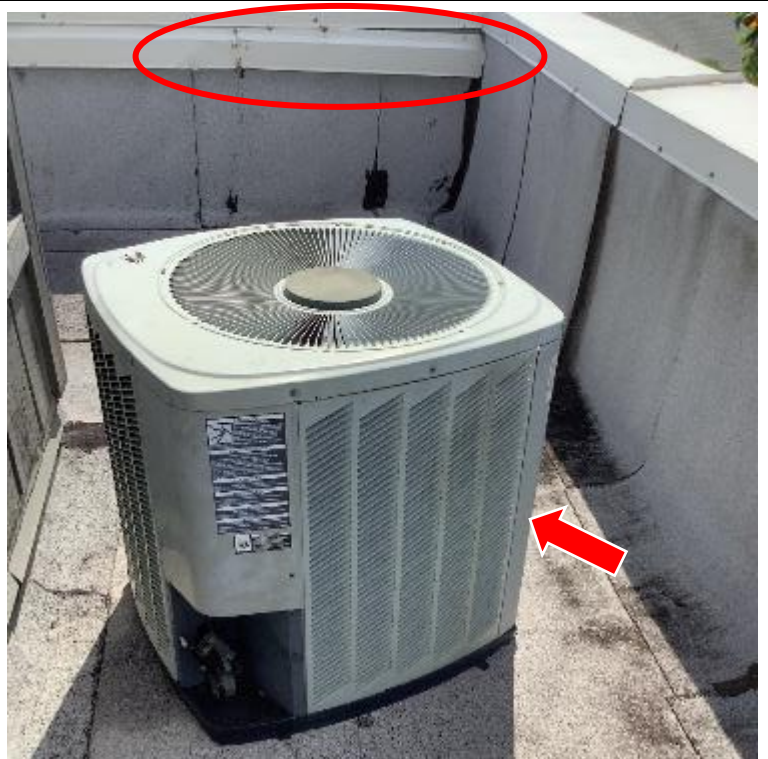
Photo 15:

A displaced A/C unit (*red arrow*). It is unclear the location the displaced unit came to rest and whether it was placed in this location to be stored temporarily. Note the damaged and displaced counterflashing (*red ellipse*) in the background displaying the proximity of the damage to the displacement.

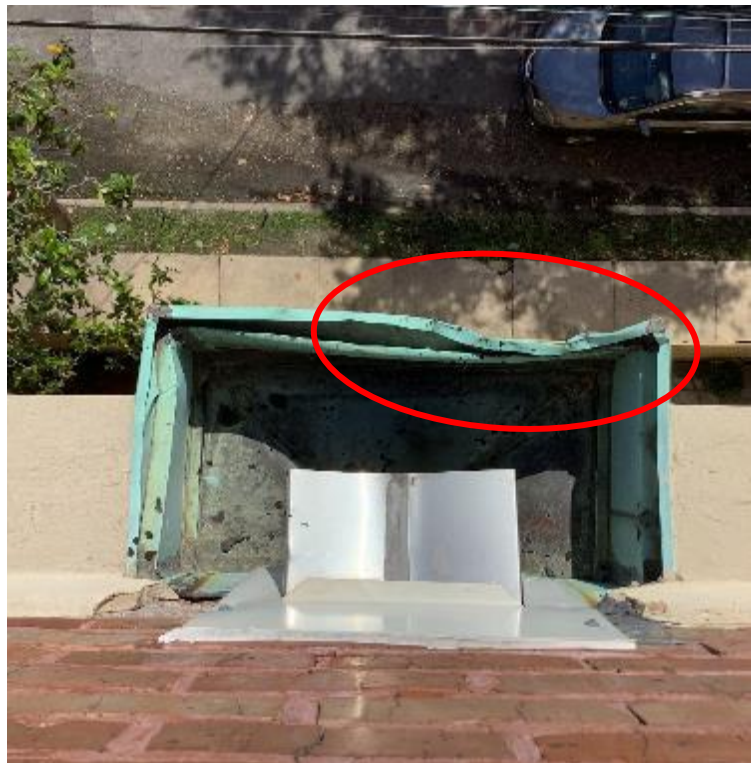
Photo 16:

An example of impact damage (*red ellipse*) observed at a scupper in close proximity to the surrounding trees.

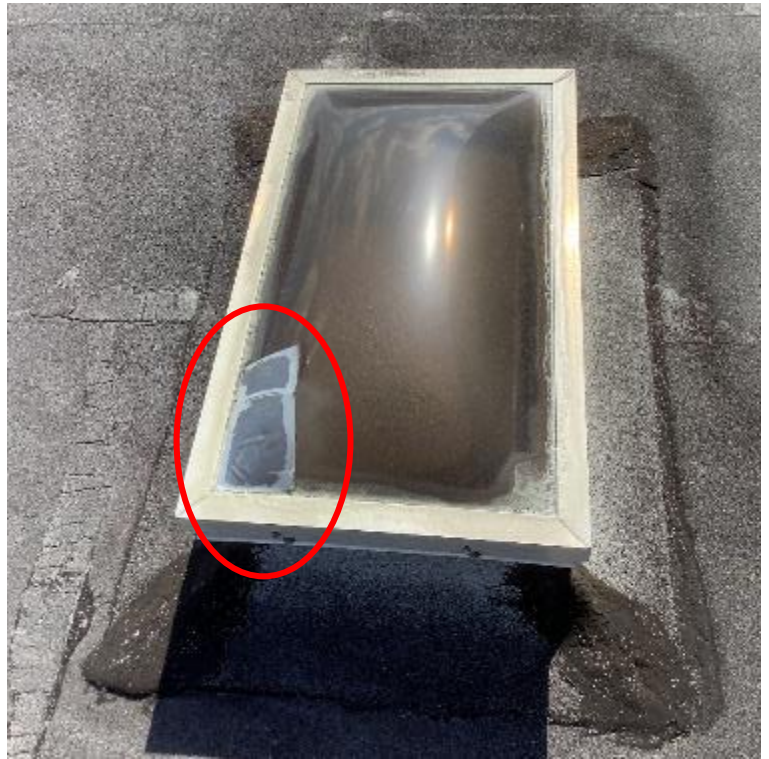
Photo 17:

A view of the damaged skylight (*red ellipse*) that has been temporarily repaired with tape.

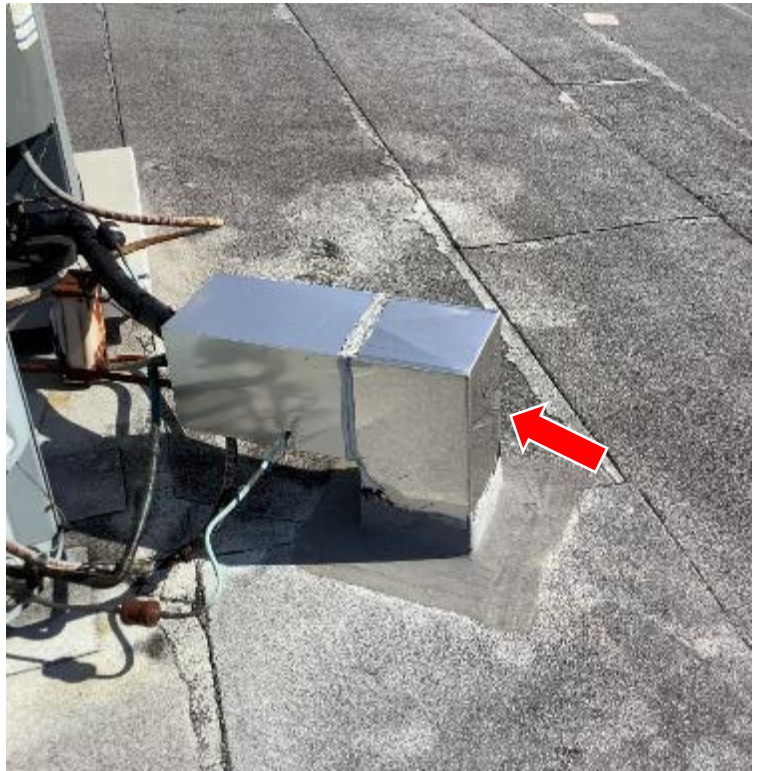
Photo 18:

A recently replaced roofing line shack (*red arrow*) observed at the low slope roof.

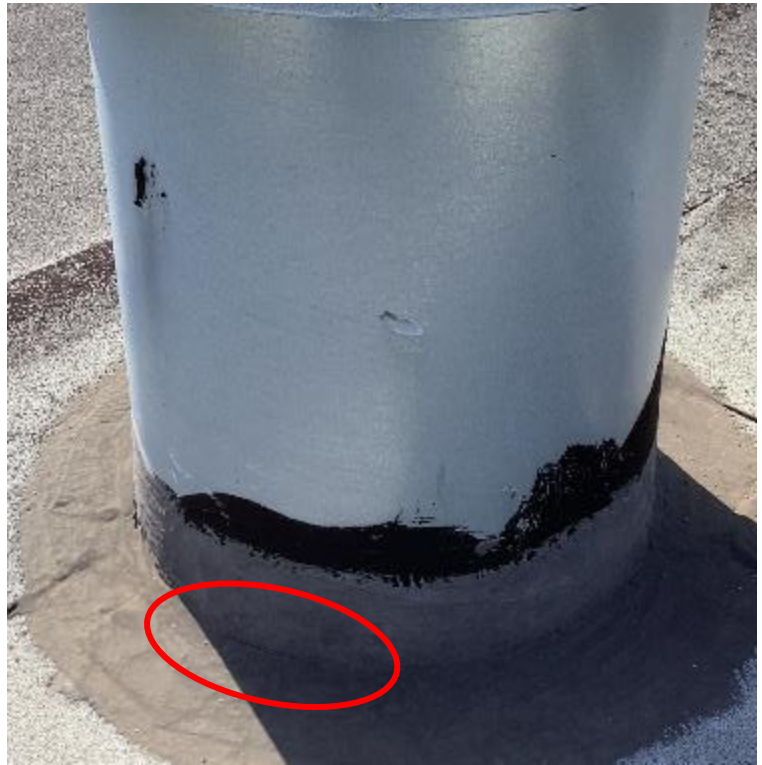
Photo 19:

An example of the wind buffeting of rooftop equipment that compromised the aging sealant (*red ellipse*).

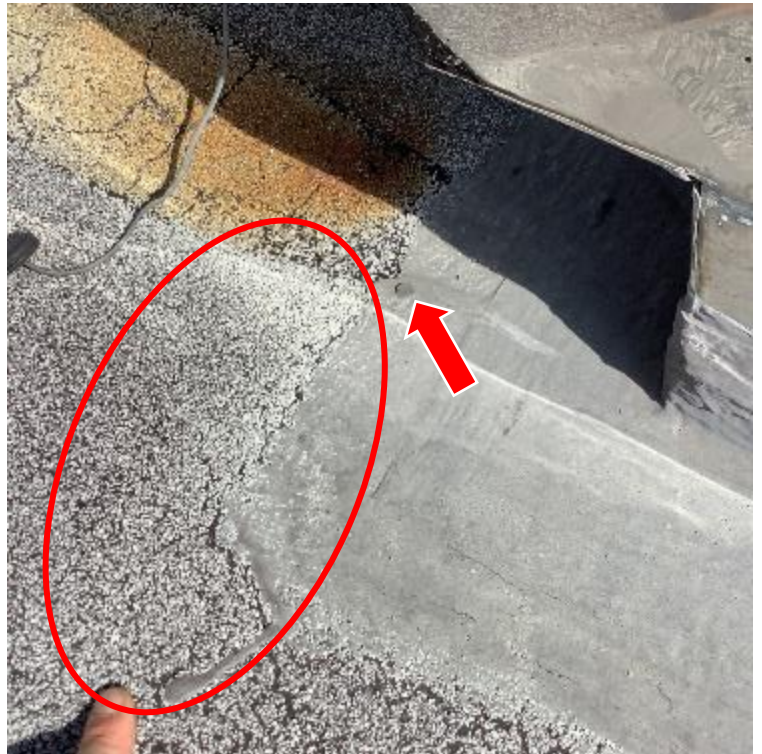
Photo 20:

An example of a blister observed adjacent to the new roofing line shack (*red ellipse*). Note that water was visible (*red arrow*) when pressing on the blister.

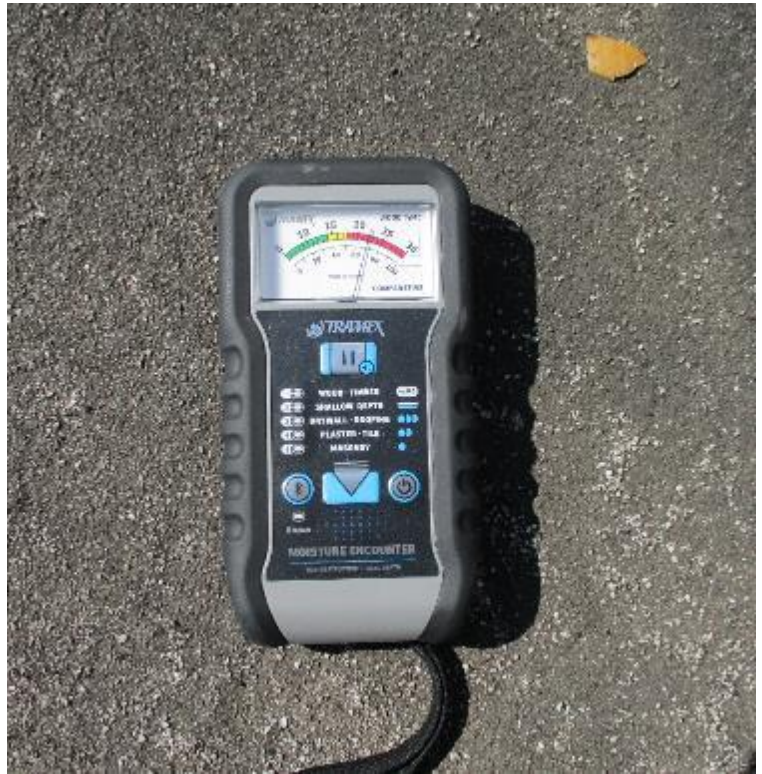
Photo 21:

A close-up view of moisture meter reading in the field of the low slope roof membrane.

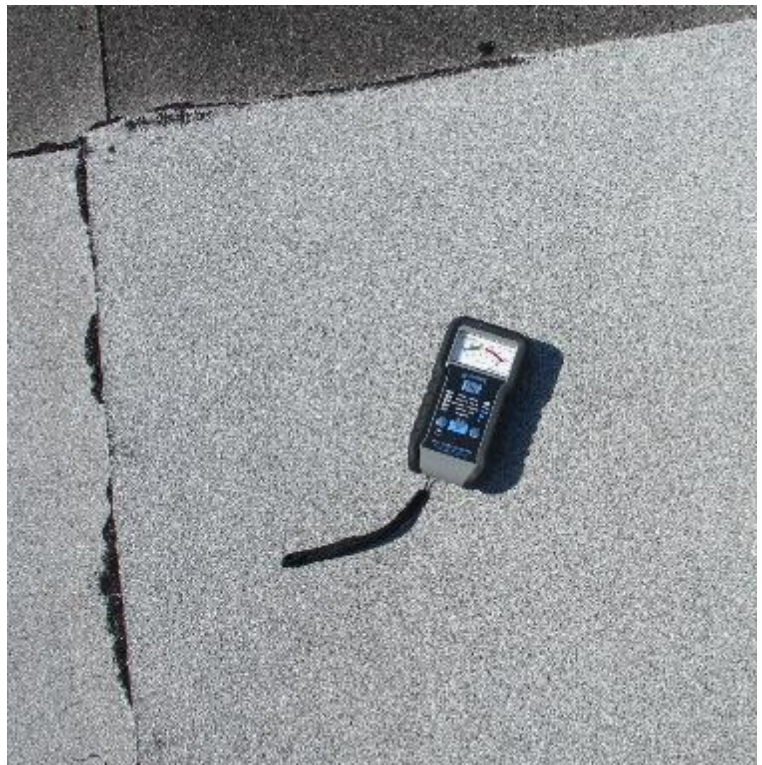
Photo 22:

Elevated moisture was measured by the moisture meter at a prior repair.

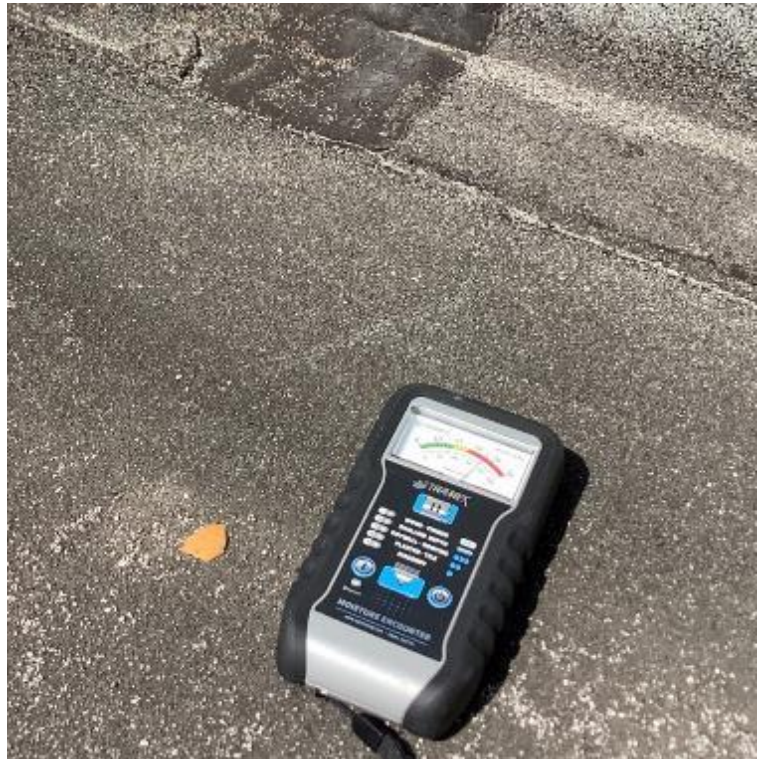
Photo 23:

Elevated moisture was measured by the moisture meter adjacent to the east parapet.

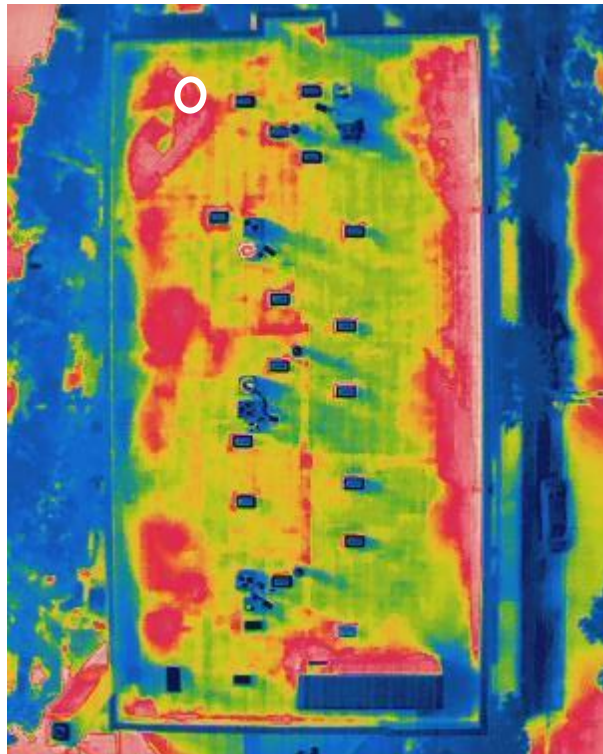
Photo 24:

The drone IR scan performed by CES displayed multiple areas of moisture trapped beneath the MB membrane. The approximate area of the roof core sample is displayed (*white ellipse*).

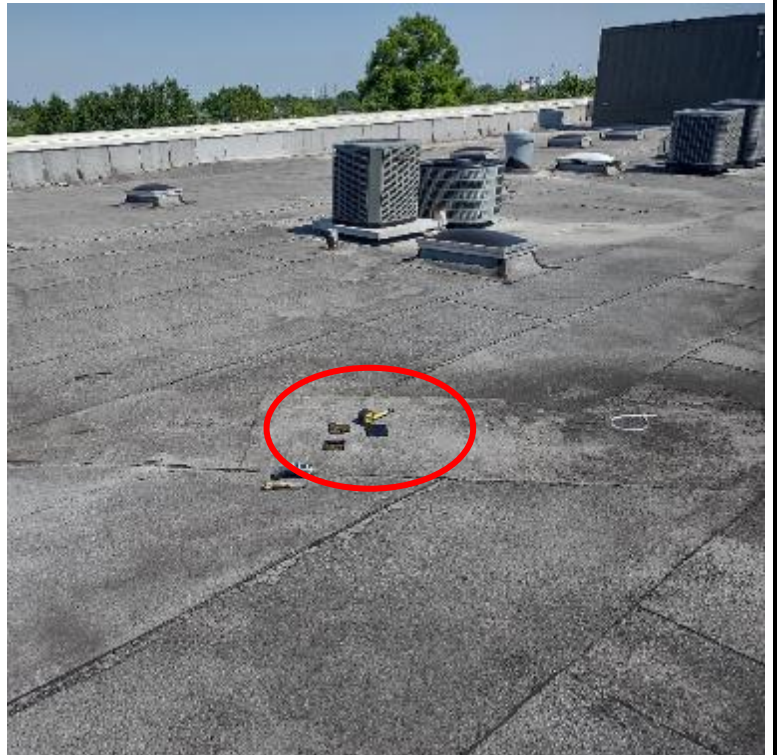
Photo 25:

The location of the core sample as viewed from the northwest corner of the low slope roof (*red ellipse*).

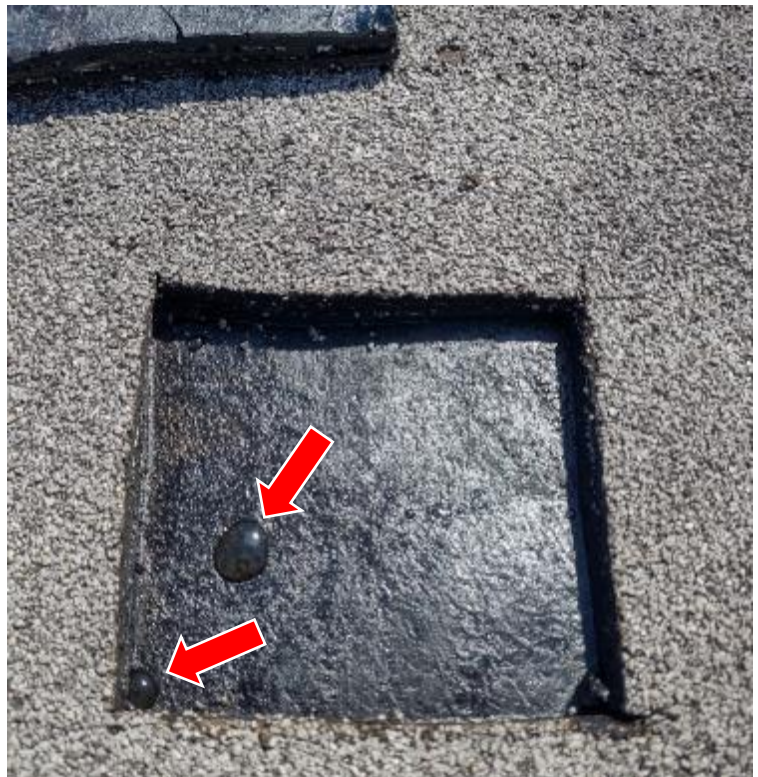
Photo 26:

Removal of the upper MB layers displayed water beneath the upper layers of membrane (*red arrows*).

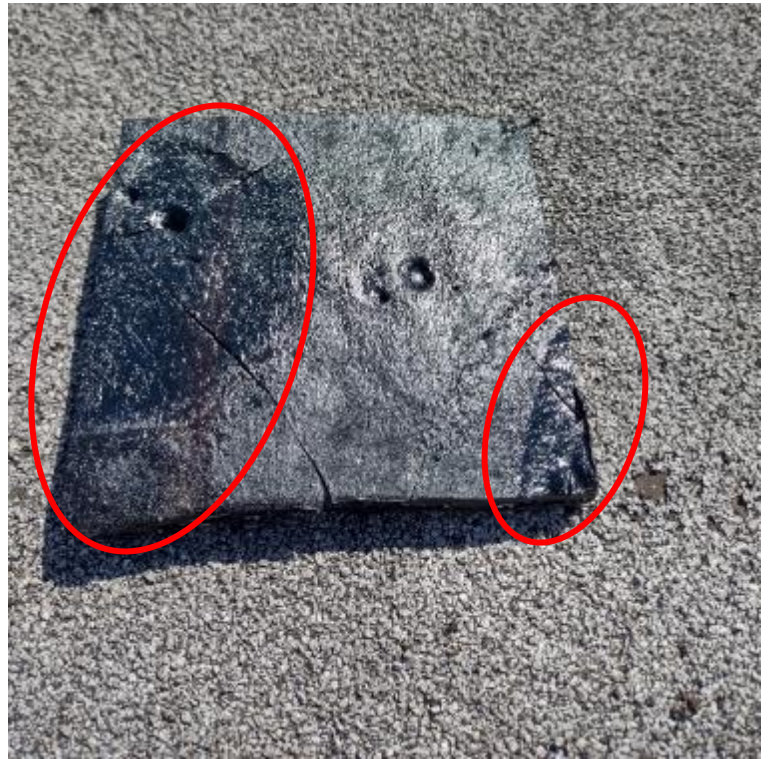
Photo 27:

Removal of the upper MB layers displayed moisture on the underside of the upper layers (*red ellipses*).

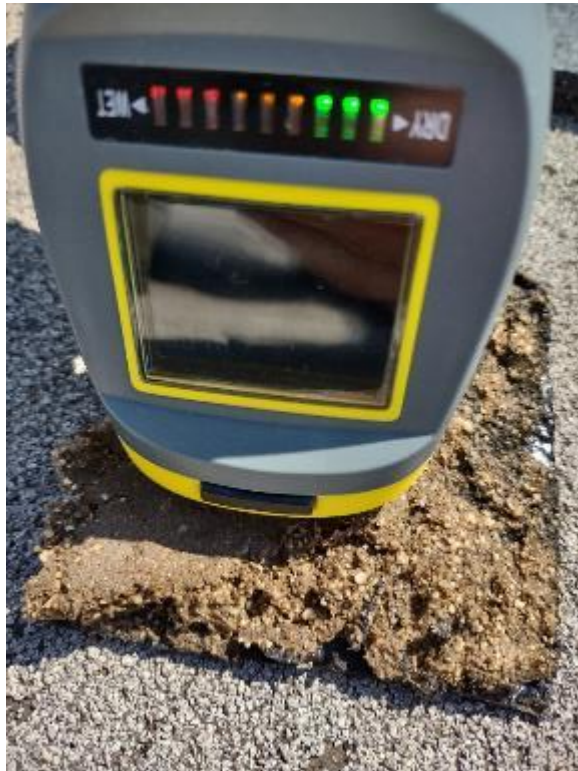
Photo 28:

The moisture meter measured the insulation beneath the layers of membrane to be wet, its highest moisture reading.

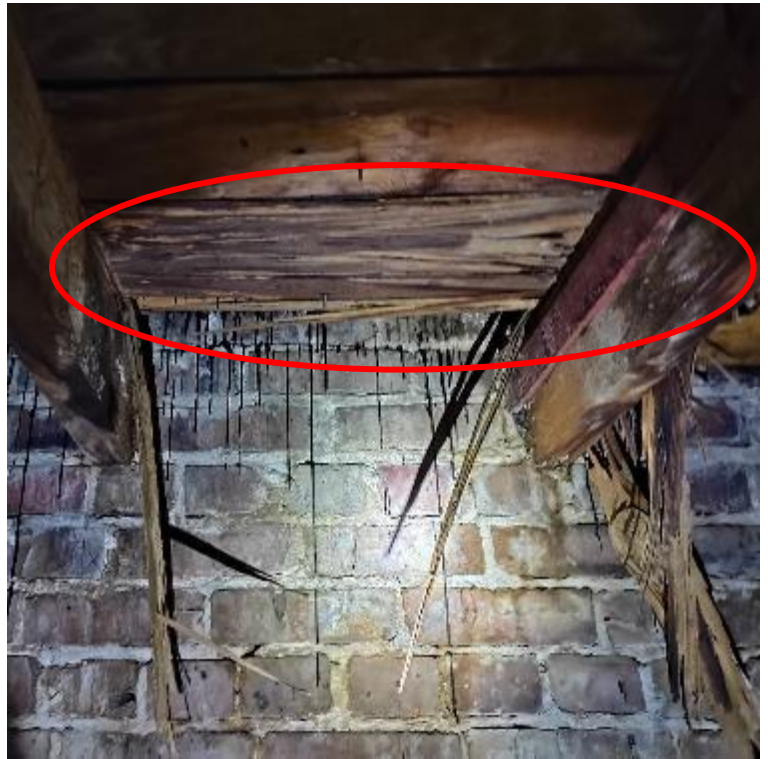
Photo 29:

An example of the water damage and degradation of the low slope subdeck (*red ellipse*). Note the degraded subdeck hanging from the roof joists (*red arrows*).

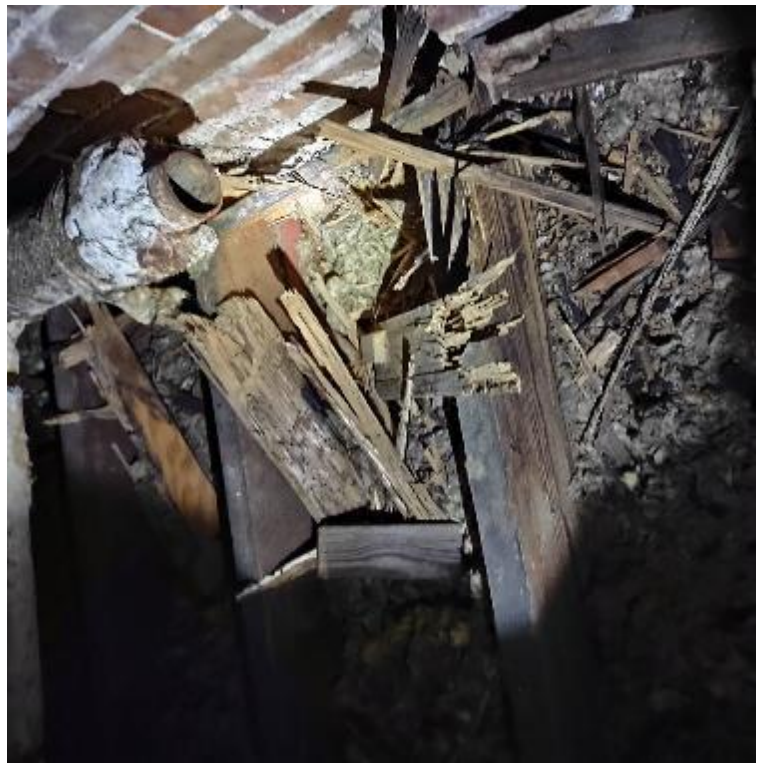
Photo 30:

An example of displaced water damaged and degraded subdeck amassing on the ceiling joists.

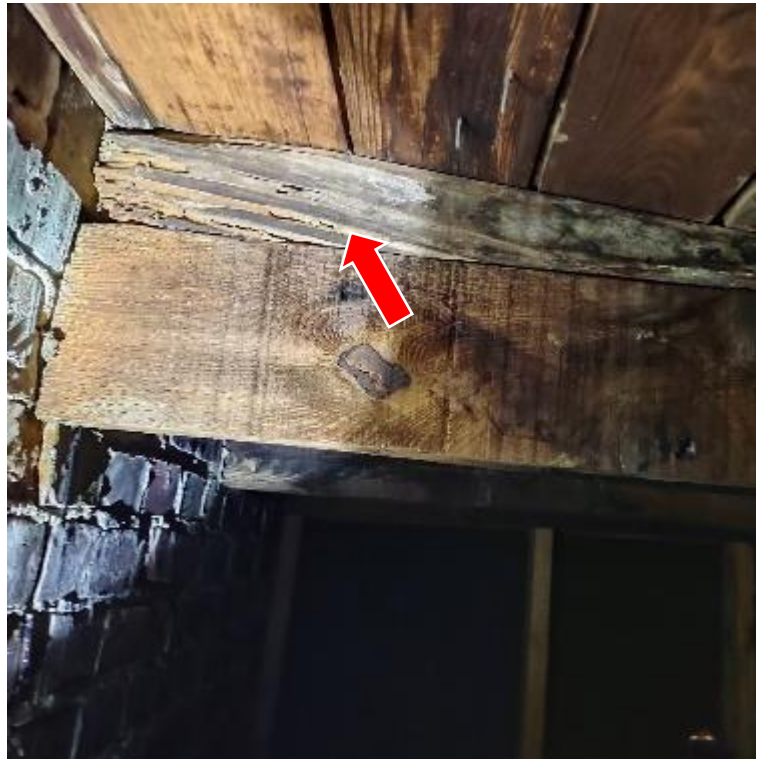
Photo 31:

An example of water damaged tapered edge shim beneath the subdeck (*red arrow*).

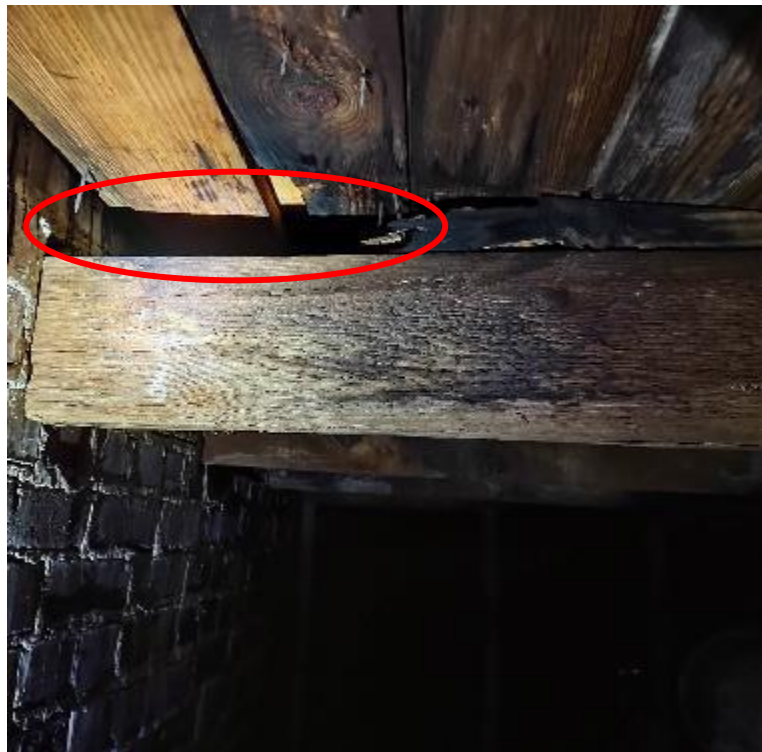
Photo 32:

An example of a damaged tapered edge shim that has become displaced beneath the subdeck (*red ellipse*).

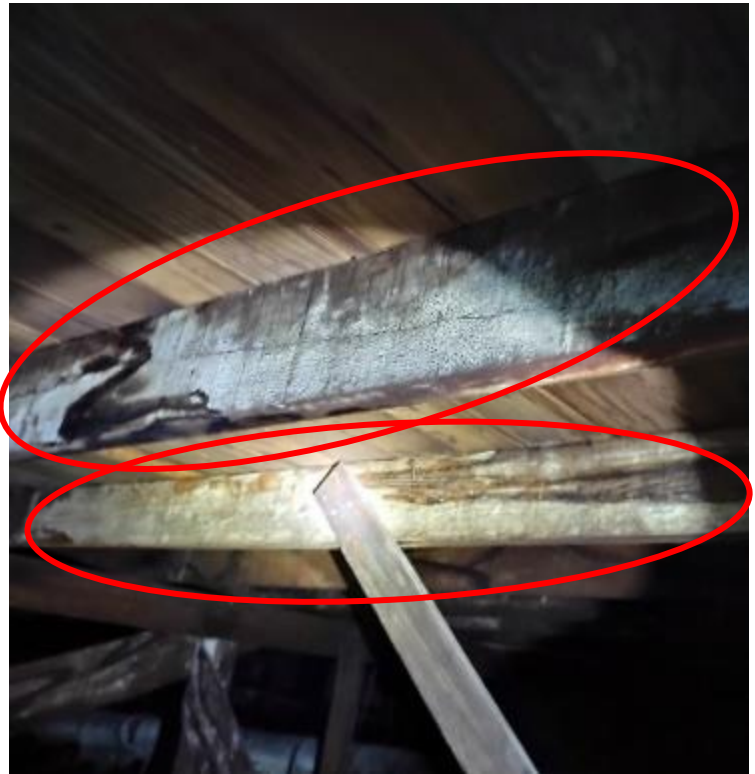
Photo 33:

An example of water damaged roof joists
(*red ellipses*).

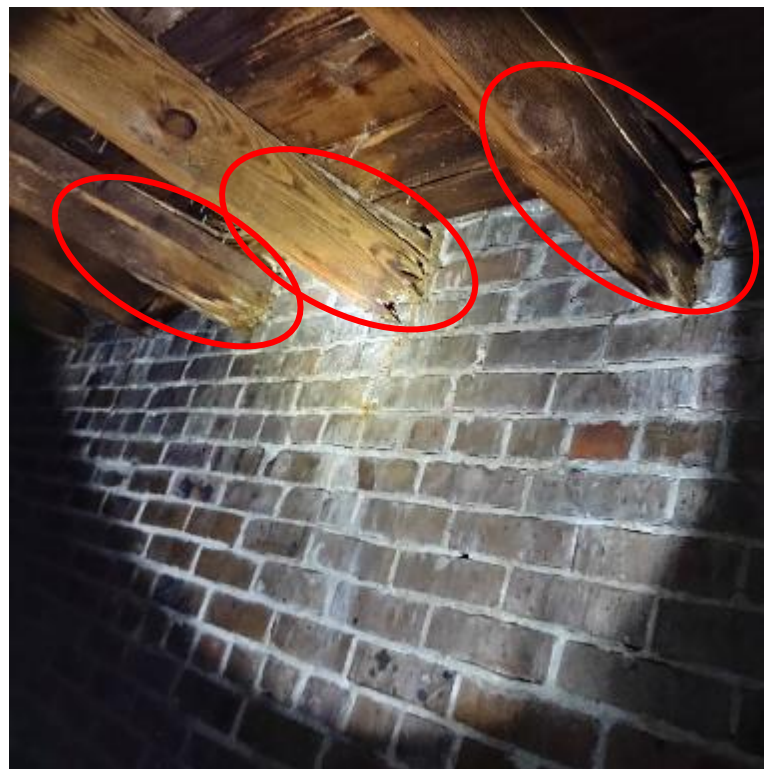
Photo 34:

An example of water damaged roof joists
(*red ellipses*).

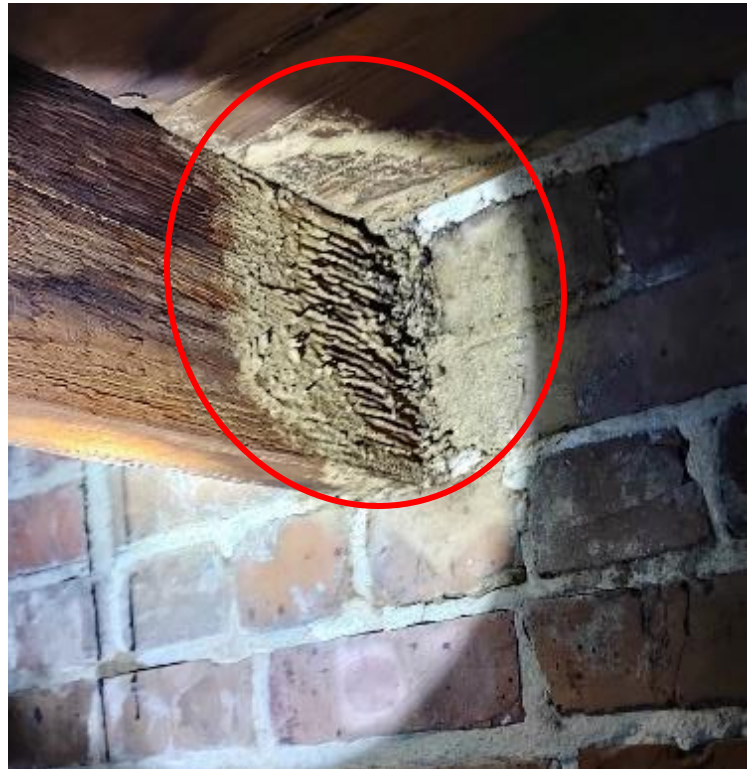
Photo 35:

An example of termite damage observed to the low slope roof framing and subdeck(*red ellipse*).

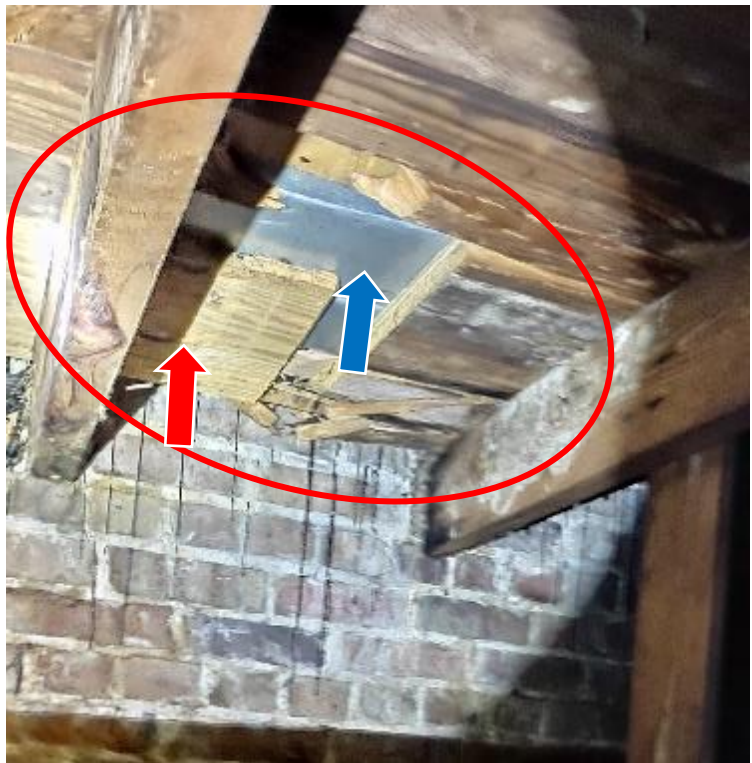
Photo 36:

An example of prior repairs to the subdeck observed at the low slope roof (*red ellipse*). CES noted plywood (*red arrows*) and sheet metal (*blue arrow*) repairs.

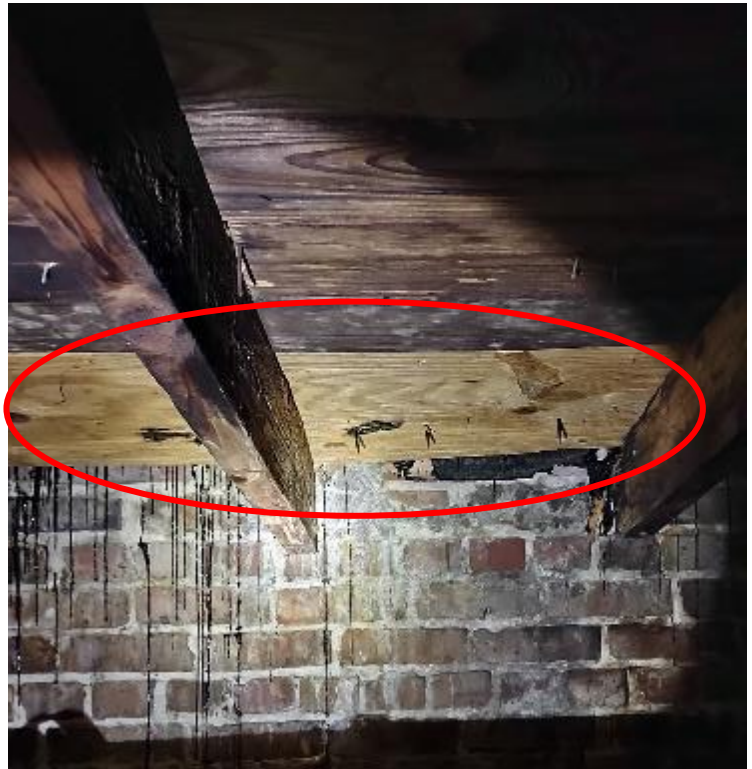
Photo 37:

An example of prior repairs to the subdeck observed at the low slope roof using plywood (*red ellipse*).
