HURRICANE IDA STORM DAMAGE ASSESSMENT

Upperline Condominiums

1114 Lyons Street
New Orleans, LA 70115

May 26, 2022

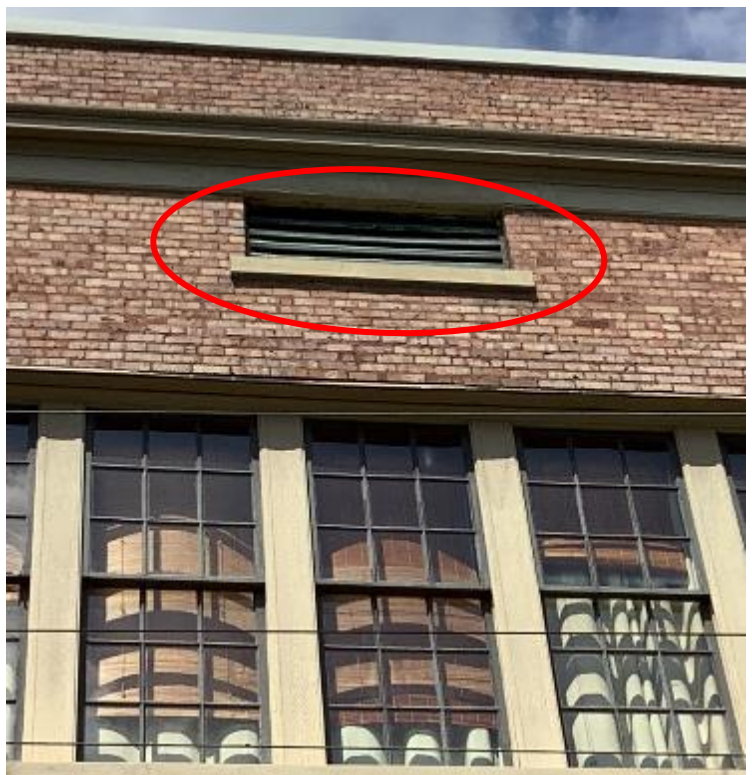
Photo 38:

An example of an attic vent as observed at the east and west elevations of the north addition (*red ellipse*).

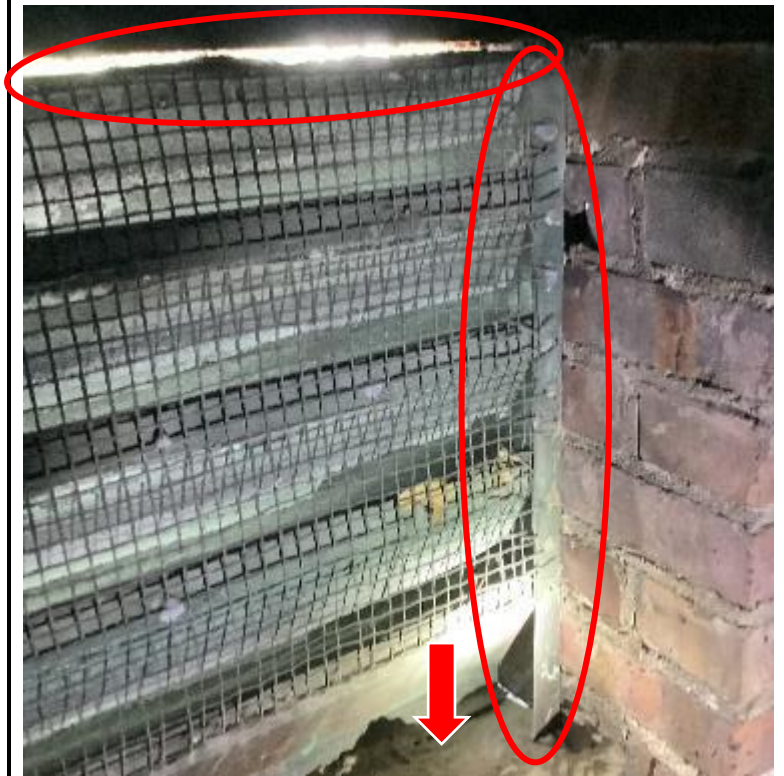
Photo 39:

An example of an attic vent as observed at the east and west elevations of the north addition, as viewed from the interior. Note that daylight was visible at all sides of the louver (*red ellipses*) and no flashing was observed to control water intrusion (*red arrow*).

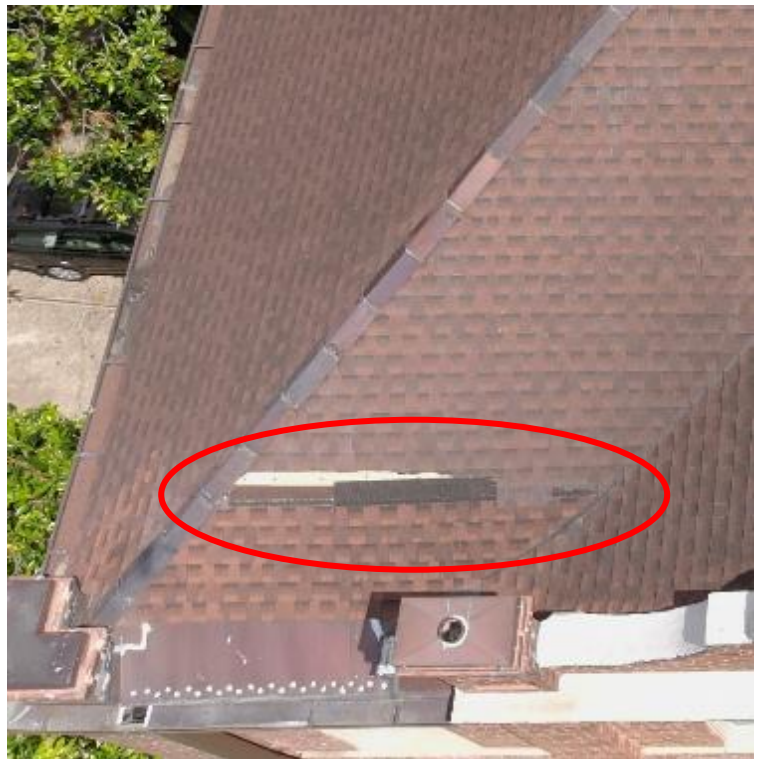
Photo 40:

Storm damaged and displaced shingles observed at the south facing steep slope roof (*red ellipse*).

The displaced and damaged shingles at the steep slope roof should be replaced. It may be possible this remediation could be performed with isolated repairs. Windborne debris damage at the cupola should be repaired and the windborne debris damaged dormer vent should be replaced. Any water damaged adjacent materials uncovered by the process of remediation should be addressed. Remove and replace all failed sealant.

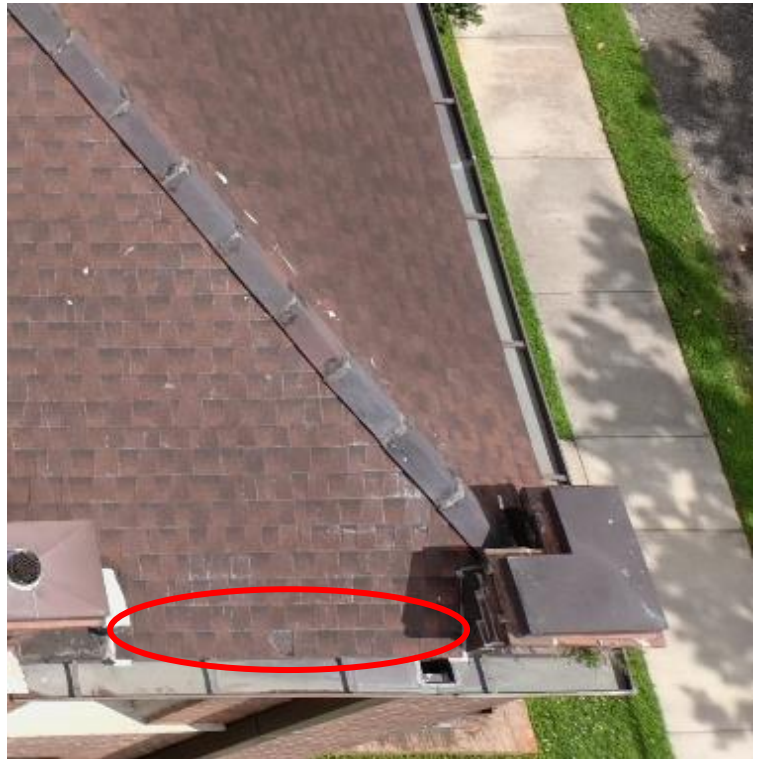
Photo 41:

Storm damaged shingles observed at the south facing steep slope roof (*red ellipse*).

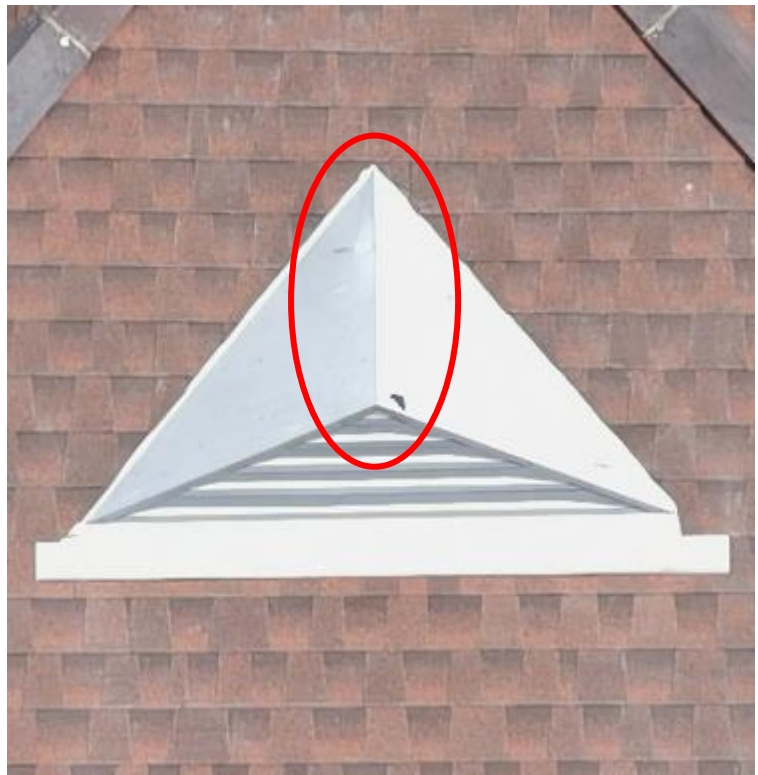
Photo 42:

Storm damaged dormer vent at the south facing steep slope roof (*red ellipse*).

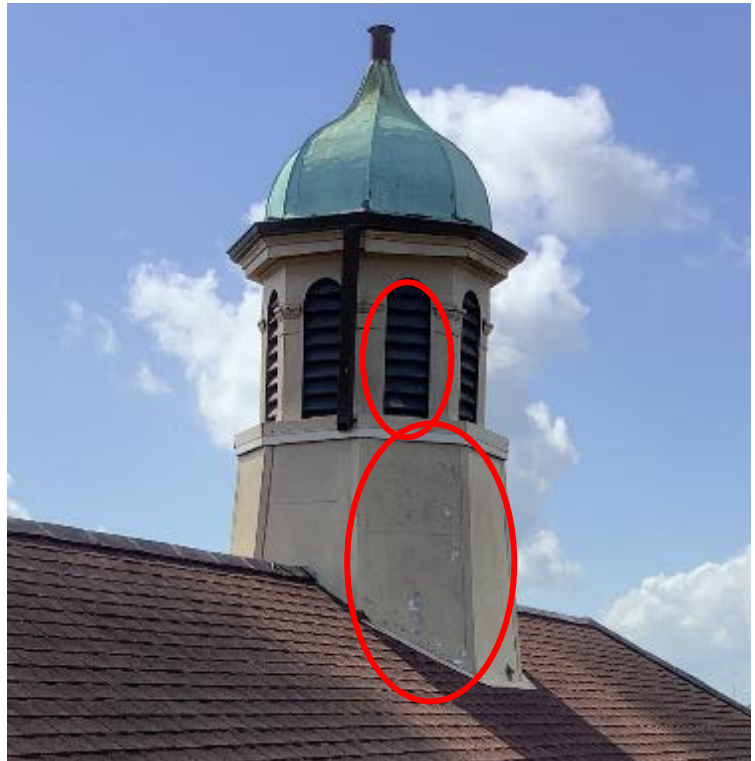
Photo 43:

The cupola at the steep slope roof displays windborne debris damages (*red ellipses*) at the louvers and base.

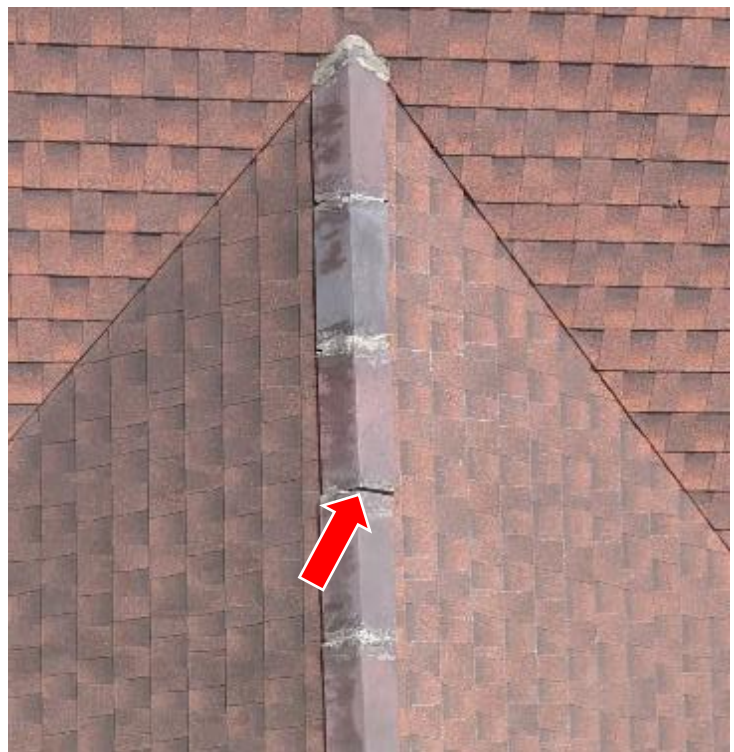
Photo 44:

An example of the sealant failure observed at the steep slope roof ridge tiles (*red arrow*)

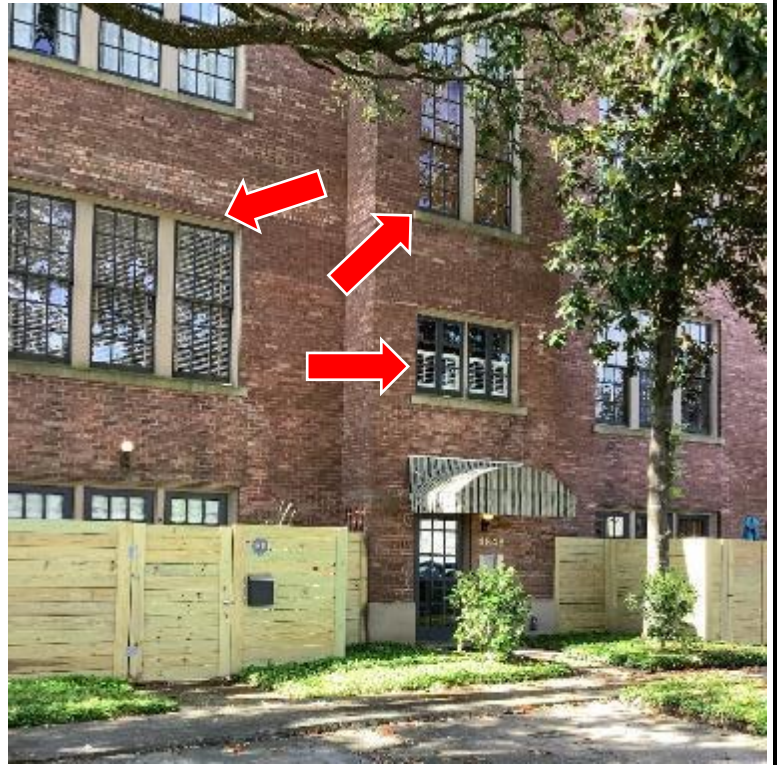
Photo 47:

An overview of the typical windows at the east and west elevations of the north addition (*red arrows*).

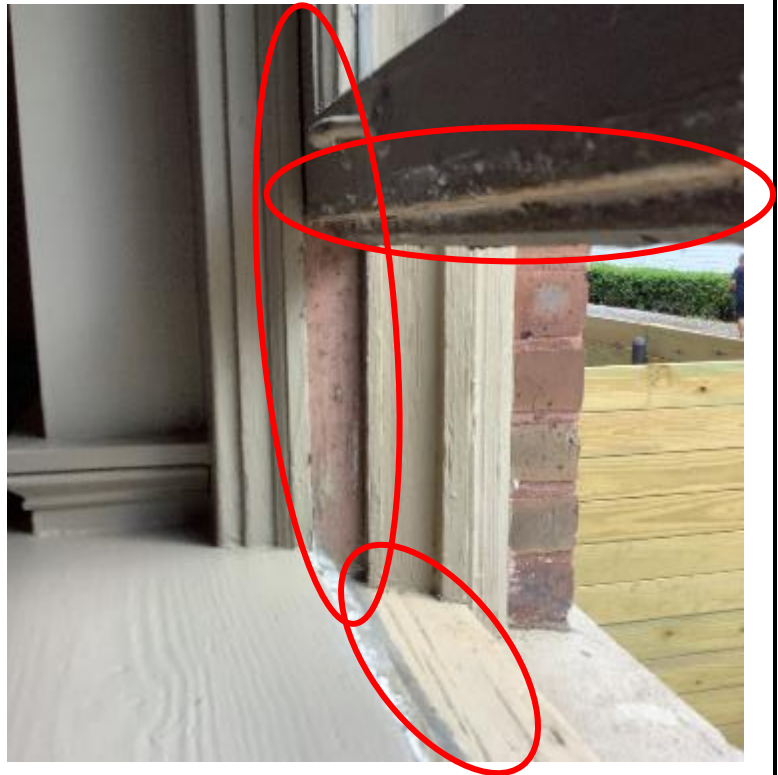
Photo 48:

Weather stripping was not observed at the window sashes, sills, or tracks (*red ellipse*).

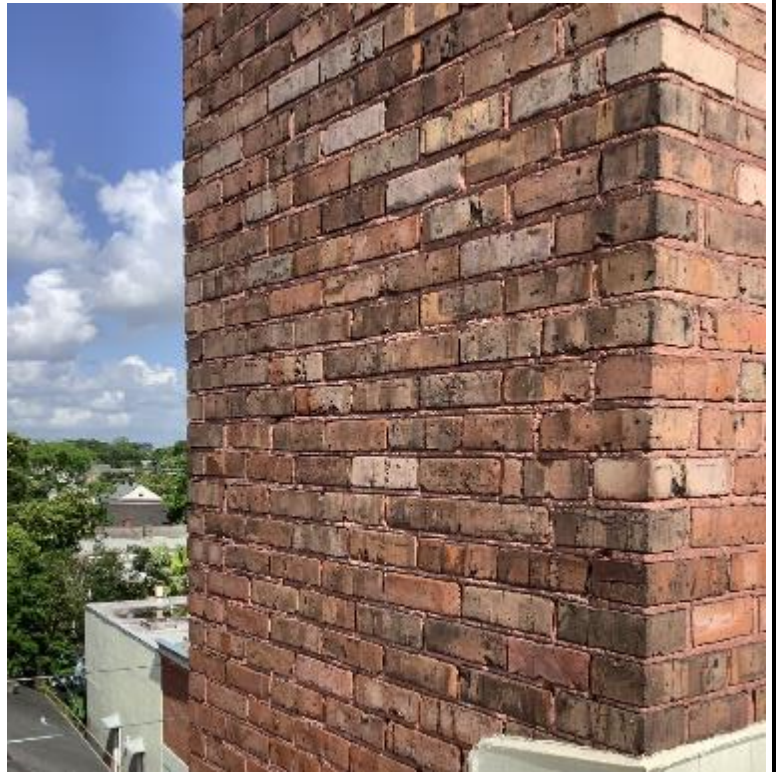
Photo 49:

An example of mortar degradation observed at the chimney stack.

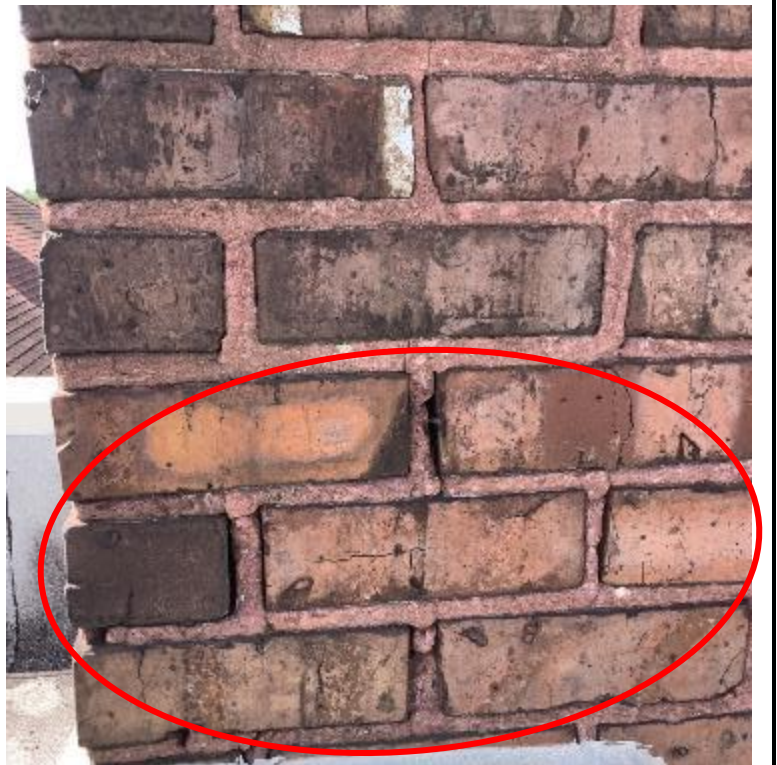
Photo 50:

An close-up view of mortar degradation observed at the chimney stack (*red ellipse*).

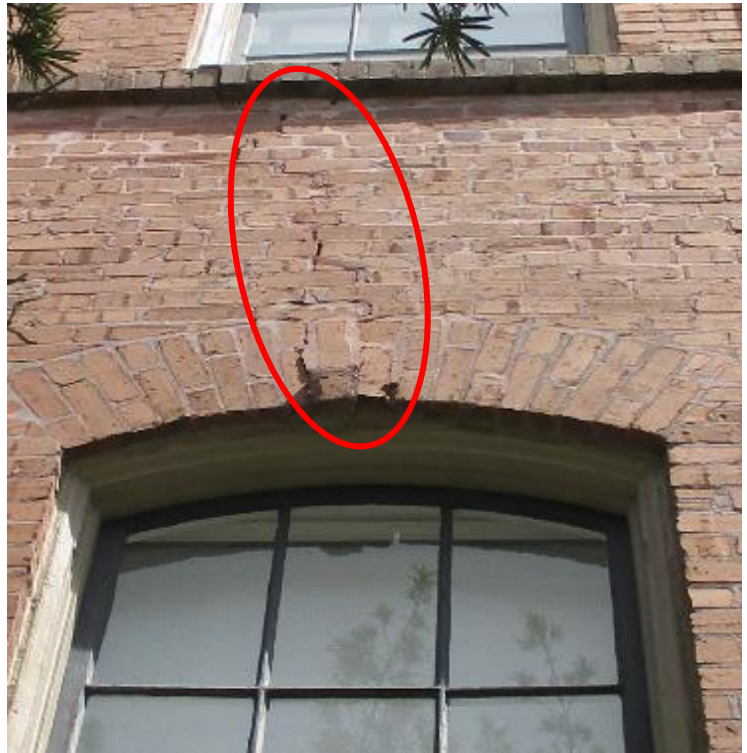
Photo 51:

An example of mortar degradation and brick cracking and deflection observed above a window (*red ellipse*).

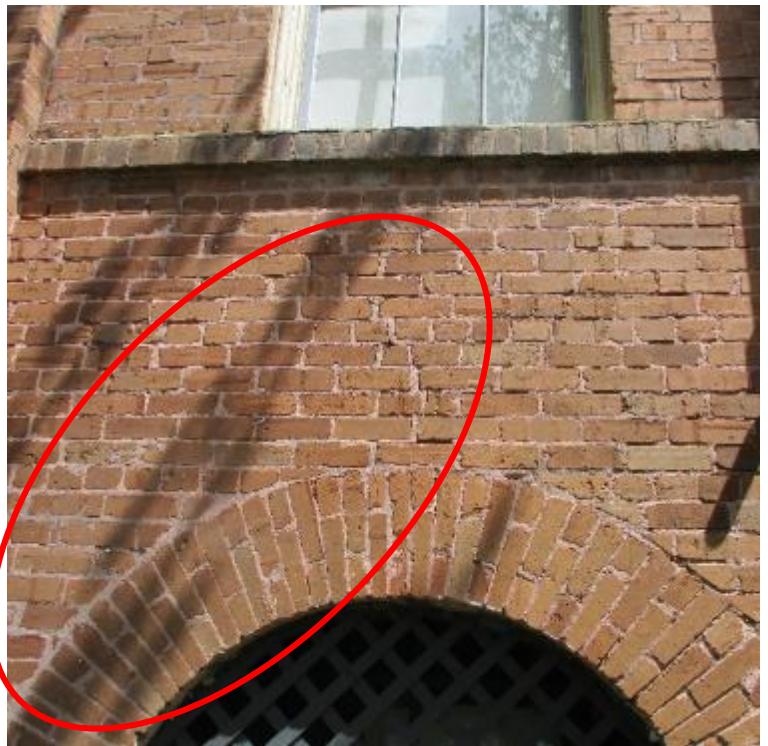
Photo 52:

An example of degradation of re-pointed mortar (*red ellipse*).

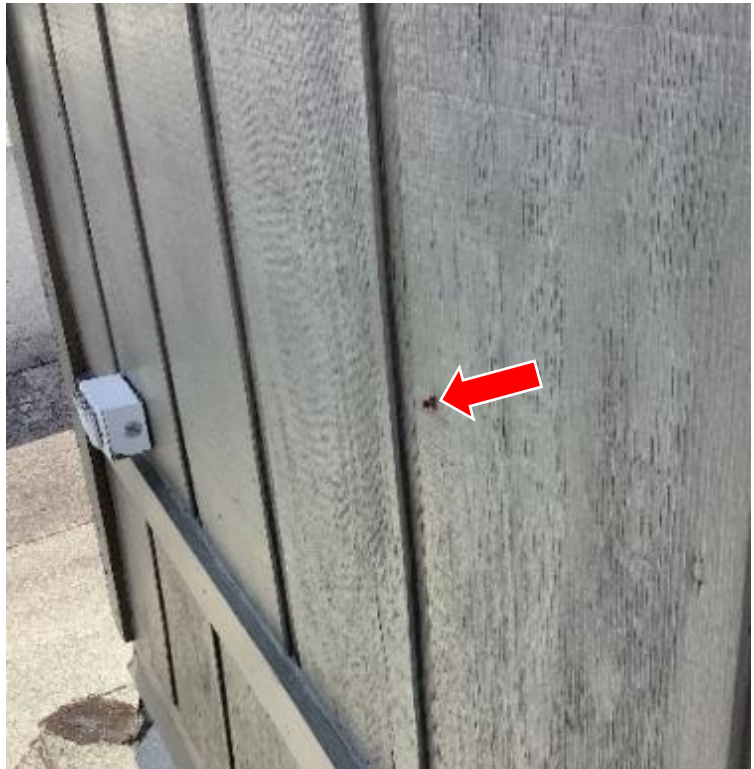
Photo 54:

An example of a disengaged fastener at the stairwell penthouse siding (*red arrow*).

The disengaged fasteners at the stairwell penthouse siding should be replaced and the fastener holes abandoned, installing the new fastener in a new location bearing in mind fastener and material edge distance spacing. All fasteners and abandoned fastener holes should be sealed. The winds of Hurricane Ida are capable of buffeting the siding leading to fastener disengagement. Water damaged siding and failed sealants should be removed and replaced. The damaged parapet coping counterflashing should also be removed and replaced.

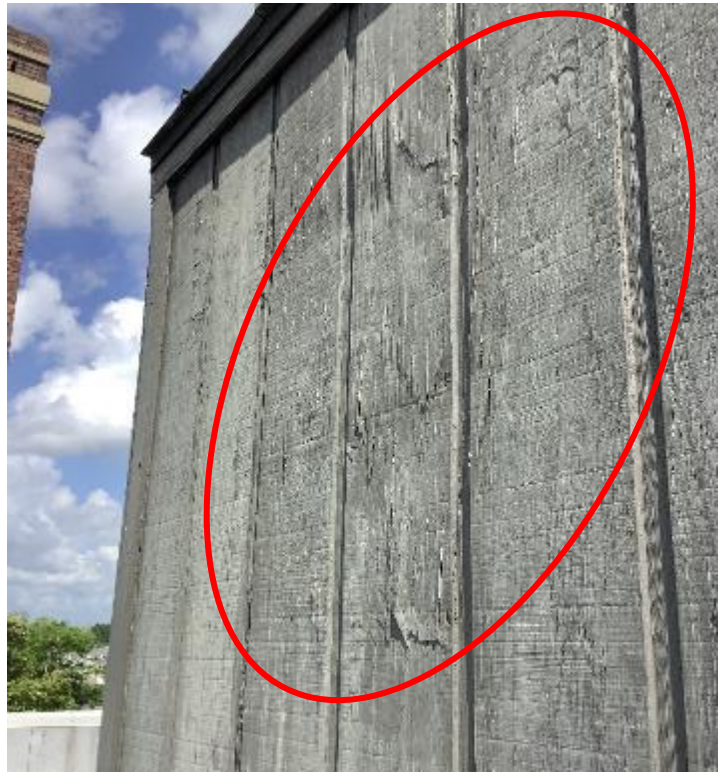
Photo 55:

An example of water damage observed at the stairwell penthouse siding (*red ellipse*).

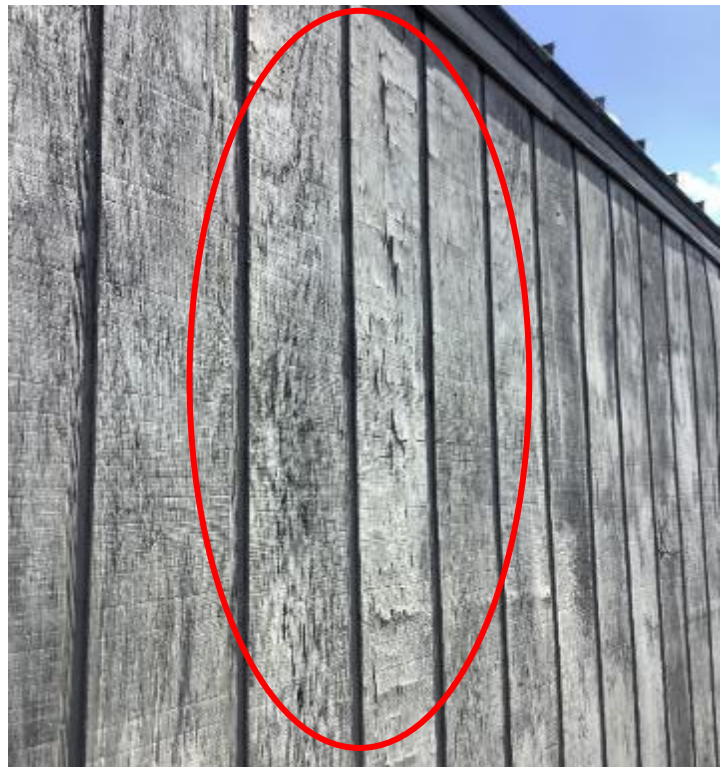
Photo 56:

An example of water damage observed at the stairwell penthouse siding (*red ellipse*).

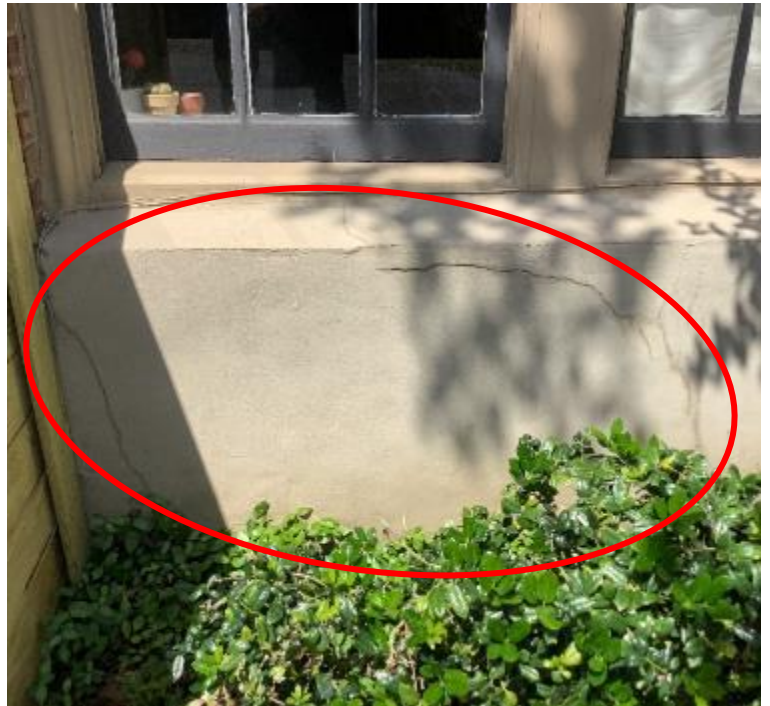
Photo 57:

An example of cracked and delaminating DEFS coating (*red ellipse*).

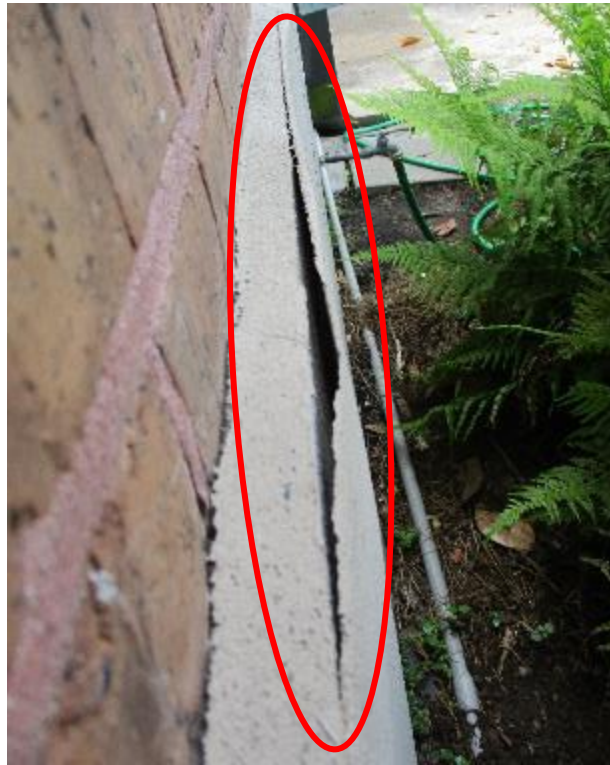
Photo 59:

An example of delaminating DEFS coating (*red ellipse*).

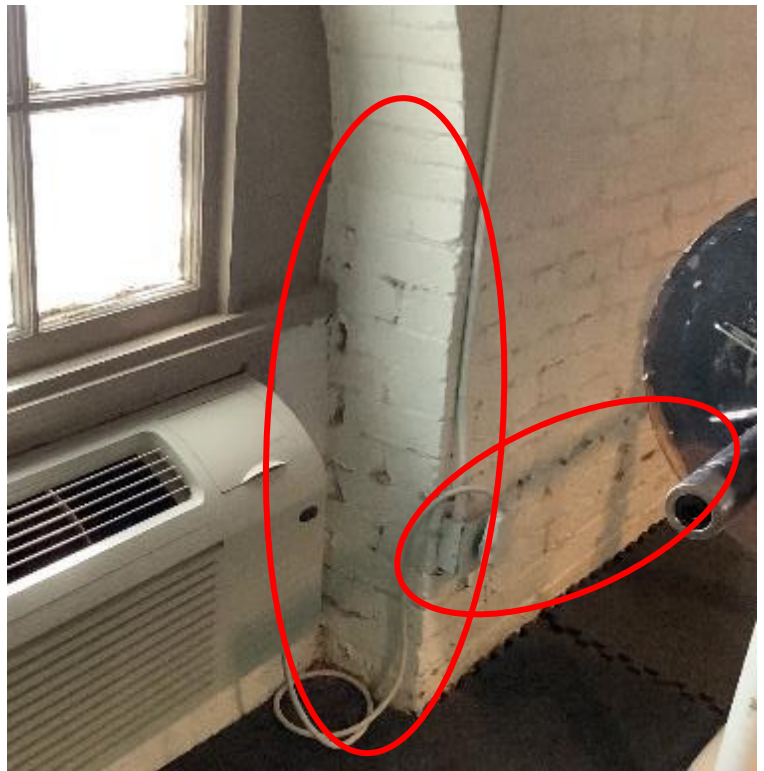
Photo 60:

An example of water damage to the interior wall finish at the basement gym (*red ellipses*).

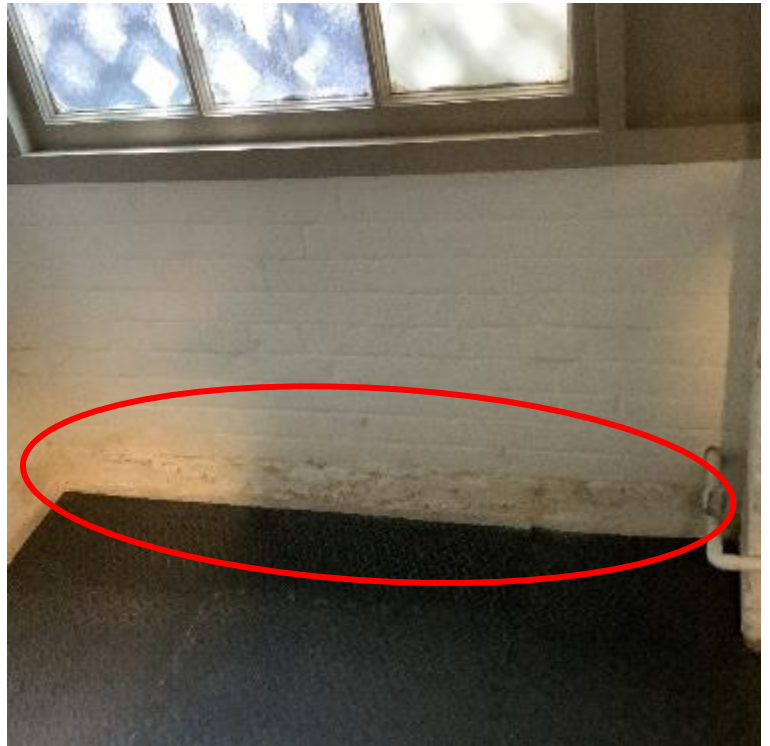
Photo 61:

An example of water damage to the interior wall finish at the basement gym (*red ellipse*).

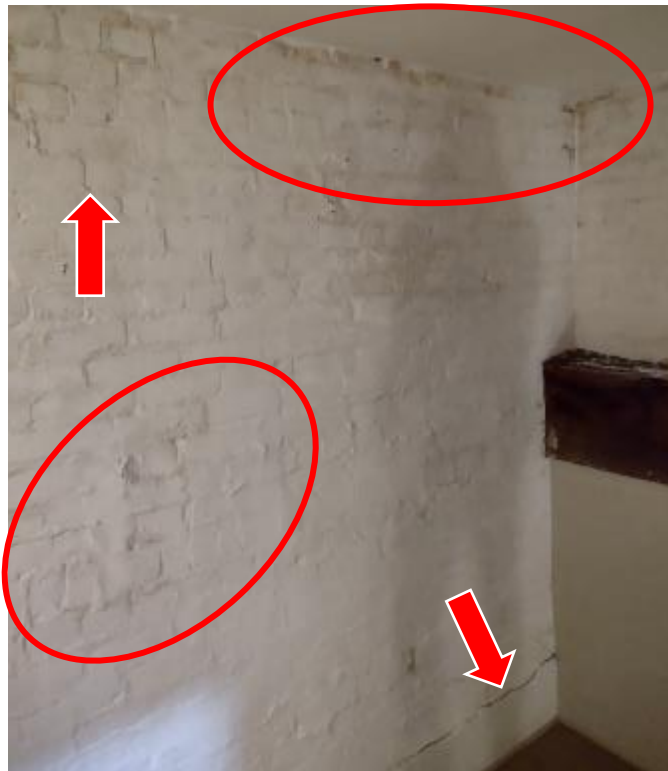
Photo 62:

An example of water damage (*red ellipses*) and cracking (*red arrows*) observed at the roof access stairwell interior wall finish.

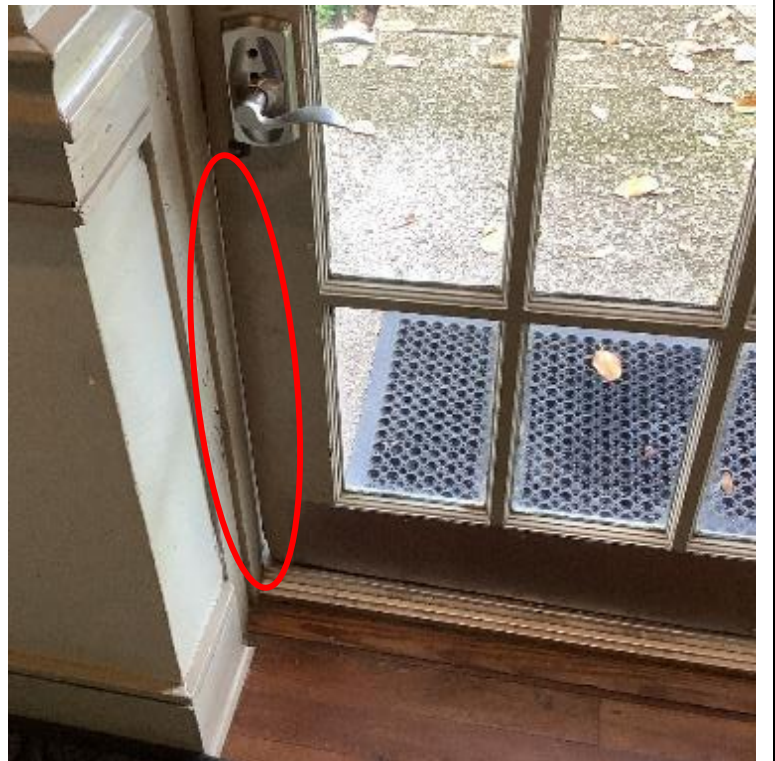
Photo 64:

The north entry door has been racked and no longer sets flush within the door frame (*red ellipse*).

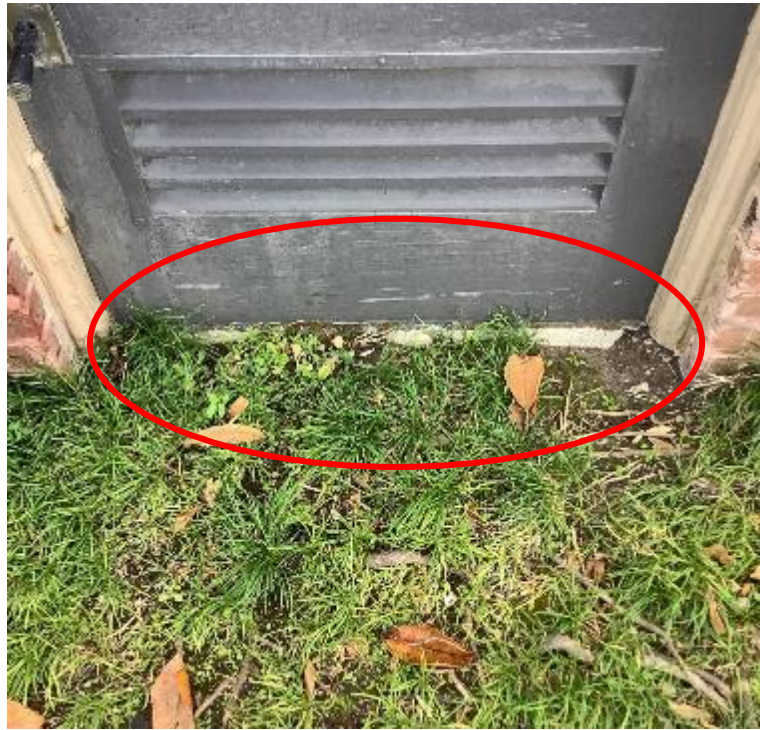
Photo 65:

The threshold of the second door from the south on the west elevation abuts directly to grade (*red ellipse*).

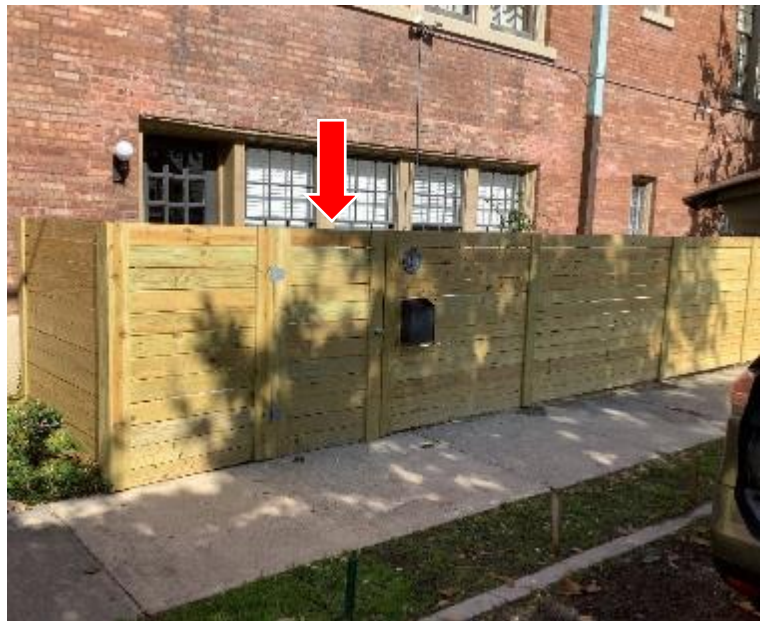
Photo 66:

At the time of CES observations, the fencing had been replaced at the property (*red arrow*).
