NEW ORLEANS HISTORIC DISTRICT LANDMARKS COMMISSION  
CENTRAL BUSINESS DISTRICT HISTORIC DISTRICT LANDMARKS COMMISSION

Re: 1015 Evelina Street

Attached, please find a report regarding an appeal of the Historic District Landmarks Commission's decision to deny an application for full demolition to grade but allow partial demolition of the rear shed addition encompassing three (3) rooms and the non-original front porch at 1015 Evelina Street.

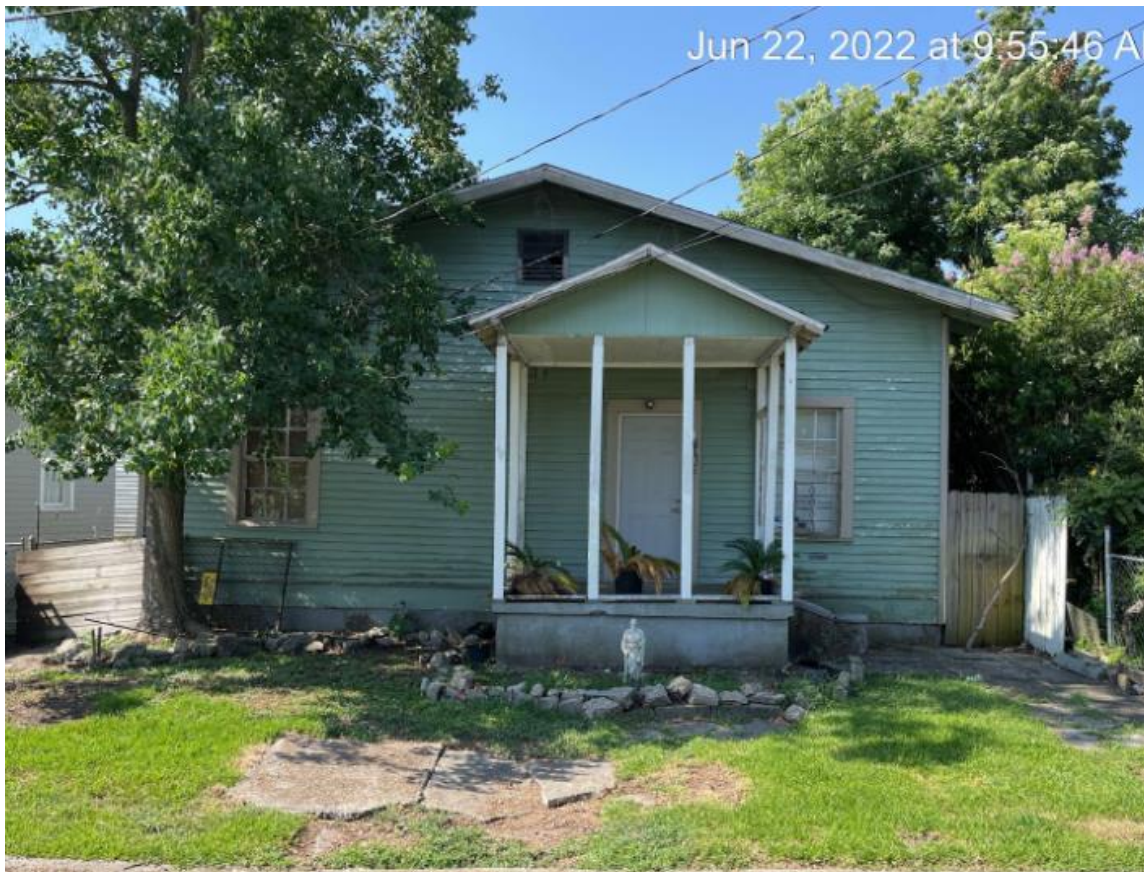
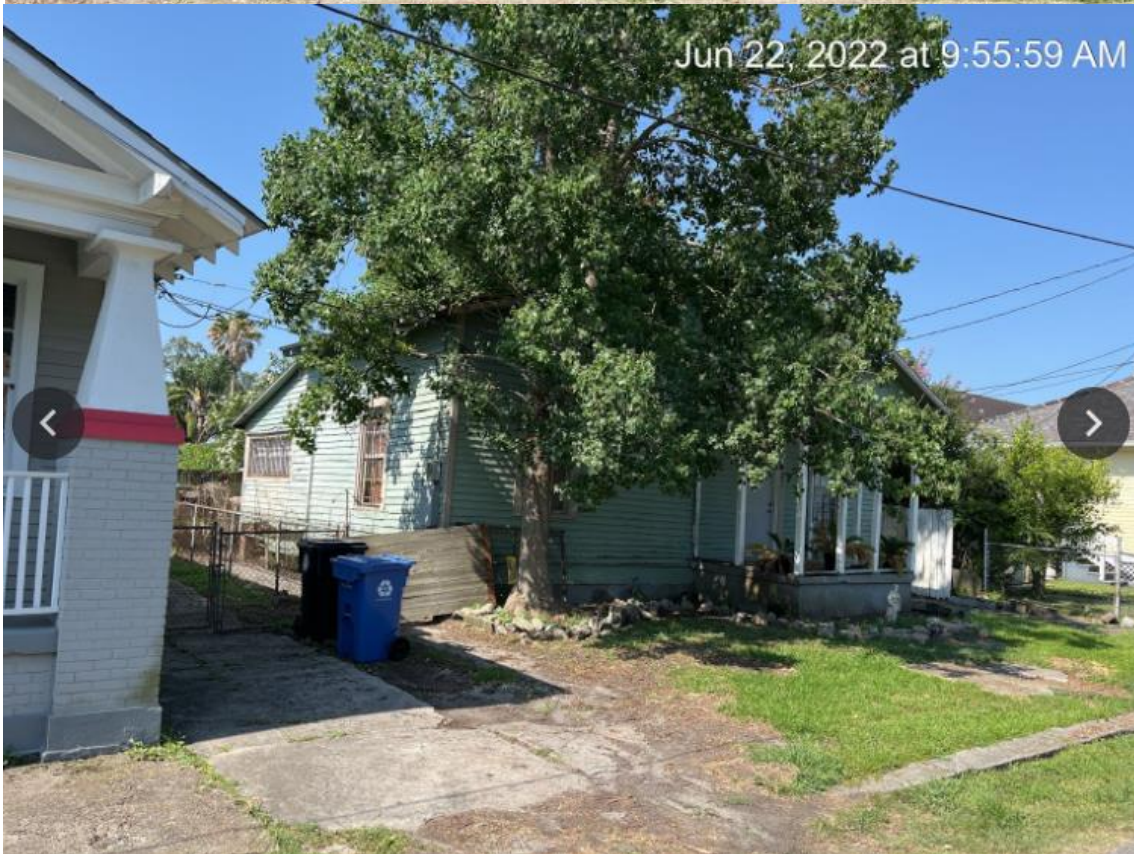
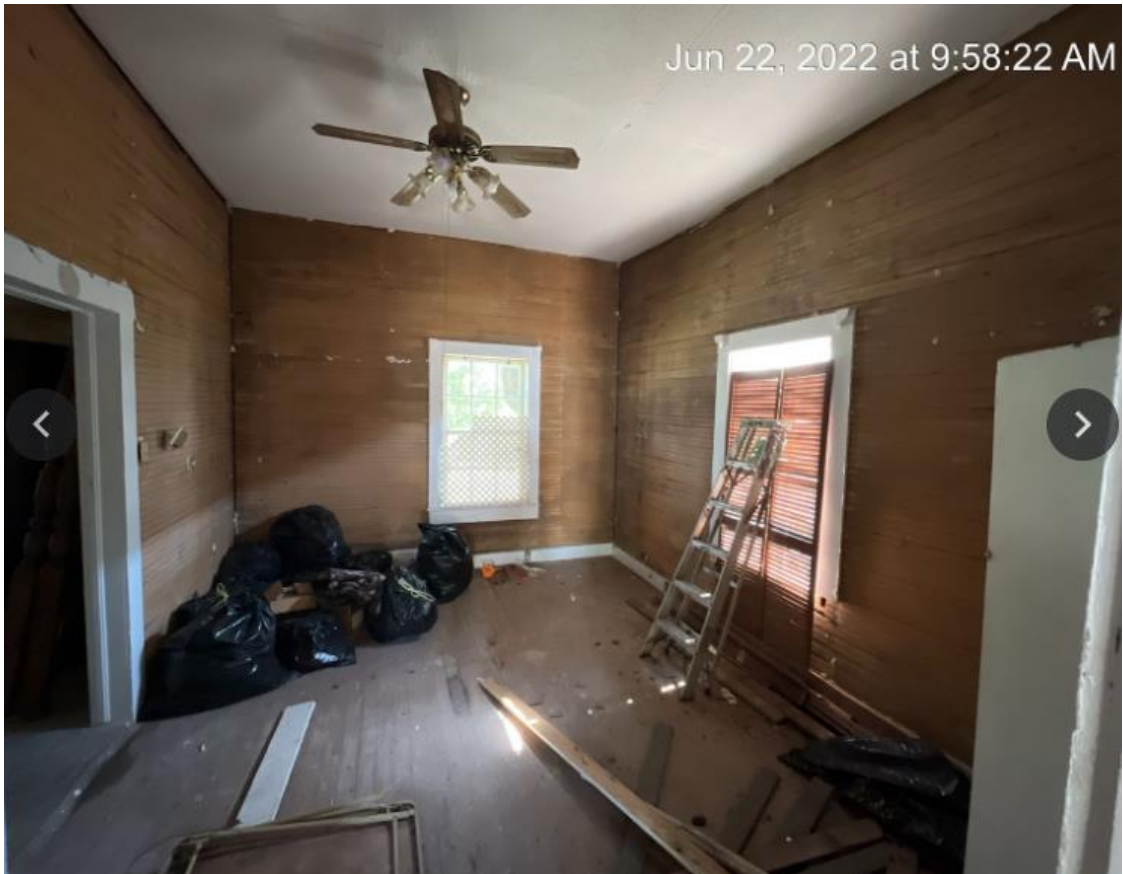
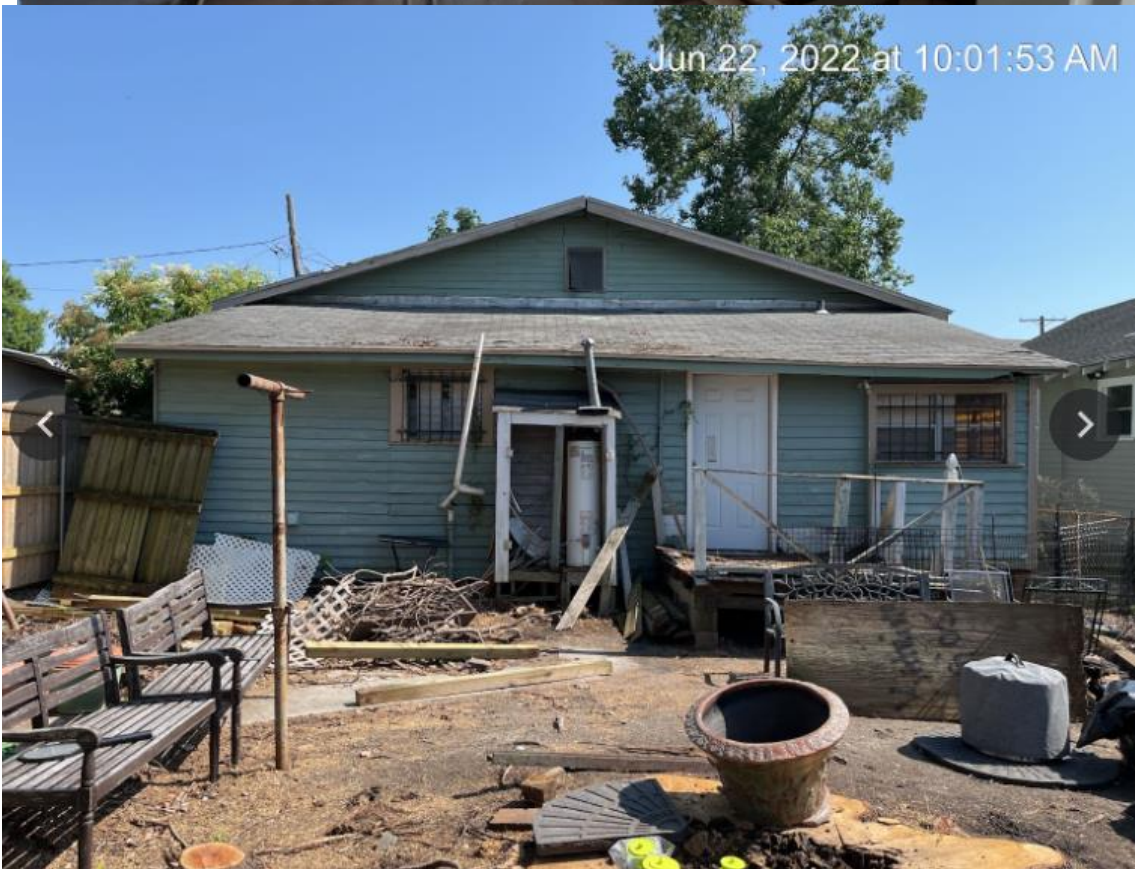
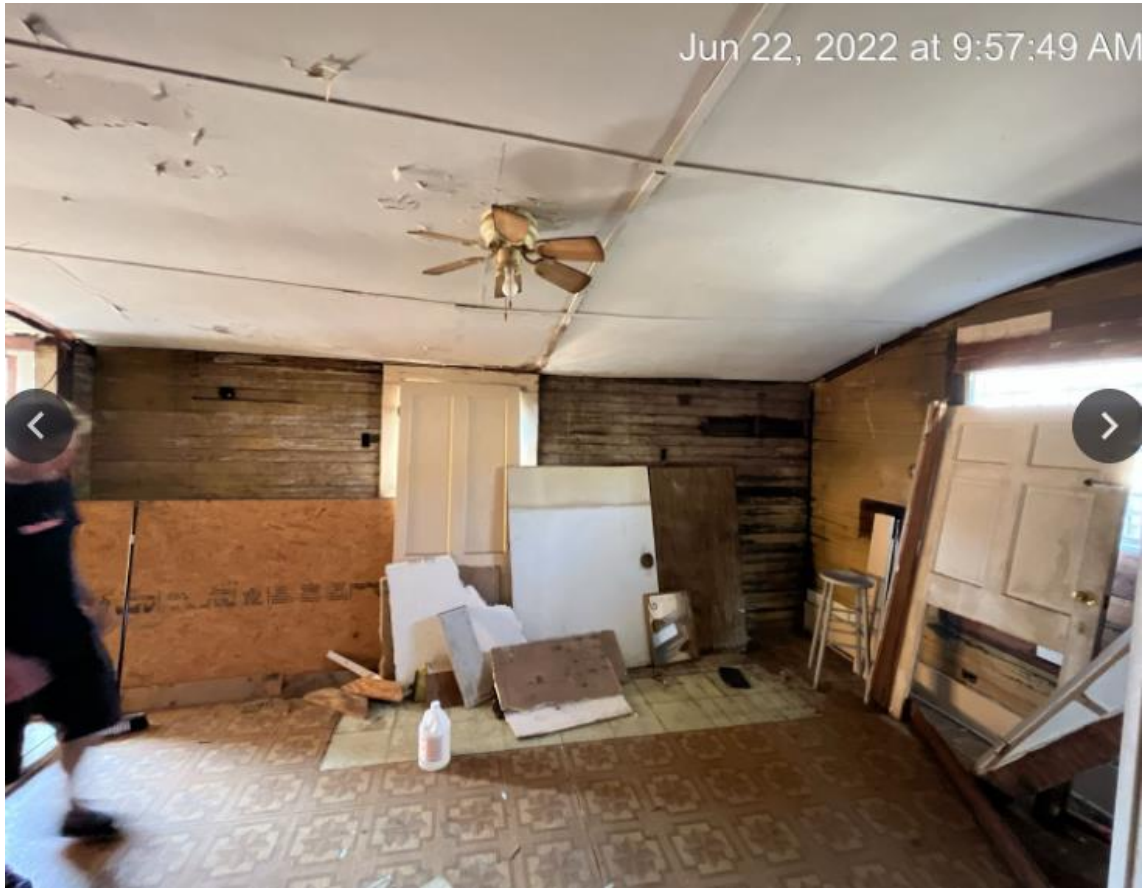
- The vacant raised single family residential building appeared to be in fair to very poor condition.
- The structure had a pier and beam foundation, wood framed superstructure with weatherboards.
- The roof is covered with asphalt shingles that appeared to be in poor condition.

- The building is covered in wood weatherboards that showed signs of deterioration throughout.
- There is less than 3'-0" of space between this building and right property line.

- The three rooms across the front of the building appear to be in fair condition, however the rear shed addition across back of the building appears to be in very poor condition.

- The windows on the rear portion are single pane aluminum windows and are incompatible with current HDLC Guidelines for new windows.
- The masonry piers do not appear to be settling or leaning on the perimeter of the building. Overall, the building foundation appears to be in fair condition.

- The rear soffit and rear wall of the building shows signs of water intrusion and/or wood destroying insect damage.

- The front three rooms of the building show minor signs of neglect but does not appear be structurally compromised in any way. The windows are square and plumb, the floor is flat and sturdy, and the ceilings are flat.
- There is no evidence of water intrusion at the front part of the building.
- The rear shed roof addition has bowing ceilings and is open to the elements. The flooring is deteriorated, missing or soft throughout.
- The walls on the rear addition are wavy and bowing in various locations.

**Overall, the building shows signs of minimal maintenance and has significant insect, water and/or vegetation damage to the rear 3 rooms. The original front portion could be salvaged but the rear addition is deteriorated, poorly constructed and should be removed.**

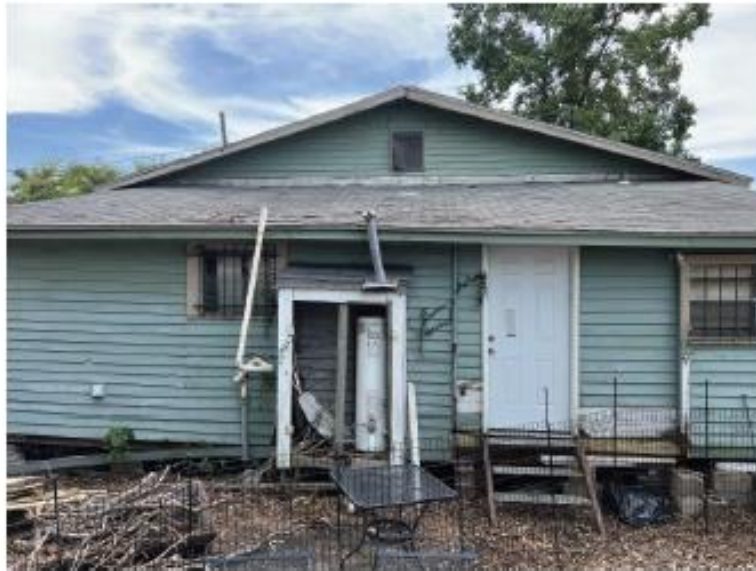
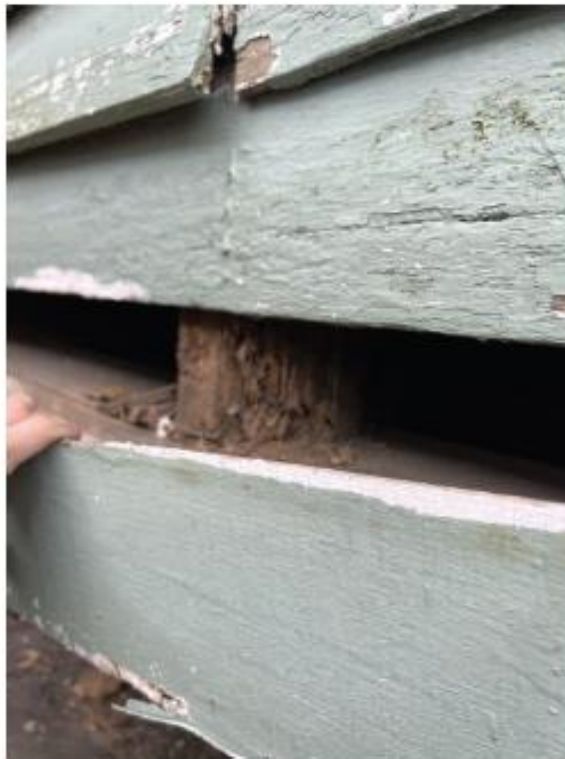
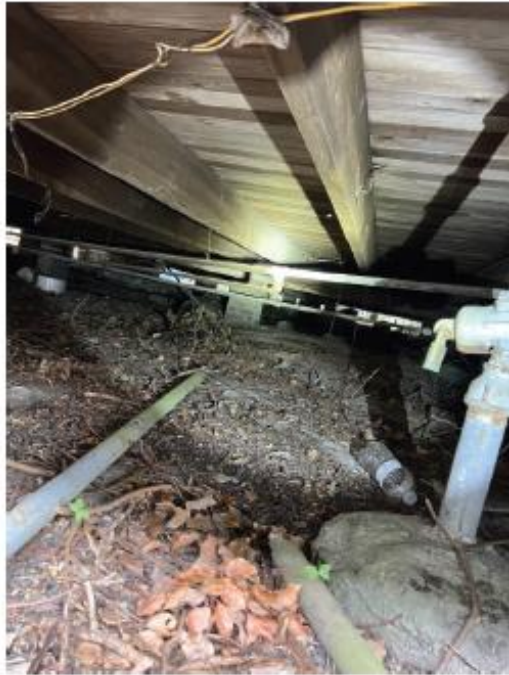
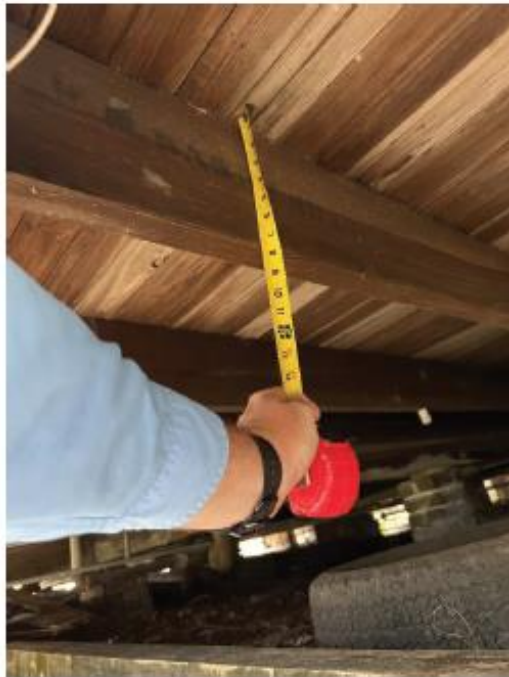
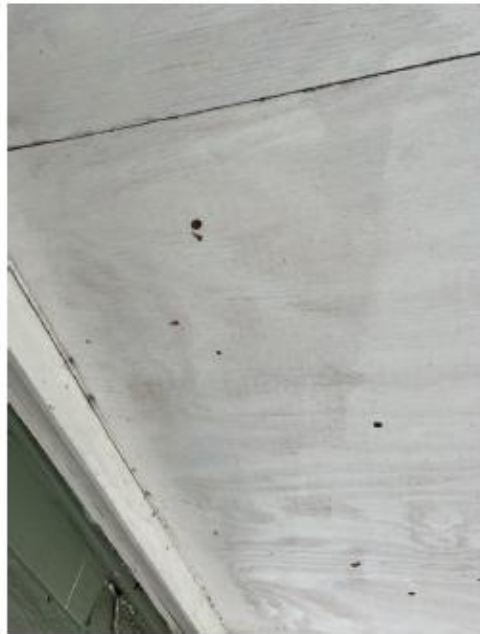
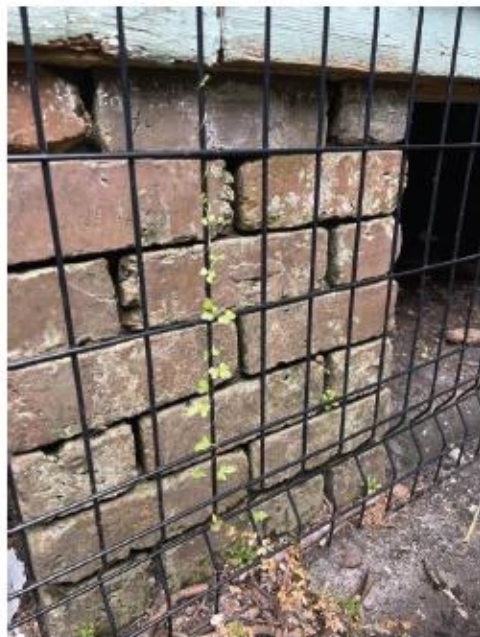
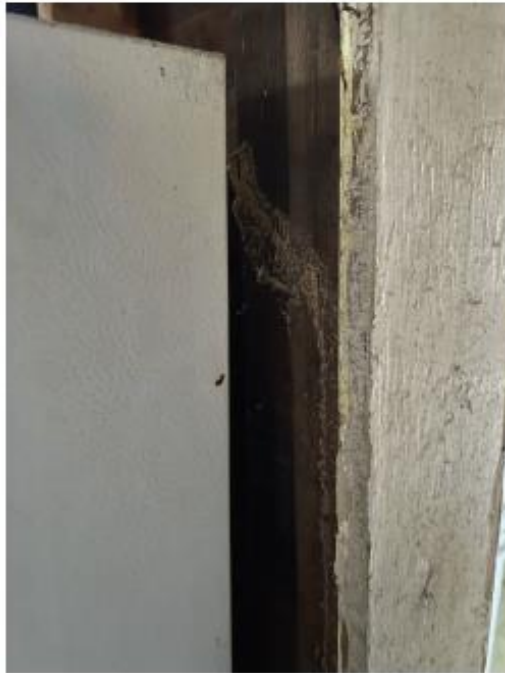
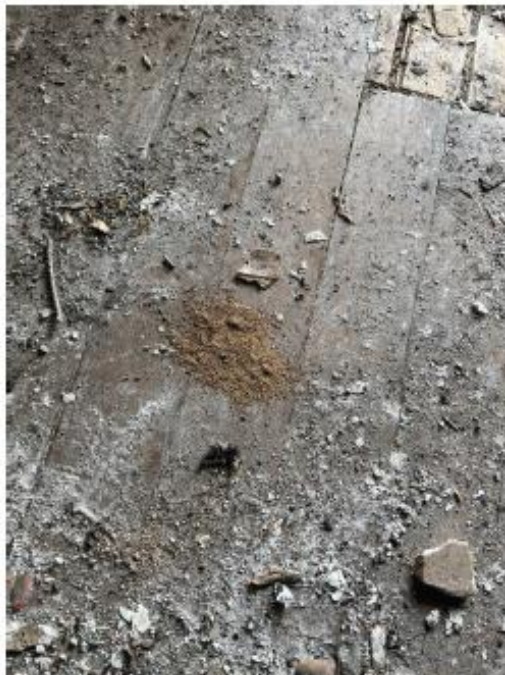
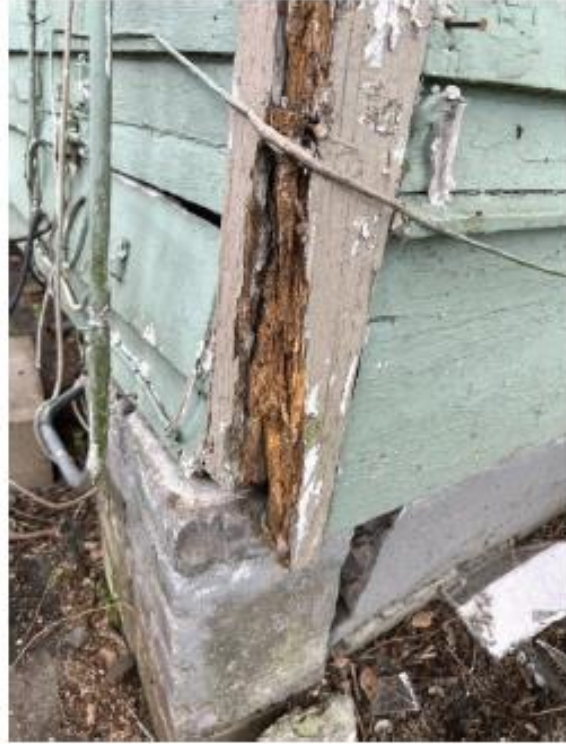
We observed the newer, rear section of the structure and found it to be poorly constructed with declining structural deficiencies. We believe the inadequate construction contributed to the accelerated deterioration of the rear section of the residence. We believe the older, front section to be the original construction of the residence and this is what our report will focus on.

The piers were constructed of brick masonry and in need of repair due to loss of grout and apparent lack of proper footing below. The sill beams above the masonry piers were affected by wood boring insects and showed signs of distress. The floor framing, in addition to showing

evidence of termites, appeared to be 2x8 framing spanning at least 17 feet which, even for old growth pine, is outside of recommended allowable spans. While the ceiling and roof framing was not visible, it is assumed to be compromised as well due to the visible horizontal and vertical separation of the rafters at the ridge, when viewed from the rear exterior of the residence.

While this front section, at quick glance, appears to be in repairable condition we found that ostensibly every structural element including the piers the sill beams, the joists, the subfloor, and the (visible) studs were either affected by wood boring insects or were otherwise non salvageable and in need of total replacement. While not every stud was visible, nor were any of the ceiling or roofing members, we believe that the deterioration of those members would be of similar nature as the rest of the exposed structural elements. Additionally, we found that the entire waterproof envelope was compromised including the exterior sheathing, windows, and roof.

It is our opinion that the entire structure needs to be demolished and rebuilt in accordance with current building codes and standards. The framing elements that were minimally affected by either long term deterioration or wood damaging insects were found to be either undersized or not properly anchored and subject to failure in the event of a high wind event. Based on the size of the front structure, we do not believe it is feasible to shore the structure while all the above-mentioned structural items are addressed. As such, it is recommended that the structure be demolished and rebuilt in its entirety. This recommendation is based on the short-term safety of contractors and long term safety of occupants and neighbors in the event of failure during renovation or failure during an act of nature, respectively.
