BUILDING ROOF-MANSARD AREA SHINGLE OVERLAY

PIC 6/16/22, 2:19 PM

16 Issues Identified

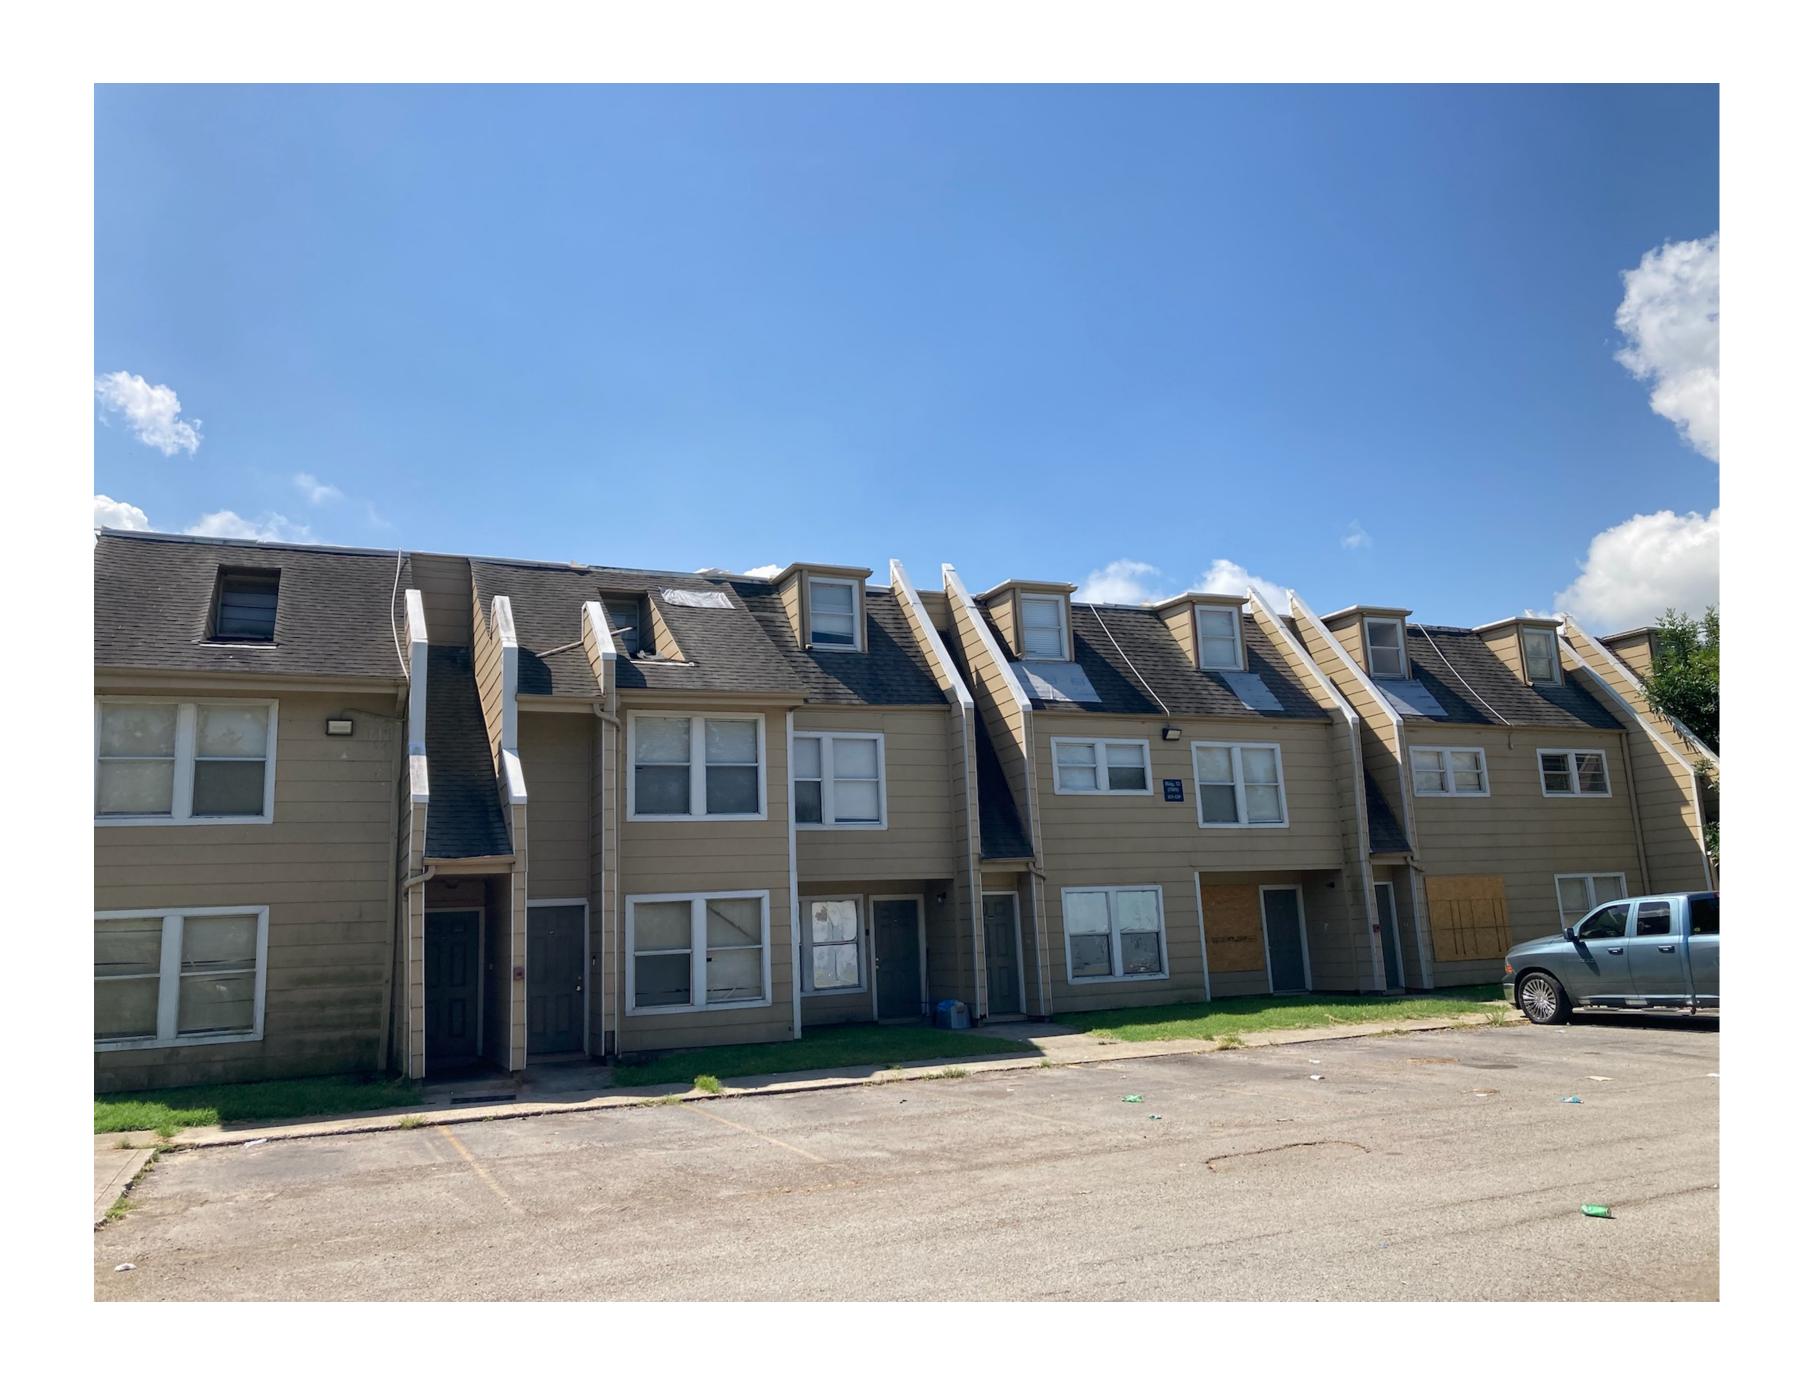
BUILDING 5: shingle overlay CENTER AND RIGHT of building penetrated with cap nails and synthetic. approx 40% of mansard roof area at front
