EXISTING CONDITIONS AND DEMOLITION ROOF PLAN

SHEET Sheet	DATE	R E V I S I O N S		11111111111111111111111111111111111111	ARCHDIOCESE OF NEW ORLEANS	
7 7 7	AUGUST 12, 2022				ST. STEPHENS GOOD SHEPHERD SCHOOL	DUPLANIEK & MERIC, ARCHIECIS, L.L.C.
	HCD, MJT				ROOF REPLACEMENT AND REPAIRS	4764 PARIS AVENUE NEW ORLEANS. LA 70122
	CHECKED BY		2203-K-1	DATENOT TO A COLL	1025 NAPOLEON AVENUE	
0 F 6	НСD				NEW ORLEANS, LOUISIANA 70115

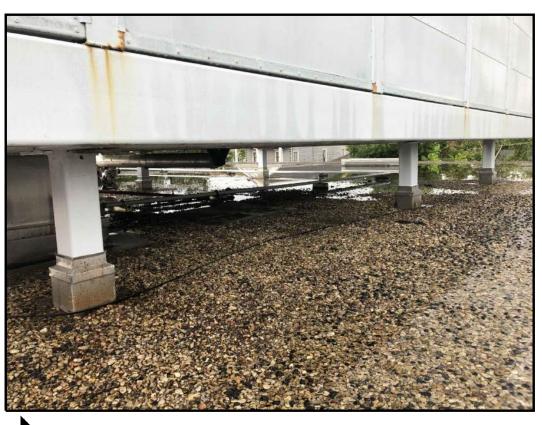
MAIN ROOF CLASSROOM BUILDING (AT MECHANICAL EQUIPMENT PLATFORM)

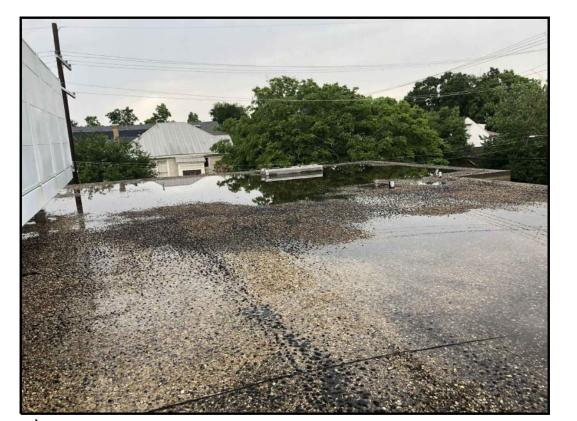
MAIN ROOF CLASSROOM BUILDING (EAST END LOOKING NORTH)
