HURRICANE IDA REPAIRS TO EXTERIOR OF THE  
BUILDING, INCLUDING RECONSTRUCTION OF  
SLATE ROOF, MASONRY STABILIZATION, AND  
WINDOW/SHUTTER REPAIRS

## 923 DECATUR STREET EXTERIOR REPAIRS

923 DECATUR ST  
NEW ORLEANS, LA 70116  
VIEUX CARRE COMMISSION SUBMISSION

DATE: 01.25.22  
PROJECT NO.: 01-21-1026-02

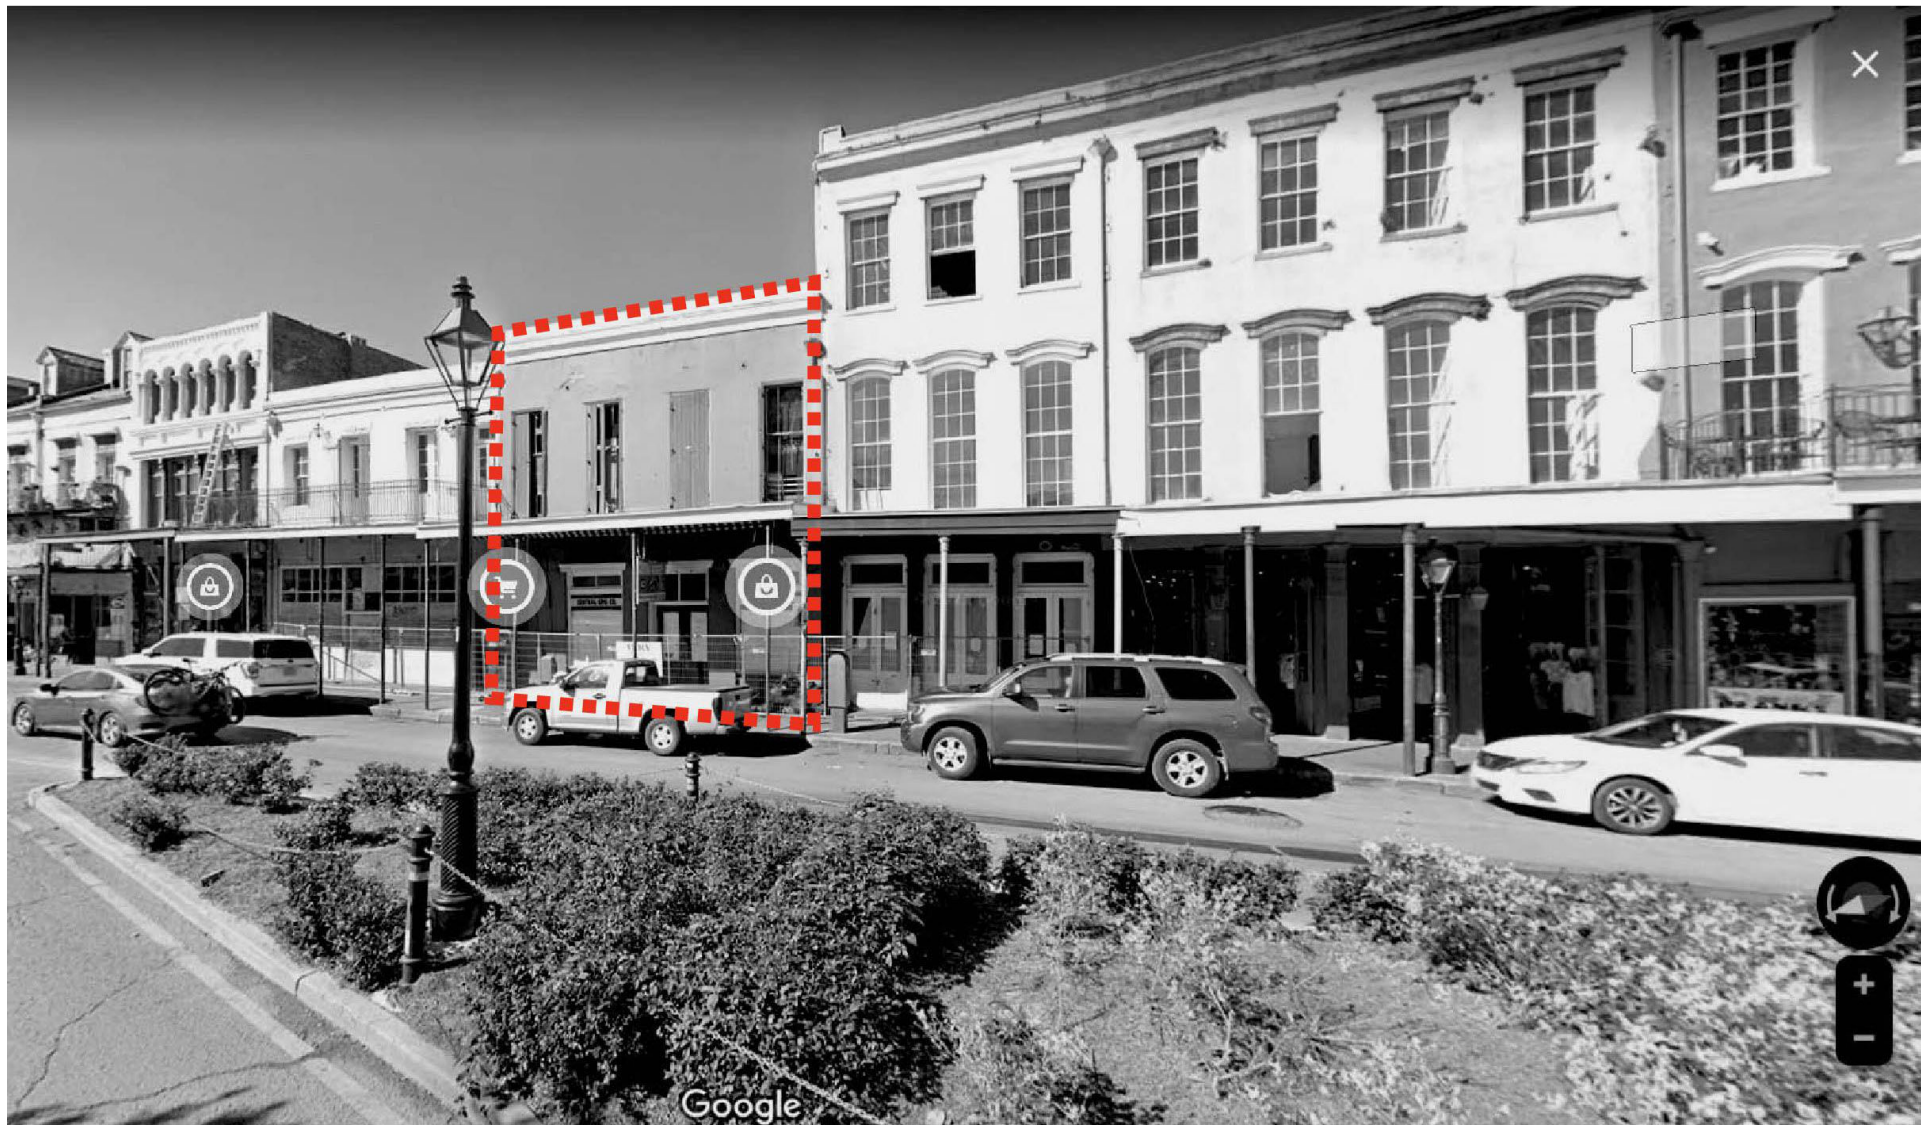
GOOGLE STREET VIEW OF STREET FRONT FACADE.

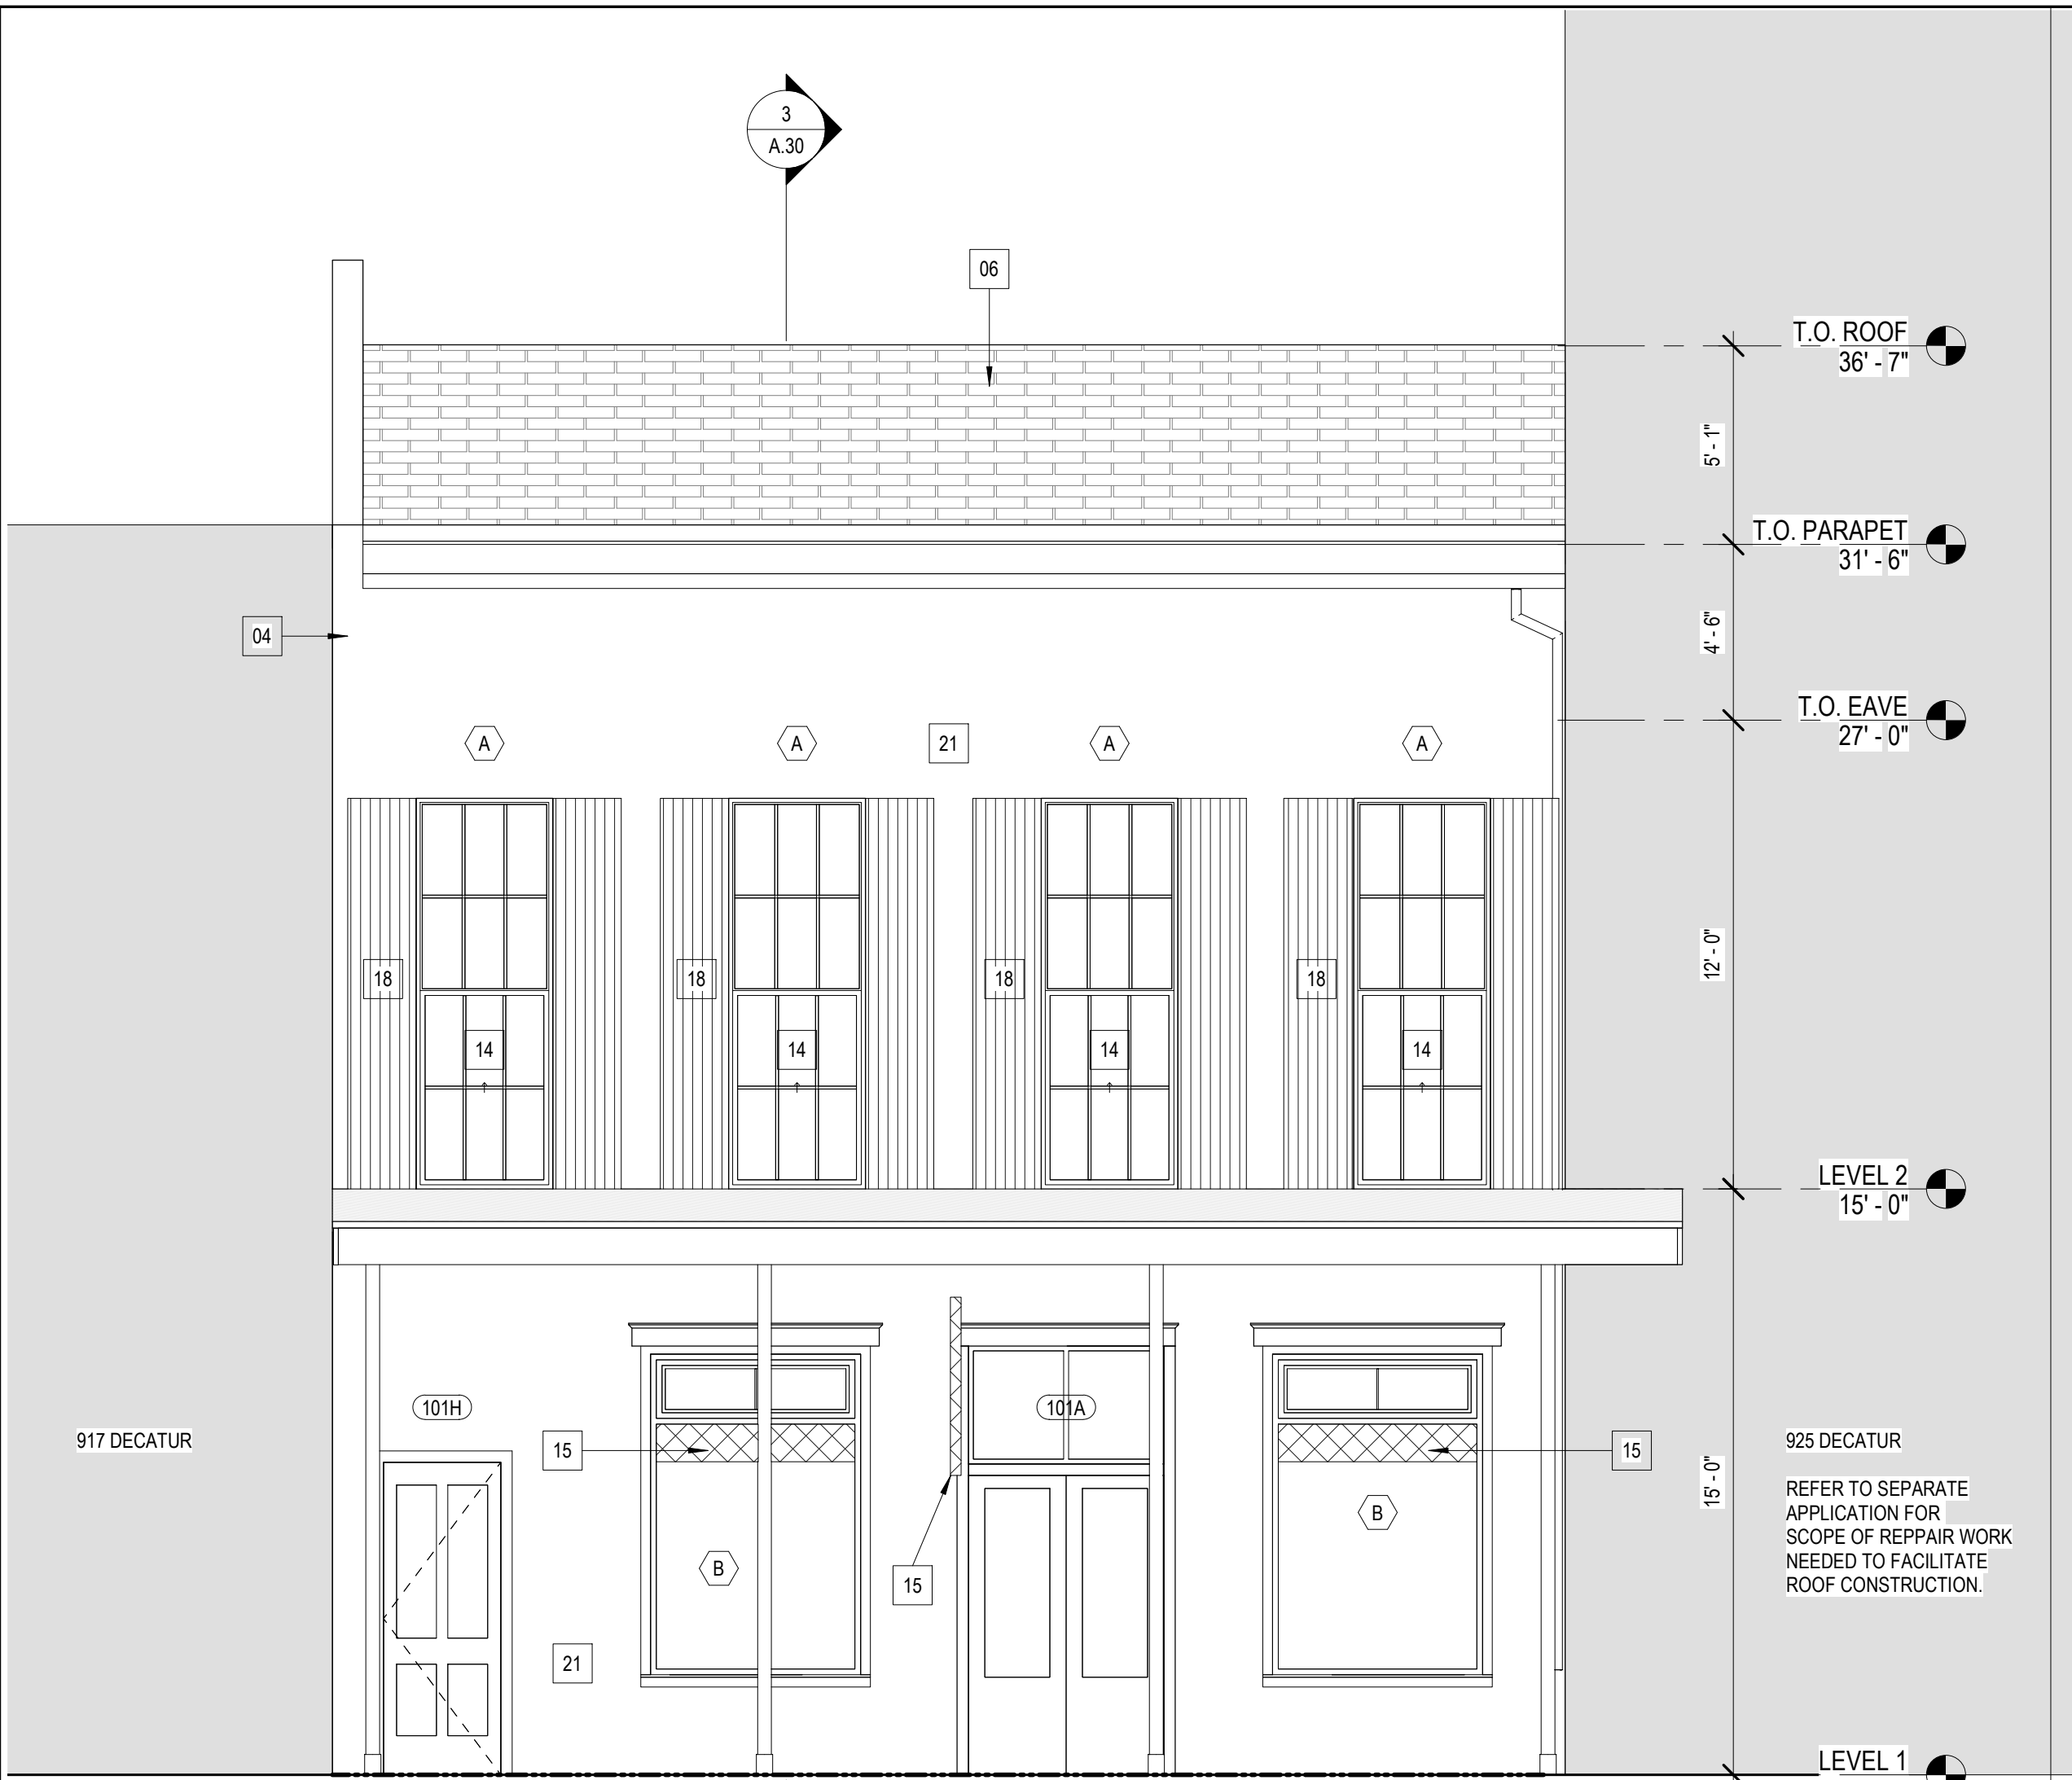
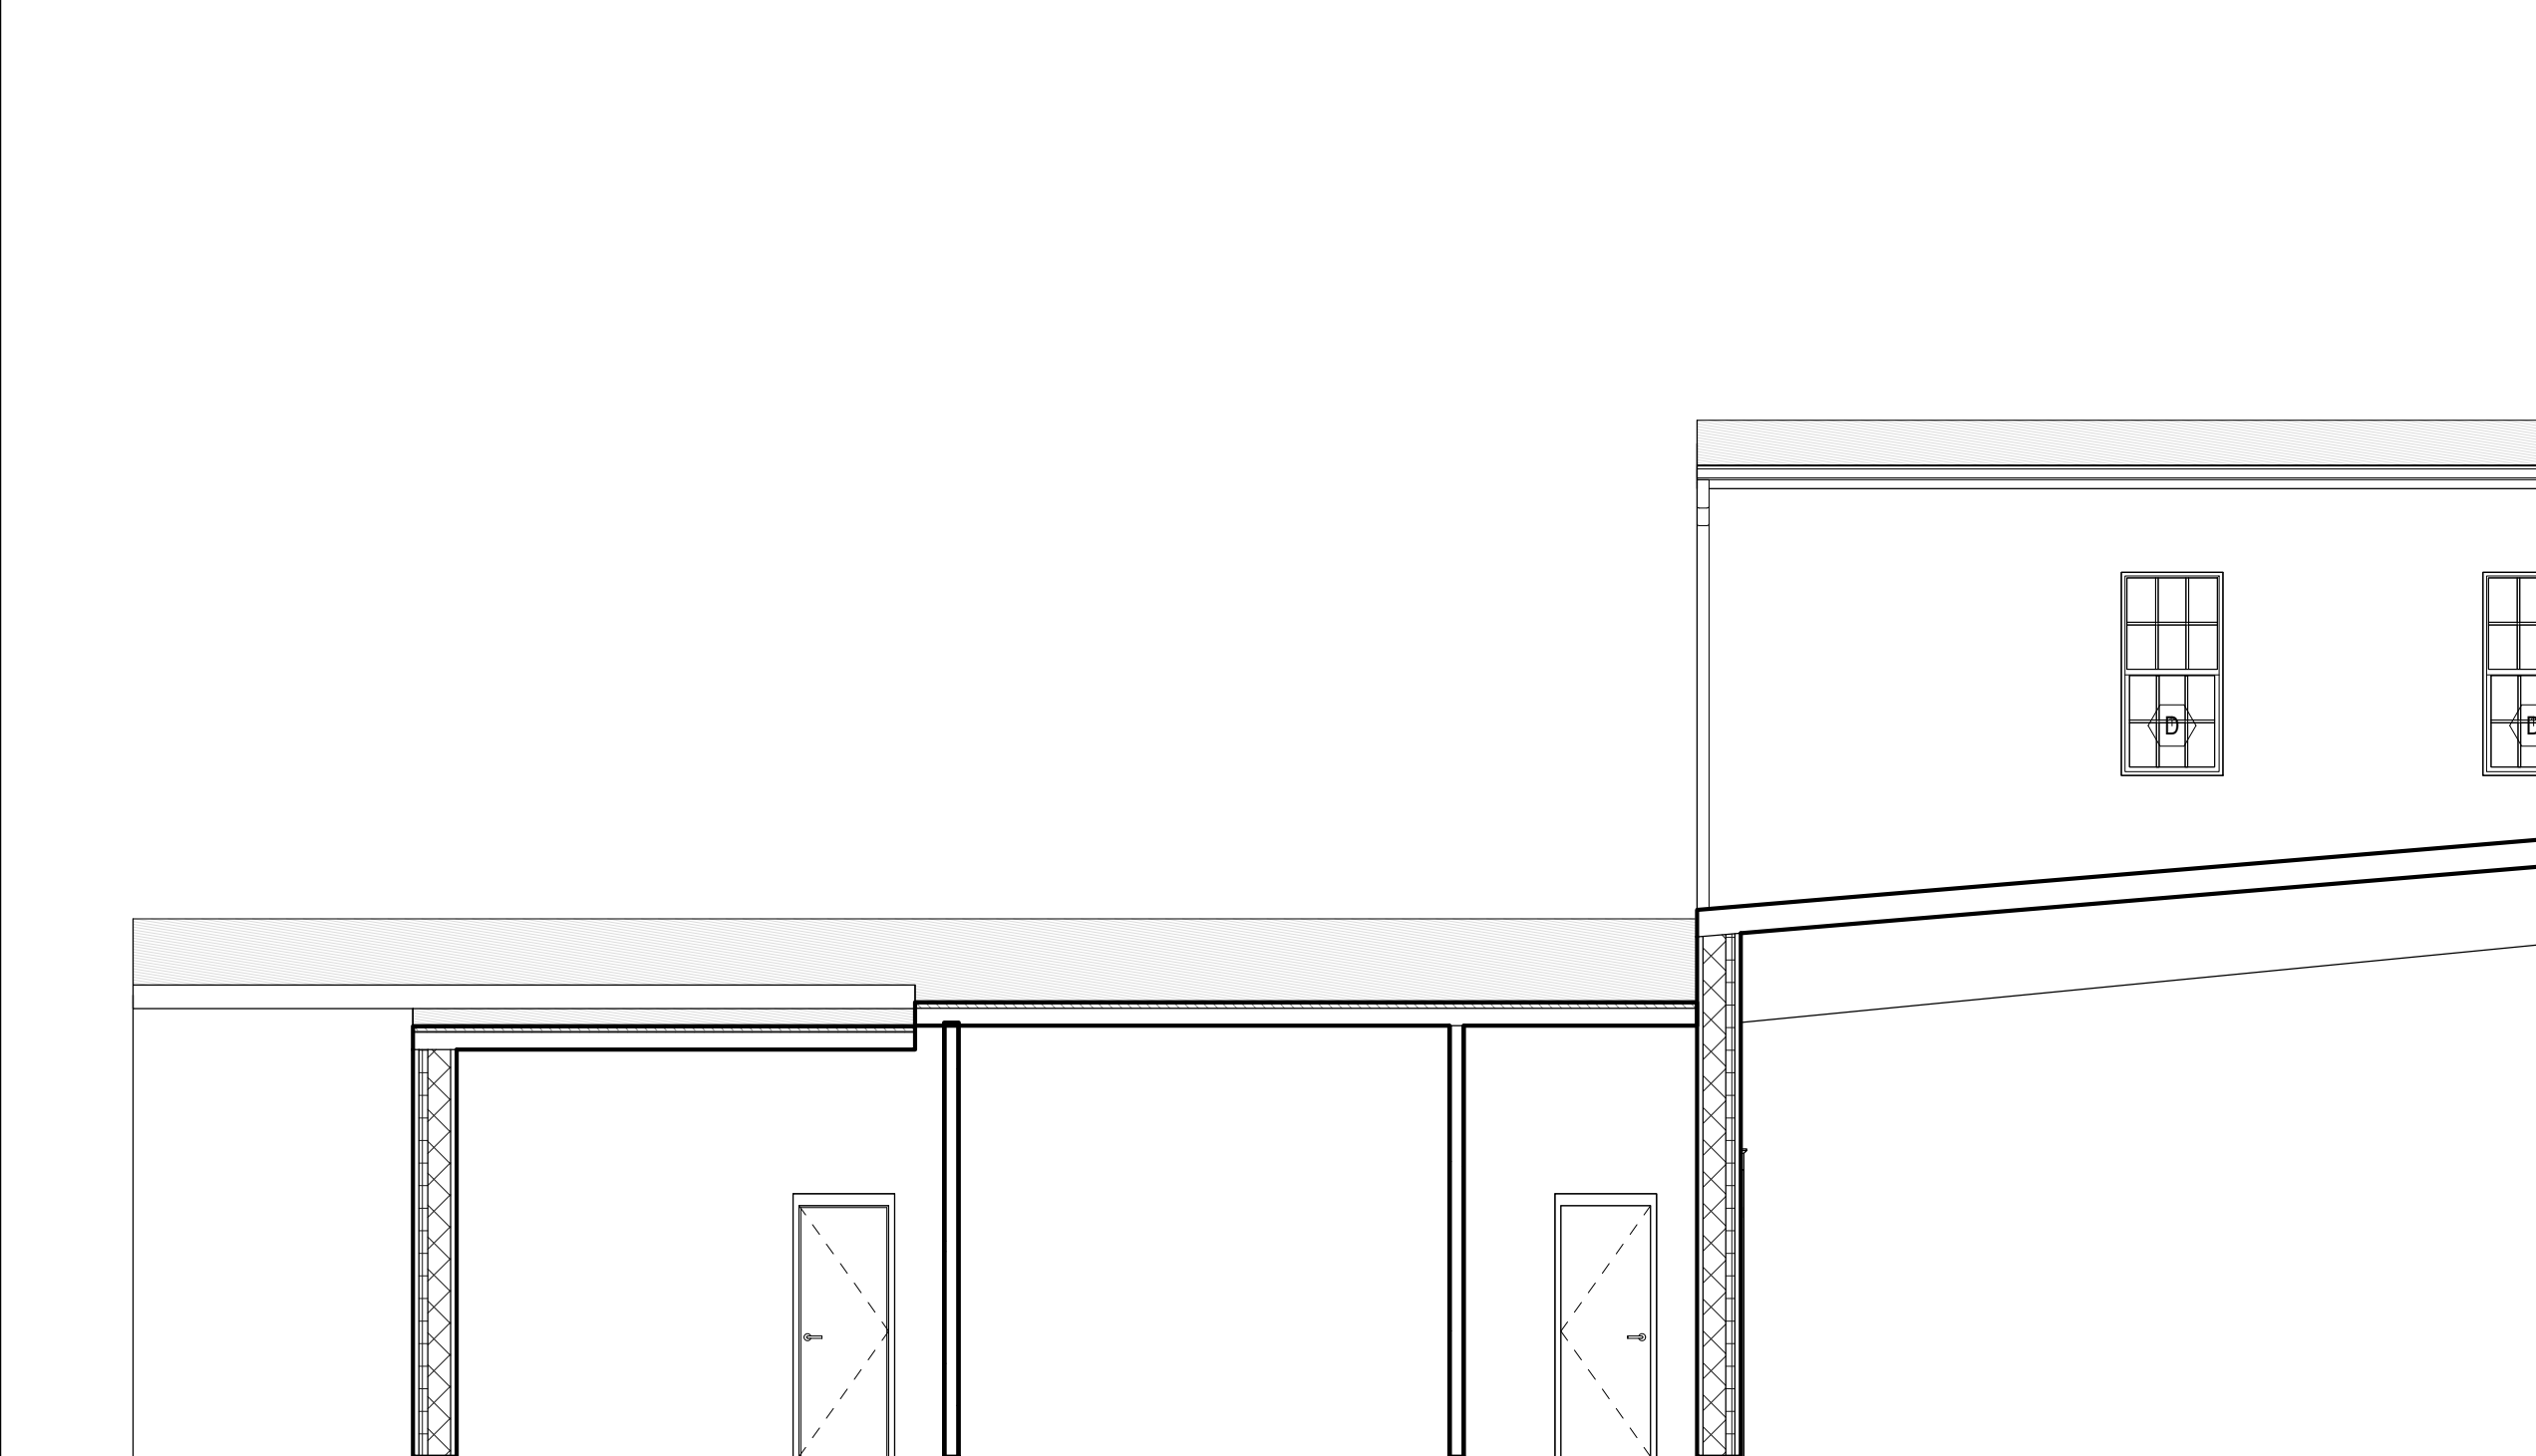
1 DECATUR STREET ELEVATION  
SCALE: 1/4" = 1'-0"

1. THE BUILDING RECEIVED SIGNIFICANT DAMAGE IN HURRICANE IDA, INCLUDING COLLAPSE OF THE EXISTING SLATE ROOF AND DAMAGE TO THE MASONRY STRUCTURAL WALLS. DEMOLITION AND CLEANUP HAS BEEN PERFORMED ON SITE AND ALL HISTORIC MATERIALS, INCLUDING BRICK, SLATE SHINGLES AND WOOD SHUTTERS, HAVE BEEN SALVAGED FOR REINSTALLATION. WHERE SALVAGE QUANTITIES ARE NOT ENOUGH TO COMPLETE REPAIRS, NEW MATERIALS WILL BE SOURCED TO MATCH EXISTING IN TYPE, SIZE AND COLOR.
2. THE COLLAPSED MASONRY PARTY WALL ADJOINING THE 925 DECATUR PROPERTY SHALL BE REPAIRED AS PART OF THE WORK SUBMITTED FOR 925 DECATUR ST. CONSTRUCTION WILL BE PERFORMED CONCURRENTLY FOR BOTH PROPERTIES.
3. EXTERIOR MASONRY AND WOOD TRIM TO BE REPAINTED, COLORS TO MATCH EXISTING.

- 04 REPAIR EXISTING MASONRY PARTY WALL USING SALVAGED BRICK. GROUT TO MATCH EXISTING.
- 06 RECONSTRUCT ROOF FRAMING. PITCH TO MATCH PREVIOUS. PROVIDE NEW PLYWOOD DECKING AND ROOFING PAPER. INSTALL SALVAGED NATURAL SLATE SHINGLES. IF ADDITIONAL SHINGLES ARE REQUIRED TO COMPLETE INSTALLATION, NEW SHINGLES TO MATCH EXISTING TYPE, COLOR, AND SIZE.

- 07 EXISTING LOW SLOPE MEMBRANE ROOF TO REMAIN (NO WORK)
- 14 EXISTING WINDOW TO REMAIN. REPAIR DAMAGED SASHES AND TRIM. REGLAZE WHERE LITES ARE MISSING OR BROKEN

- 15 EXISTING SIGNAGE TO REMAIN
- 18 EXISTING BOARD AND BATTEN SHUTTERS. WHERE DAMAGED, REPLACE WOOD LIKE IN KIND AND PAINT. WHERE MISSING, REPLACE LIKE IN KIND, PAINT COMPLETE. REUSE ALL SHUTTER HARDWARE.
