HURRICANE IDA STORM DAMAGE ASSESSMENT

Upperline Condominiums

1114 Lyons Street
New Orleans, LA 70115

May 26, 2022

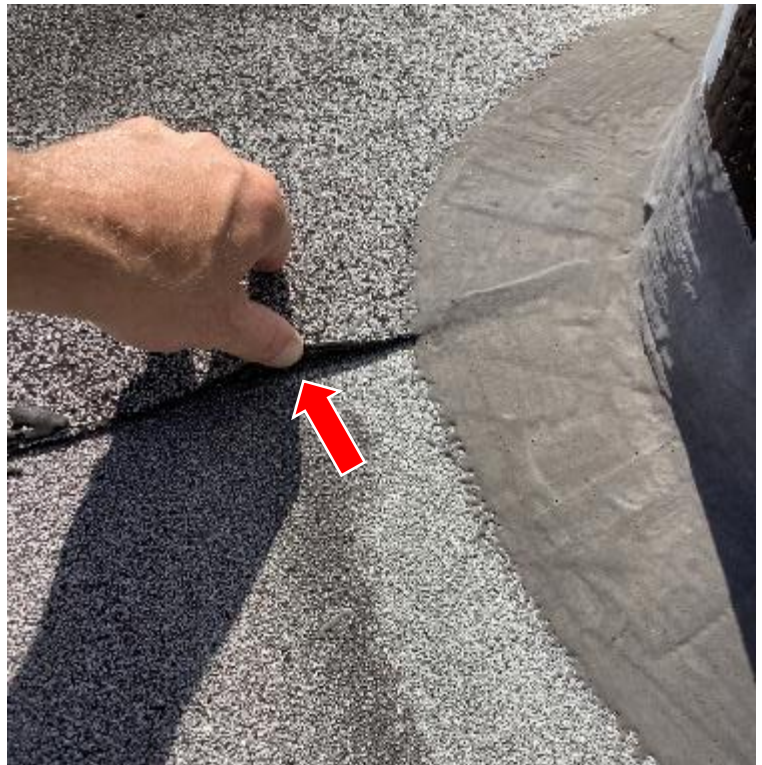
Photo 11:

An example of unadhered laps at the low slope roof MB membrane (*red arrow*).

IR imagery displayed multiple areas of moisture trapped beneath the MB membrane at the low slope roof. Core sampling verified the IR imagery and exposed saturated insulation beneath. All moisture damaged insulation must be removed and replaced. The extent of moisture trapped beneath the MB membrane displayed in the IR scan suggests that replacement of the roofing system may be less expensive and time consuming than performing isolated repairs due to the quantity of damage and the damage to the insulation. All water damaged roofing framing and decking, as observed from the attic space below and any damages uncovered by the process of remediation, should be addressed prior to the installation of new insulation and roofing.

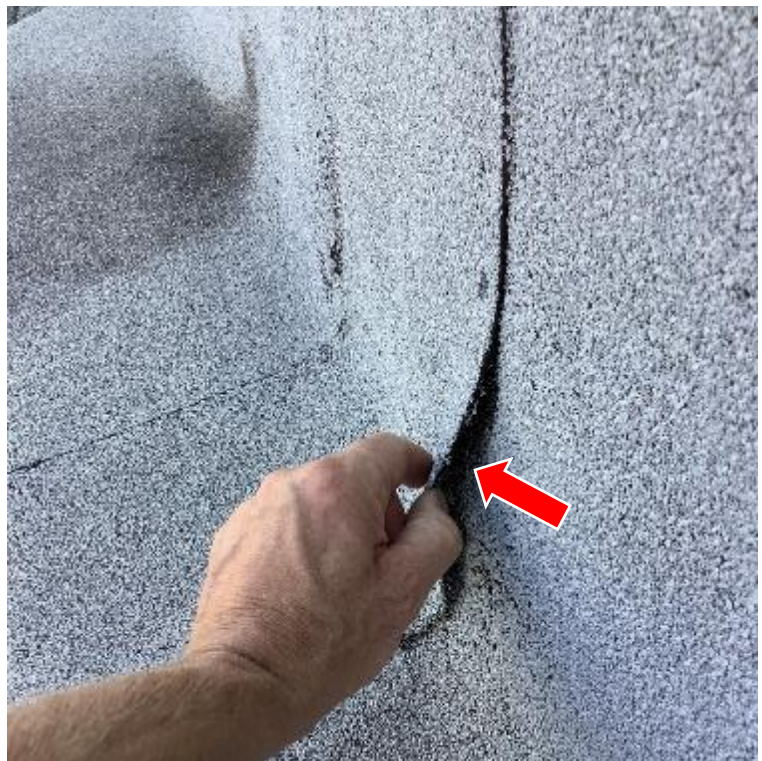
Photo 12:

An example of unadhered laps at the low slope roof parapet MB membrane (*red arrow*).

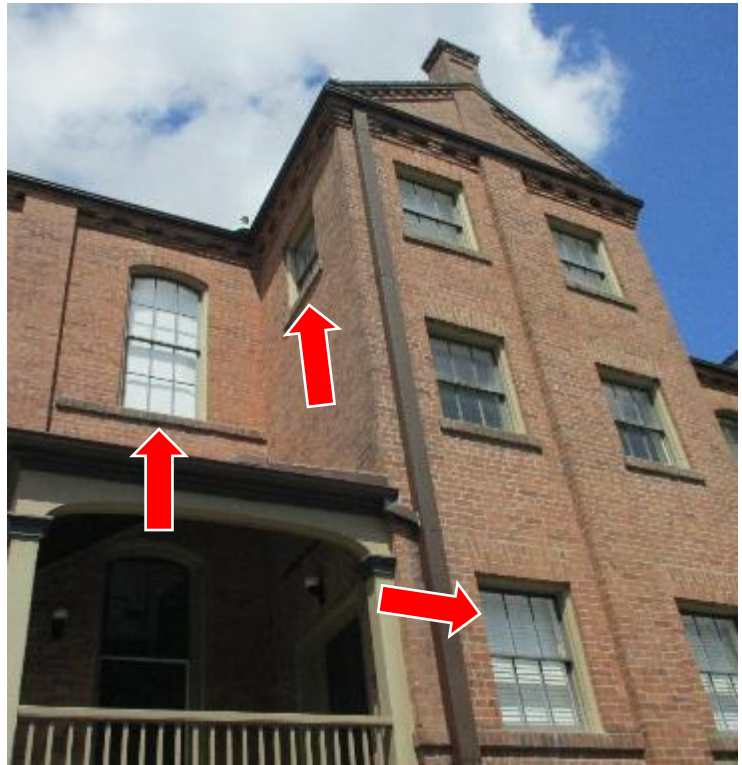
Photo 45:

The window systems present are reportedly original construction. These window systems predate water resistance testing and ratings and are likely not capable of resisting the conditions experienced in the storm event. Sash misalignment, broken panes, and loose glazing has been reported throughout the building. The aged sealants have been exploited by the storm worsening these conditions and leading to paths of water intrusion. All aged sealants should be removed and replaced and any window system deficiencies should be addressed. Water damaged interior finishes have been reported at most of the window openings and had been remediated prior to CES observations.

An overview of the typical windows at the original building (*red arrows*) at the south end of the property.

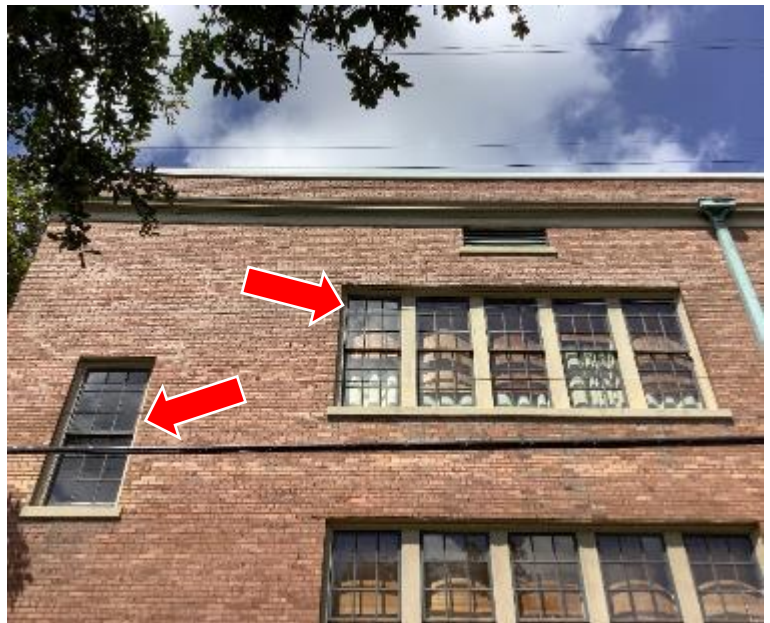
Photo 46:

An overview of the typical windows at the east and west elevations of the north addition (*red arrows*).

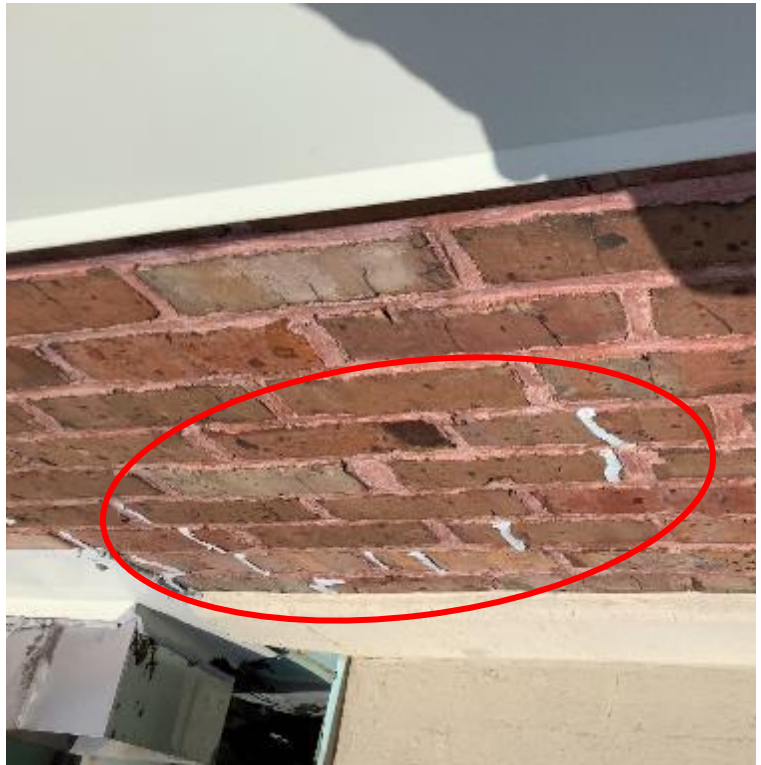
Photo 53:

Displaced flashing at the building transition to the parapet (*red ellipse*).

cupola should be addressed accordingly. The displaced and damaged parapet counterflashing should be replaced.

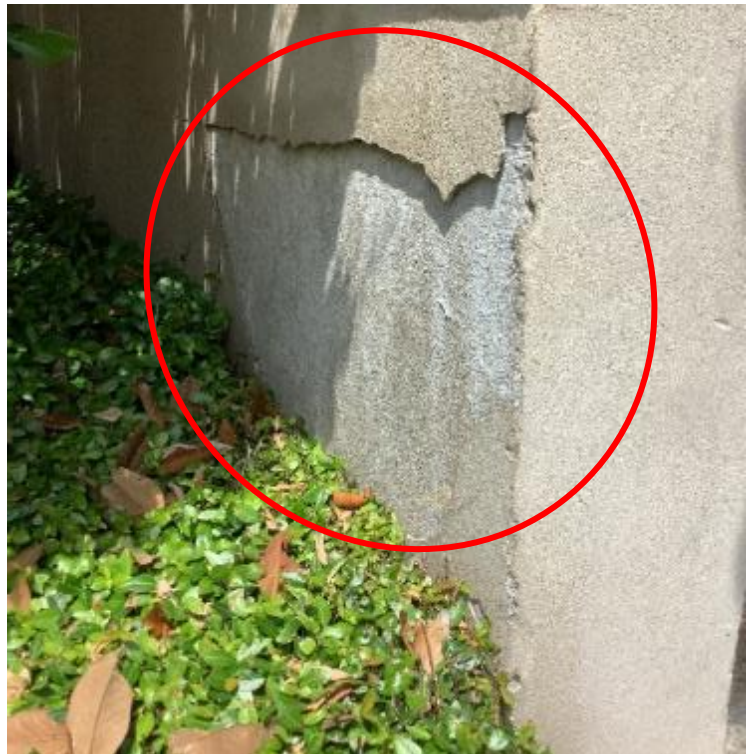
Photo 58:

An example of displaced DEFS coating (*red ellipse*).

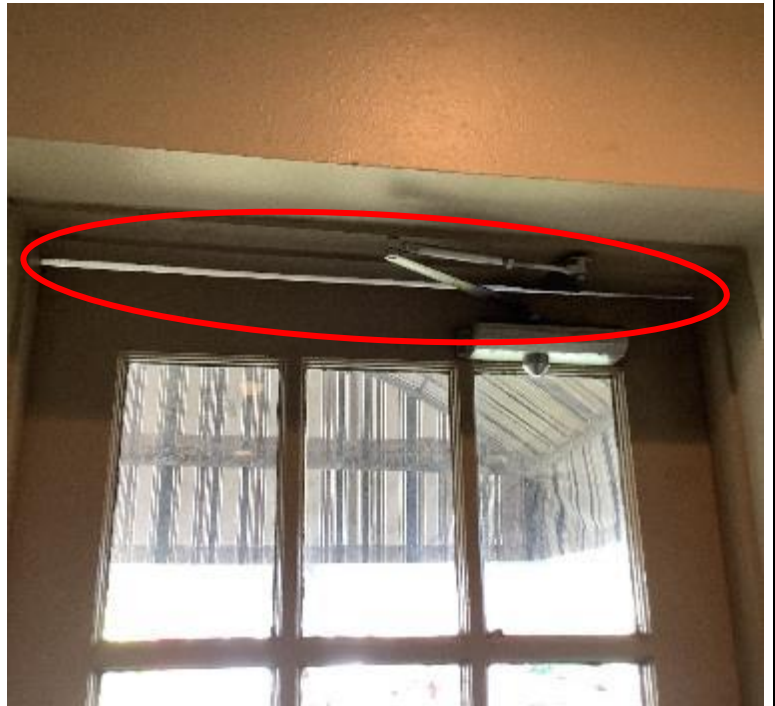
Photo 63:

The north entry door has been racked and no longer sets flush within the door frame (*red ellipse*).

All fencing around the property had been replaced at the time of CES observations. The reported damages to the fencing are consistent with hurricane damages. The racked entry door observed at the north elevation should be replaced. Grading should be performed to inhibit the intrusion of surface water at basement doorways.
