# NEW ORLEANS HISTORIC DISTRICT LANDMARKS COMMISSION CENTRAL BUSINESS DISTRICT HISTORIC DISTRICT LANDMARKS COMMISSION

Re: 722 Cadiz Street

Attached, please find a report regarding an appeal of the Historic District Landmarks Commission's decision to deny an application to demolish the Contributing-rated structure at 722 Cadiz Street.

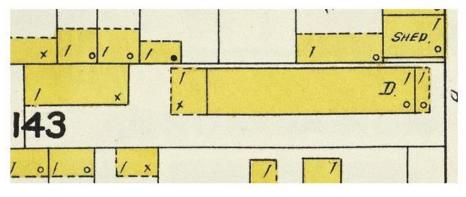
# Sanborn Maps:

and 1900 and it first appears on the 1896 Sanborn map as a one-story, single-family residential building located closely to the right side property line. The building appears to have been altered and expanded periodically over the years and alternated between residential and commercial use. However, it appears that it has retained much of its original type, scale, massing, roof form, and footprint to this day with the exception of the front porch which may be a later addition after the 1951 Sanborn map.

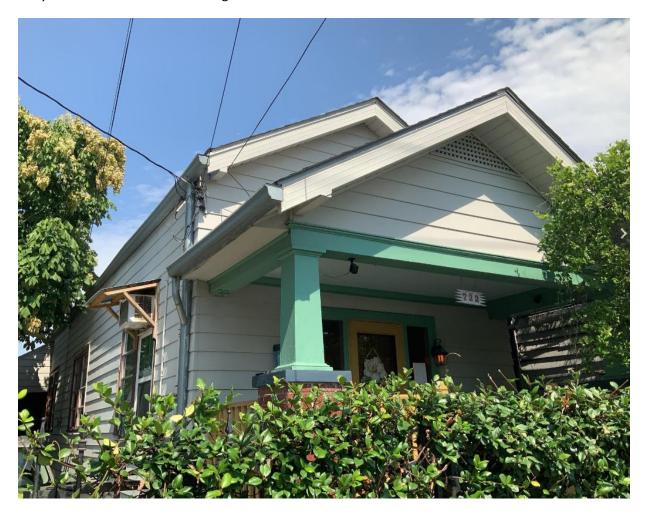
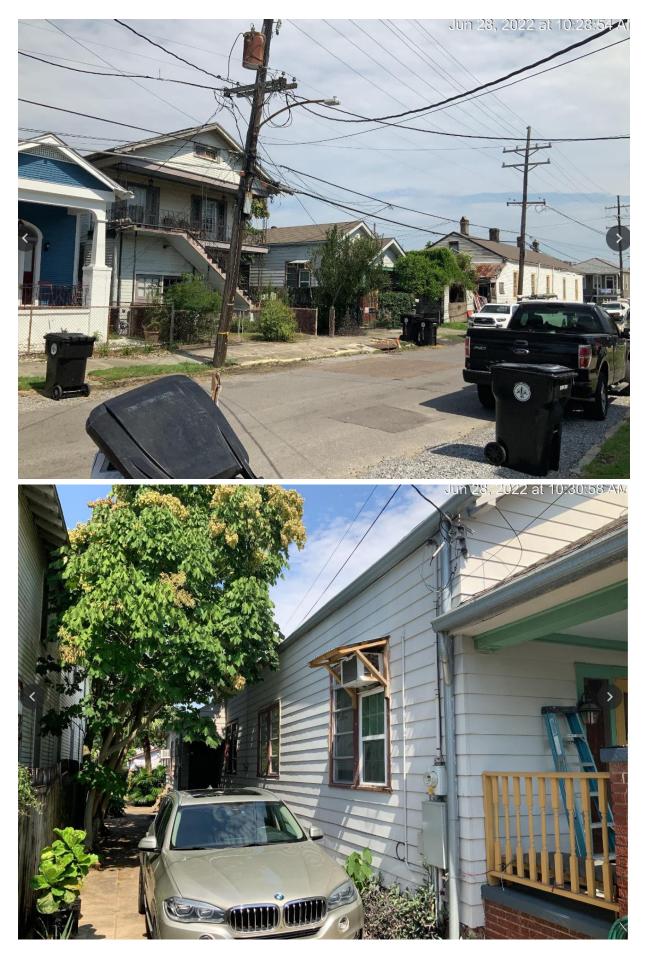
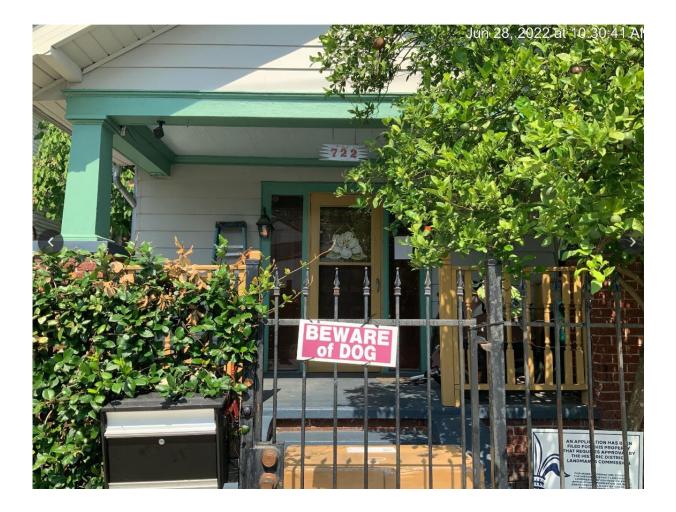
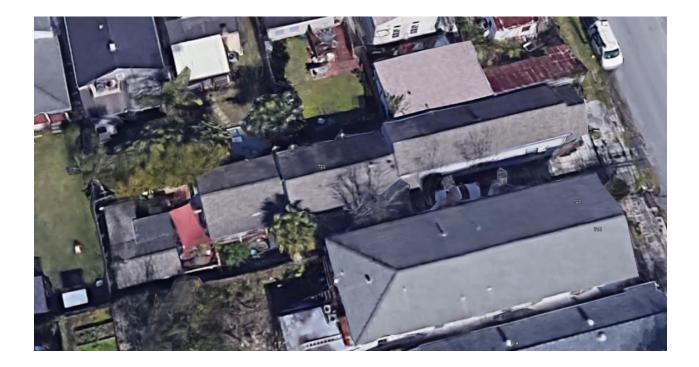
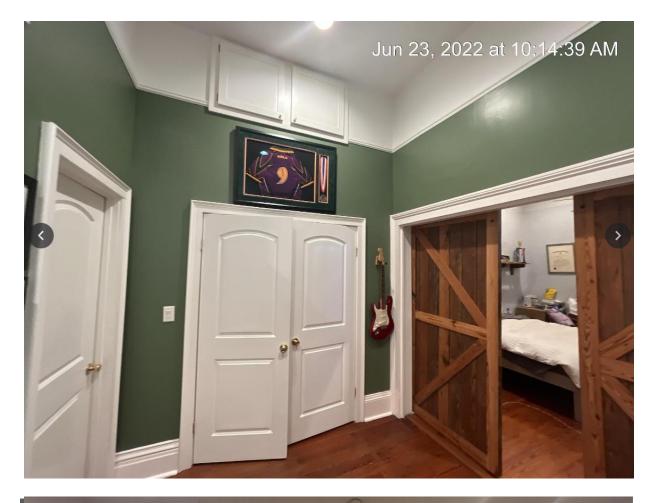
- The condition of the building or structure: HDLC Inspector Alex Nassar performed an interior/exterior visual inspection on June 23, 2022 and determined the building to be in good condition. On the exterior, the building walls appear straight and plumb with no signs of structural defect. The masonry piers do not appear to be settling or leaning on the perimeter and overall the foundation appears to be in good condition. The front three rooms of the building are in good condition and likely constitute the original historic building, with the rear additions being lower in header height. There is only about 18" between the right side wall and the property line where an adjacent accessory structure limits access to this side of the building. On the interior, the building is in good condition, occupied and well maintained. There is no evidence of water intrusion or termites. However, the floor surface of the front three rooms is not level and slopes toward the right side property line. Leveling the building would be very difficult due to the limited access on that side. The full inspection report is included below for reference.

- The occupied raised single family residential building appeared to be in good condition.
- The structure had a pier and beam foundation, wood framed superstructure with aluminum siding.
- The roof is covered with architectural asphalt shingles that appeared to be in good condition.

- The front three rooms are in good condition and likely constitute the original building.
- There appears to have been a series of 2-3 rear additions over the life of the building. In these areas of the building, the ceiling height is lower than the front three rooms.

- The original windows have been replaced throughout with historically inappropriate aluminum single pane windows.
- The masonry piers do not appear to be settling or leaning on the perimeter of the building.
   Overall, the building foundation appears to be in good condition.

- The exterior walls are straight and plumb and do not show signs of structural defect.

- The interior of the building is in good condition, occupied, and well maintained.
- There is no evidence of water intrusion or wood destroying insects.
- The interior floor plan has been modified.
- The floor surface of the front three rooms is not level and has a consistent slope towards the right-side property line. Levelling the building would be very difficult if not impossible due to the lack of access to that side of the building.

Overall, the building shows no signs of neglect, wood destroying insects, water intrusion or vegetation damage. The building is located on the site in a manner that is not conducive to proper maintenance or reshoring.
